Our Ref: 212167/NMW/sej

7 April 2022

**Re: PLAS TAN Y BWLCH, MAENTWROG, BLAENAU FFESTINIOG LL41 3YU****Executive Summary**

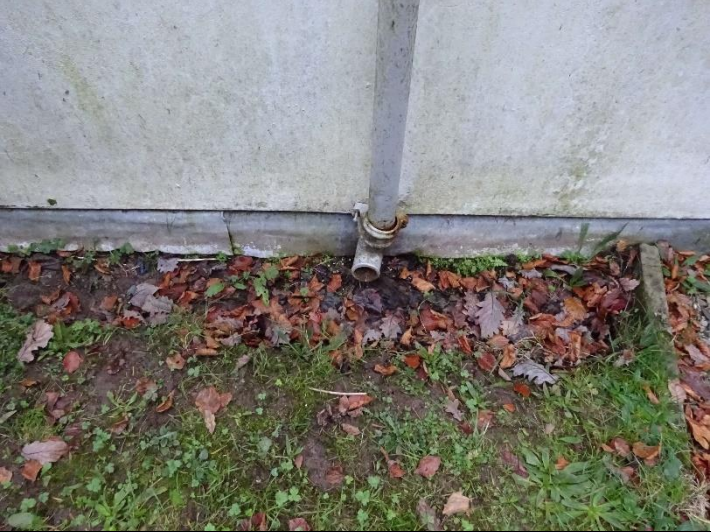
Comments	File	Photograph
Clogged surface water channel over the green roof.	7

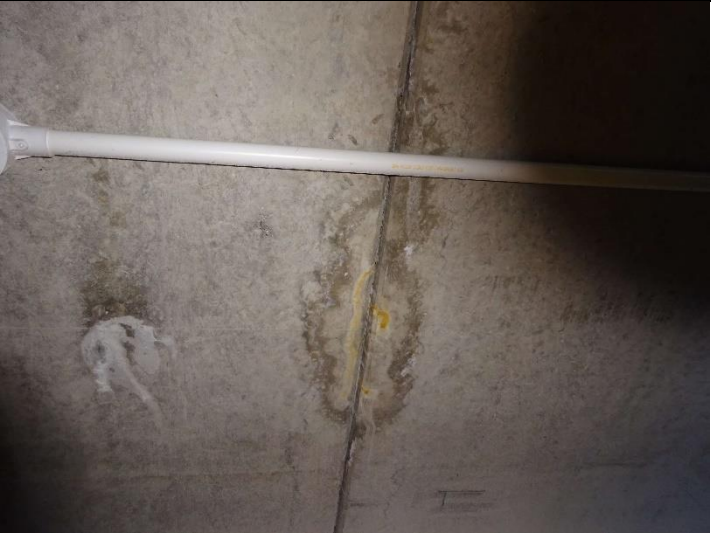
A photograph showing a metal downpipe at the base of a concrete wall. The pipe is partially blocked by a dense layer of brown and red autumn leaves. The ground in front of the pipe is covered with green weeds and more fallen leaves.
Water staining between the green roof's concrete sections.	8

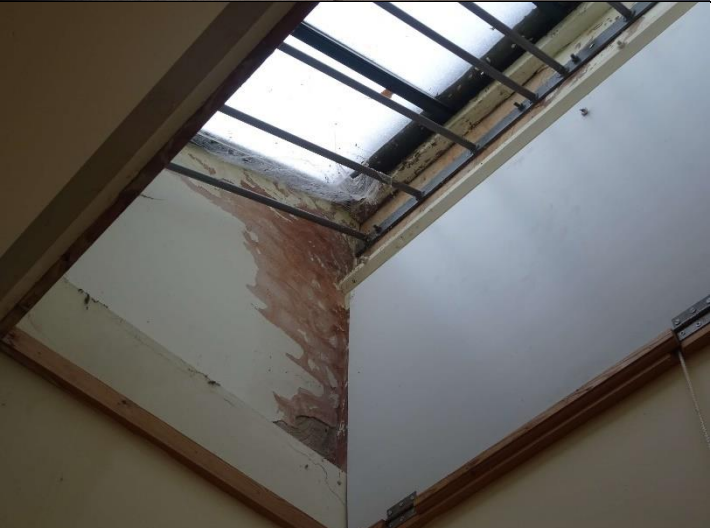
There was evidence of penetrating dampness to the glazed mono-pitched roof over the AV Room which manifested as staining to plasterwork to the roof's supporting walls. This is likely to be a result of the missing and partially detached flashings combined with poor detailing at its junction with the flat roof. We also noted that part of the green roof's EPDM waterproofing layer appears to have been pulled away from the structural deck which will inevitably exacerbate this issue.

A close-up photograph of a concrete surface, likely a roof or wall. A horizontal metal pipe runs across the middle. Below the pipe, there is a prominent, irregular brown stain on the concrete, indicating water damage or staining.
Water damaged plaster to wall supporting glazed roof.	9

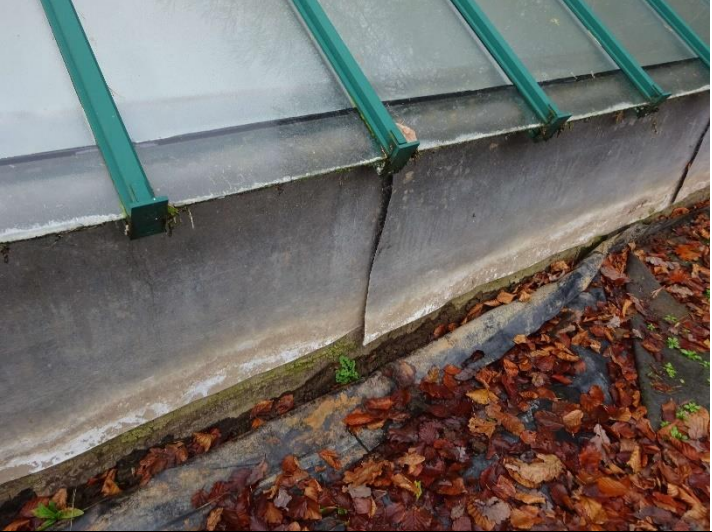
It is generally in serviceable condition, however, we noted evidence of penetrating damp internally which may relate to the lack / missing lead flashings at the junction with the green roof. We recommend that these are reinstated within the short term and that a robust weatherproofing detail is designed and formed with the former stable's green roof.

Comments	File	Photograph
Loose flashing to glazed roof and poor detailing at green roof junction.	10

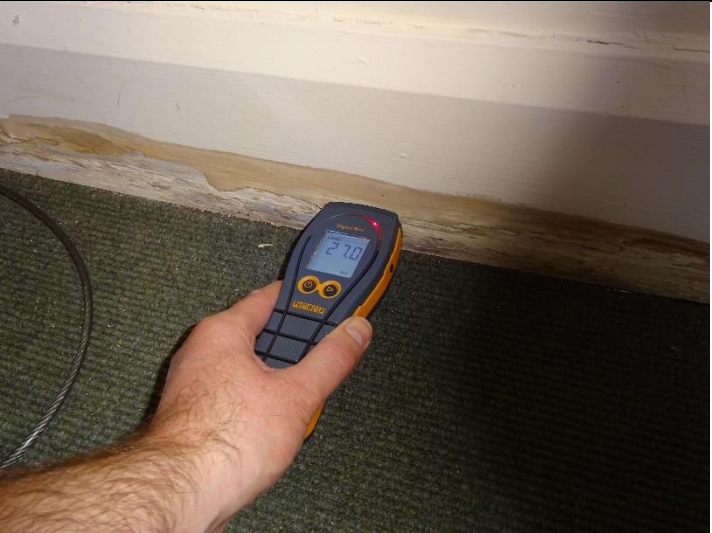
Within the AV Room and the lobby immediately adjacent, were water-damaged skirting boards, wall plaster and carpets. We suspect that this is a result of a leak associated with either the wastewater pipe or supply pipe serving the sink in the cleaner's cupboard off the AV Room. There is also staining to the boxing-in to an internal wall within the lobby which may also be linked with the aforementioned defect. Further investigation will be required to identify the source of the leak (s) and repairs effected.

Water damaged skirting boards in AV Room.	11

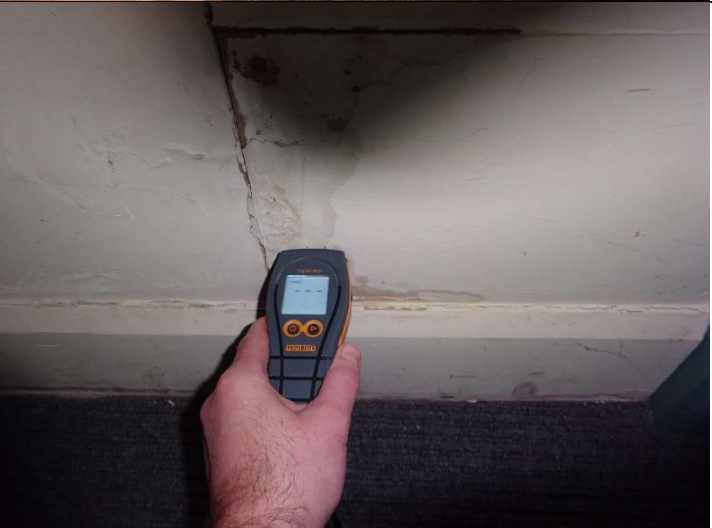
Water damaged boxing – in to lobby adjacent to AV Room.	12

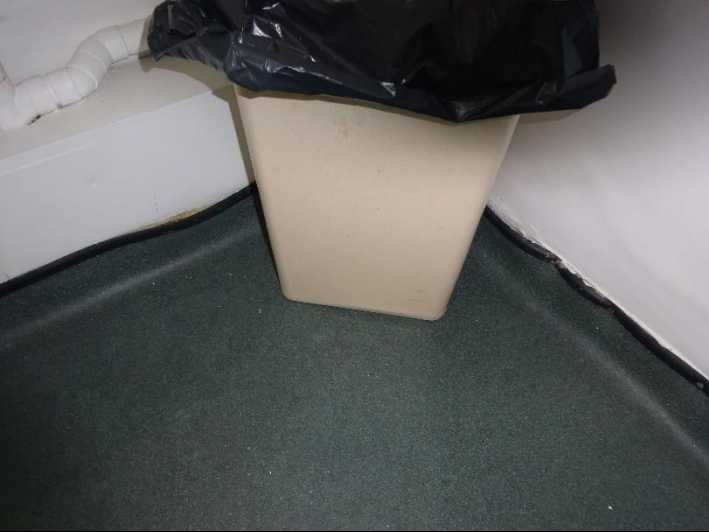
There was evidence of a leak within the disabled WC and kitchen as the upstands to the vinyl floor coverings were partially detached from the wall and some staining was visible to the wall plaster at low level.

Comments	File	Photograph
Debonding vinyl upstands in disabled WC due to dampness.	13

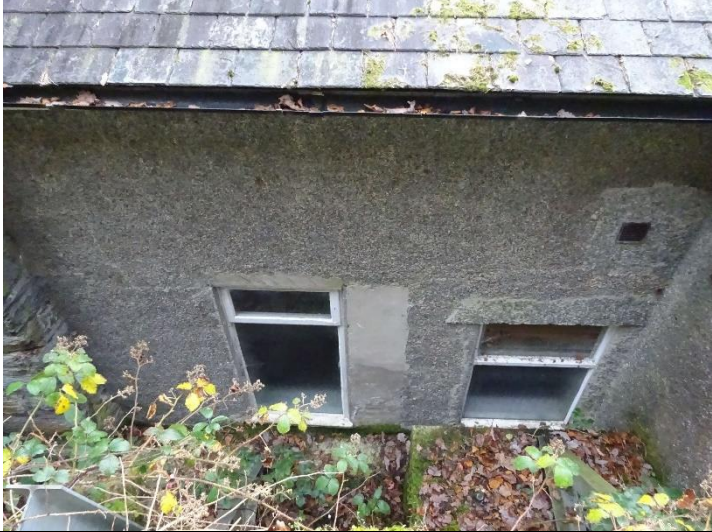
We suspect that in part this is due to the render applied to the wall extending all the way to the ground. It therefore allows moisture to “wick-up” the wall which can give rise to problems with dampness. Render should be removed to 150mm above ground level and a bell mouth drip detail formed at the base of the render, designed to encourage rainwater to fall away from the base of the wall and thereby reduce the chances of dampness penetrating.

Comments	File	Photograph
<p>Render extending to the ground which could cause dampness.</p>	<p>16</p>

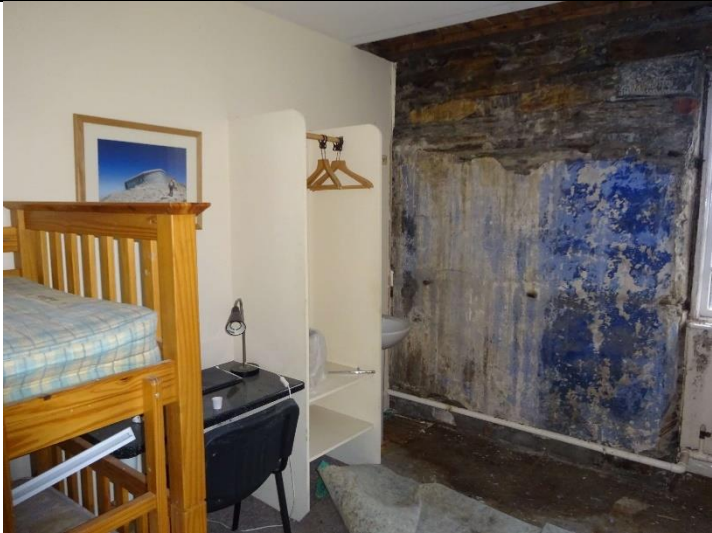
Within the three-storey annex, there is evidence of water penetration in Room 26. Damaged plasterboards have been removed, exposing the remains of the original lime plaster and ashlar substrate. This appears to be a consequence of a leak from services above, but equally some penetrating dampness cannot be ruled out as a contributory factor. Further investigation will be required and remedial works undertaken.

<p>Water damage to external walls (room 26).</p>	<p>17</p>

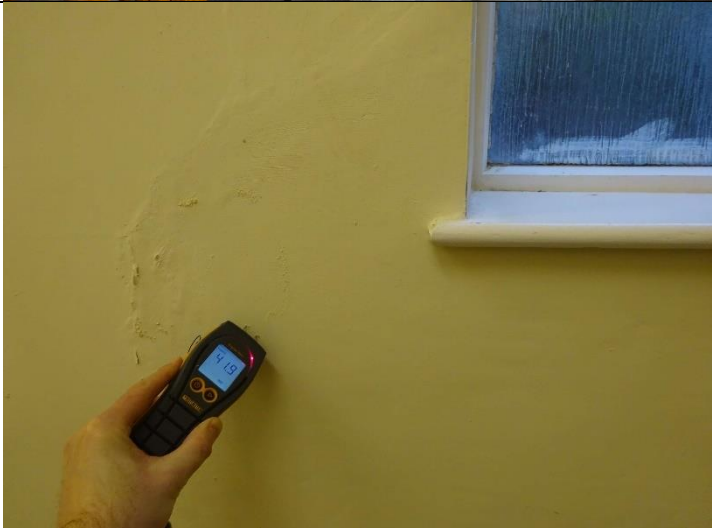
To the ground floor WC / shower room, there was extensive dampness to the rear external wall up to 1.2mm above finished floor level and around the associated window jamb. This we believe is also a consequence of the render extending to the base of the wall. Refer to previous comments and recommendations in this section.

<p>Water damage around ground floor WC / shower room's external walls (three-storey annex).</p>	<p>18</p>

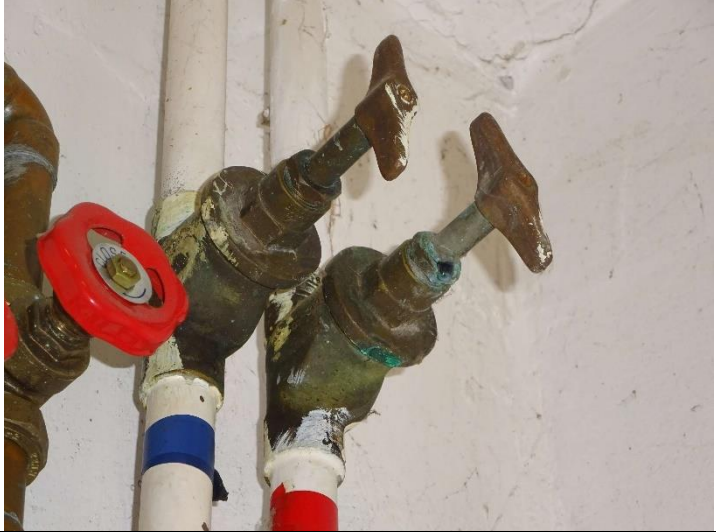
We also noted dampness to the walls within the entrance hall and the bathroom and to the rear left-hand reception room / office floor. We identified a stop tap positioned at high level within the bathroom was dripping onto the floor. Given the extent of staining to the floor coverings and wall surfaces immediately adjacent, it appears to have been ongoing for some time. It may have also caused at least some of the dampness within the immediate area and to the entrance hall and rear reception room / office. This should be repaired within the short term and allowed to dry out. Patch redecoration and renewal of floor coverings can then be undertaken.

Comments	File	Photograph
Leaking stop tap in Caretaker's flat.	19

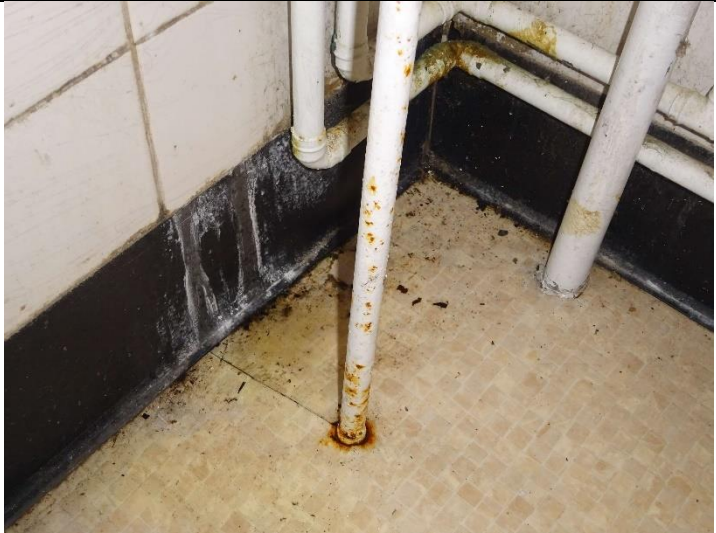
Floor immediately below leaking stop tap.	20

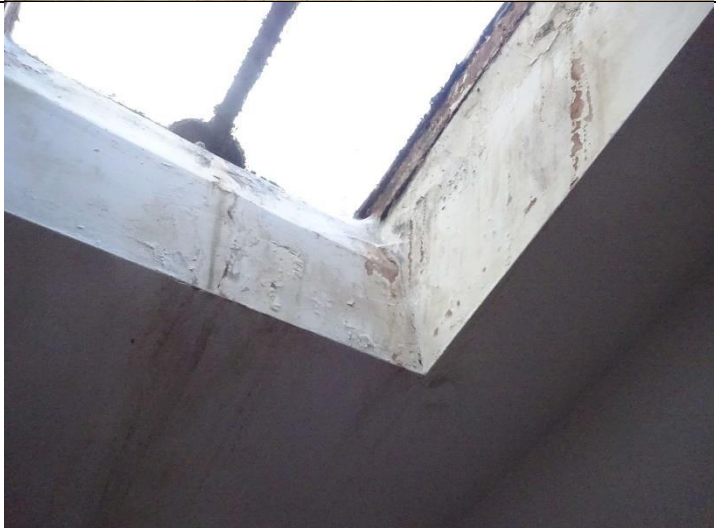
Around the roof light in the two-storey annex's rear roof slope (immediately above the stairway which connects it to the three-storey annex), is evidence of penetrating dampness. When tested with a moisture meter, we identified that the plasterboard was dry, however, we recommend that investigation and remediation is undertaken.

Water staining around two-storey annex's rooflight.	21

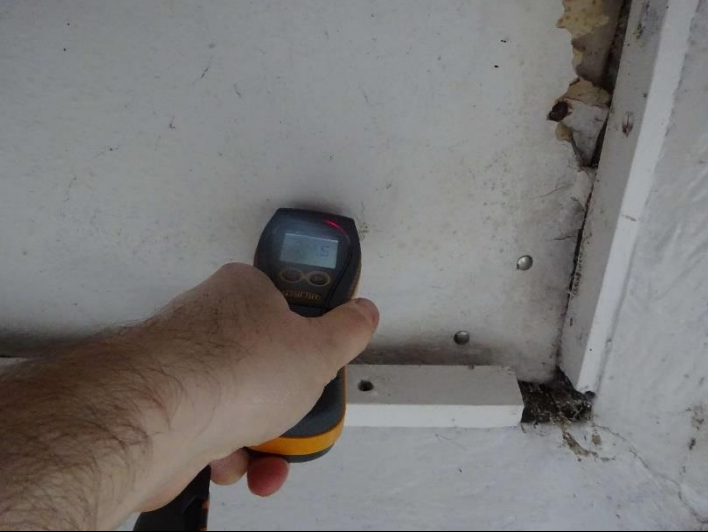
Within Room 15, there was evidence of penetrating damp to the ceiling over the bay window and some staining further into the room which may be a result of a failure of the lead sheet covering and flashings to the flat roof immediately above or to the outlet associated with it. When tested with a moisture meter, we identified that the material was damp which suggests that this is an ongoing issue and should be repaired.

Comments	File	Photograph
Penetrating dampness to ceiling over room 15's bay window.	22

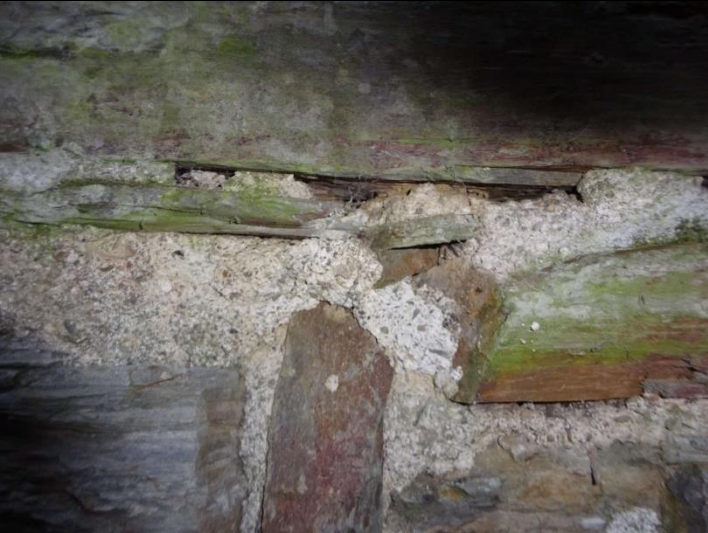
To the ashlar walls, there is evidence of eroded, friable and missing mortar to the joints of the external walls in various areas comprising the former stable's gable end walls and in various locations to the three-storey annex and to a lesser extent, the two-storey annex.

Missing / friable mortar to external walls.	23

We recommend that repointing is undertaken within the short term in order to reduce the likelihood of penetrating dampness within the accommodation.

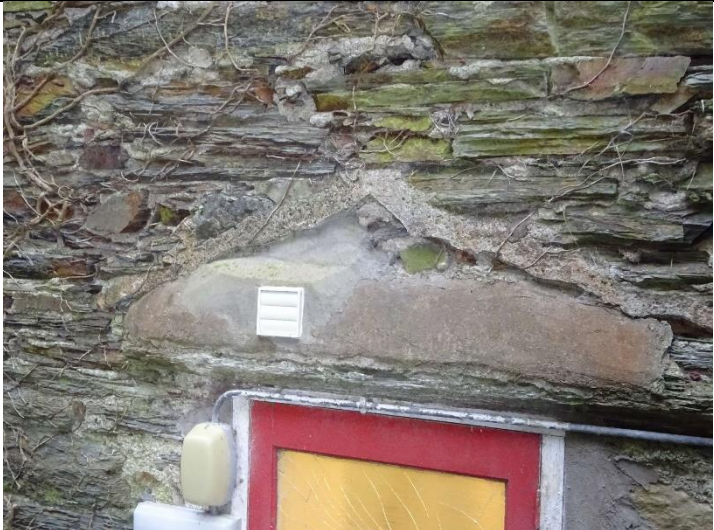
We noted that in some areas, as is typically found, the mortar mix used in the repointing has a cement content that would not be present in the original mix and is therefore rather "hard". The original mortar would have had a mix incorporating lime to maintain breathability and a degree of flexibility to accommodate movement. Over the longer term the cement-based mix might result in earlier deterioration of the adjoining masonry and could lead to problems with water penetration.

Comments	File	Photograph
Inappropriate cementitious mortar repair.	25	 
Further related image.	26

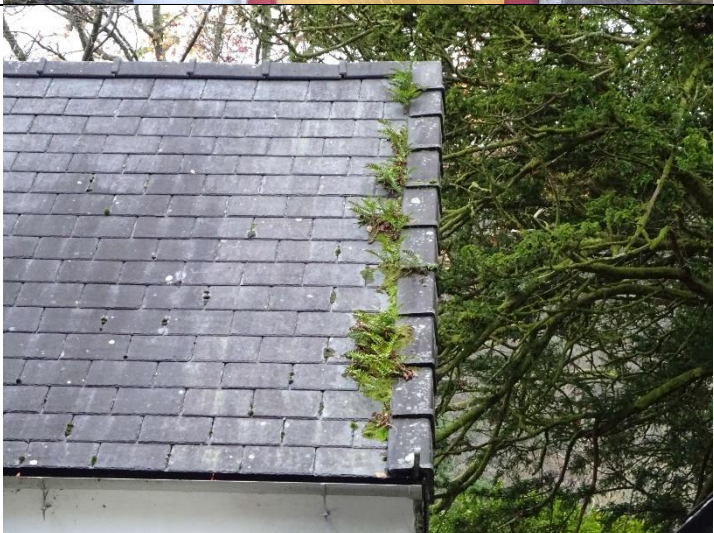
We noted some minor quantities of moss and other vegetation to some slopes and verges which should be periodically removed as their presence can often lead to blockages within rainwater fittings below and damaged verge mortar.

Vegetation growing along roof verge.	27

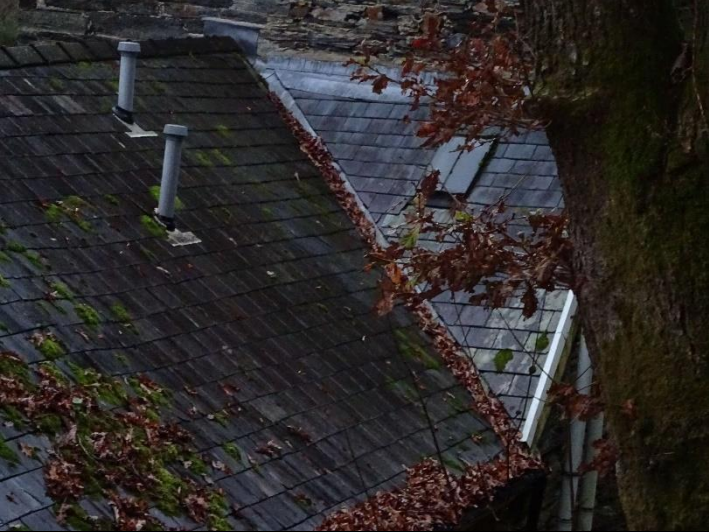
We noted debris to (leaf litter, etc) to clogging a number of the valleys and valley gutters which should be cleared. Particularly of note was the valley to the rear roof slope of the two-storey annex which in allowing penetrating dampness which is manifesting as water-staining to the ceiling below.

Comments	File	Photograph
Partially clogged valley.	31

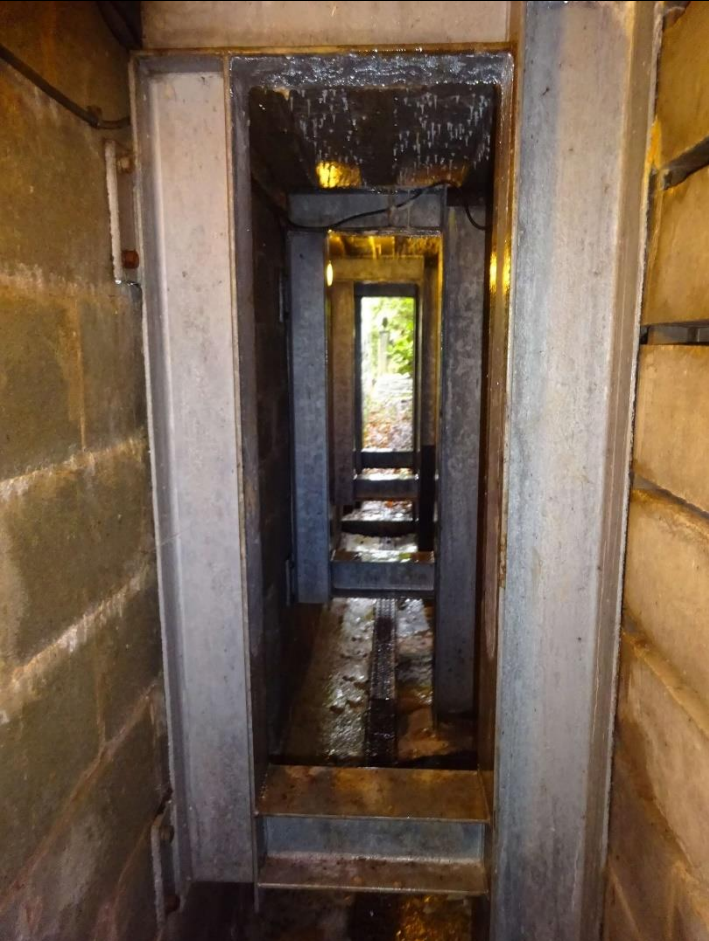
We also noted from a vantage point within a trench/passageway between the auditorium's rear external wall and the hillside, that the EPDM waterproofing layer stopped short of the rear wall. The effect of which allowed penetrating dampness within the trench/passageway and through the structural concrete deck.

Penetrating dampness through the green roof into the trench / passageway.	32

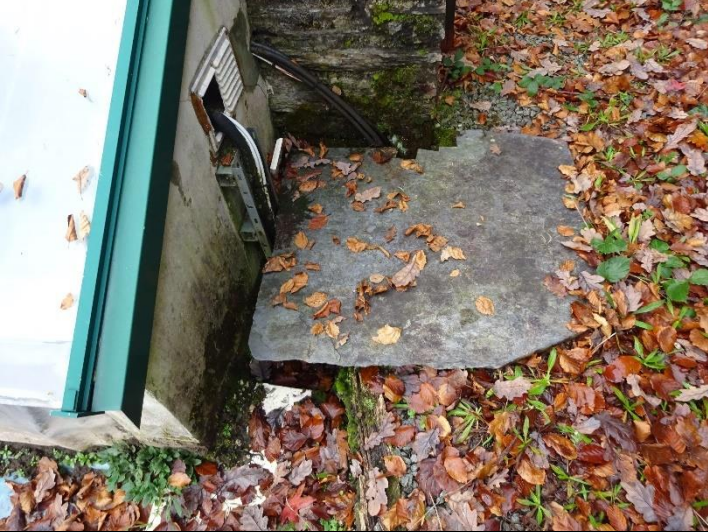
To the rear left-hand corner of the flat roof is a services duct where various data and power cables are located. The duct has been covered by a loose-fitting piece of slate which only provides superficial protection against penetrating dampness and is therefore only considered a temporary solution. We recommend that a permanent and more satisfactory form of weather proofing detail is formed in order to prevent the ongoing water ingress within this area and should be done in conjunction with main re-roofing works to the flat roof.

Comments	File	Photograph
Cable ducting temporary cover.	33

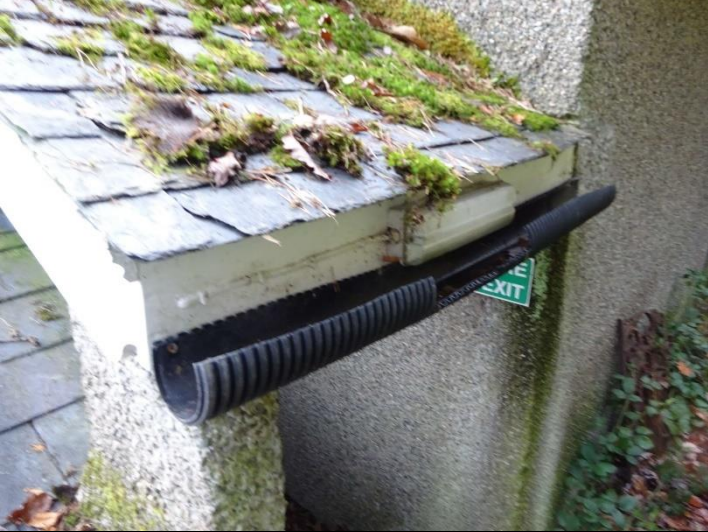
Comments	File	Photograph
Inappropriate rainwater disposal.	36

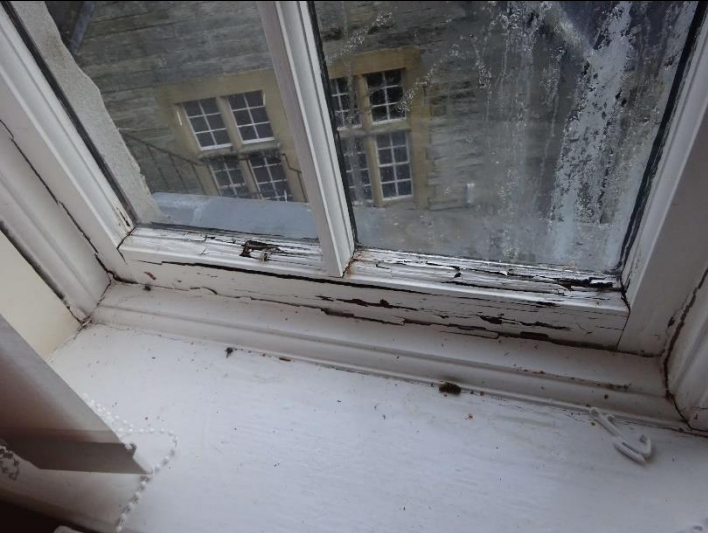
Decay to window's timber frame.	37

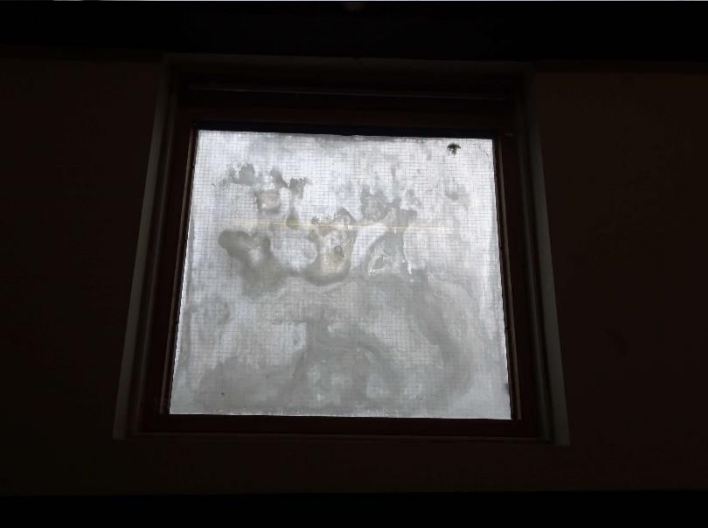
Hermetic seal failure to rooflight's double glazing.	38

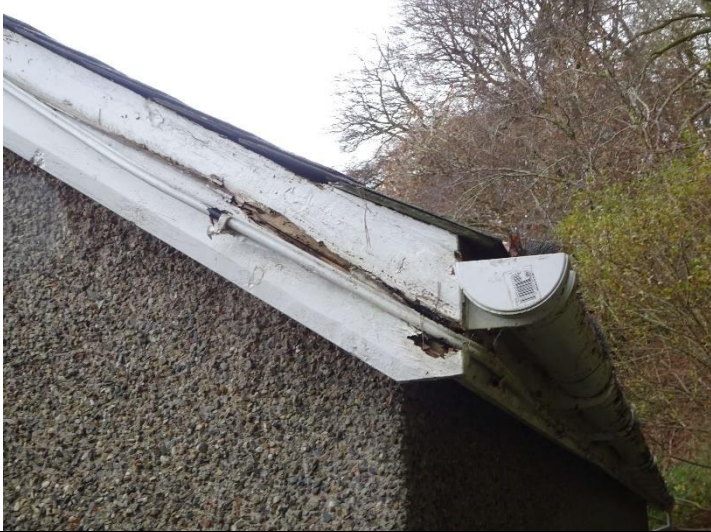
Comments	File	Photograph
Decayed bargeboard to Field Work Room.	39

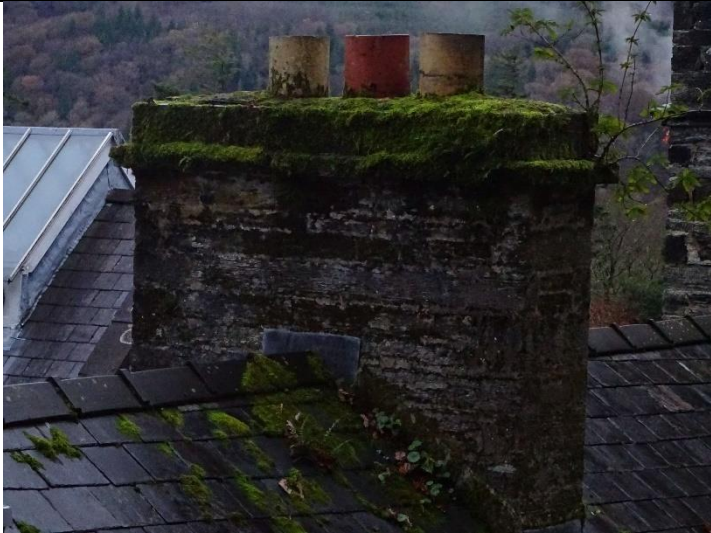
Chimney stack covered with extensive vegetation and no cowls.	40

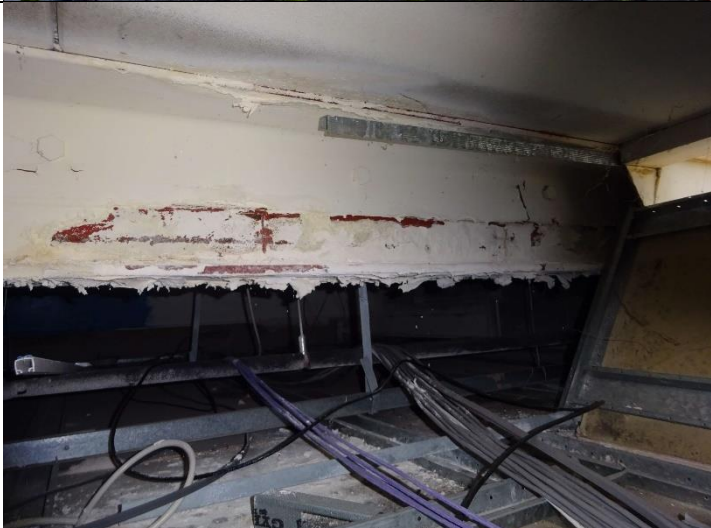
Flaking paintwork to steel beam as viewed from AV Room's loft hatch.	41

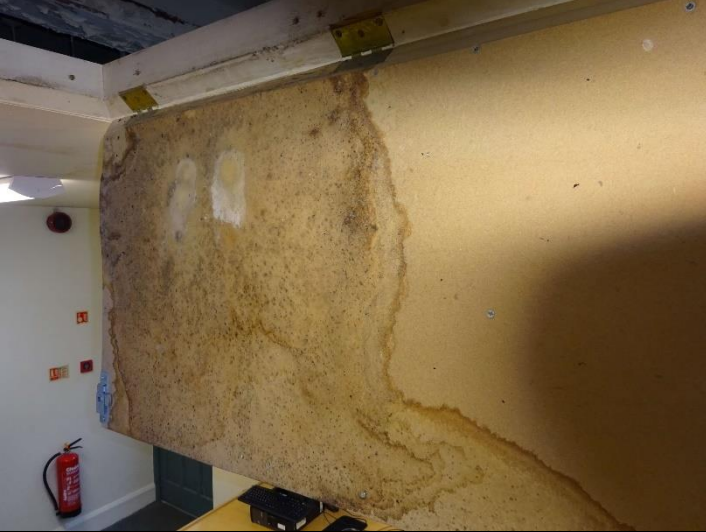
Comments	File	Photograph
Water staining to underside of AV Room's loft hatch.	42

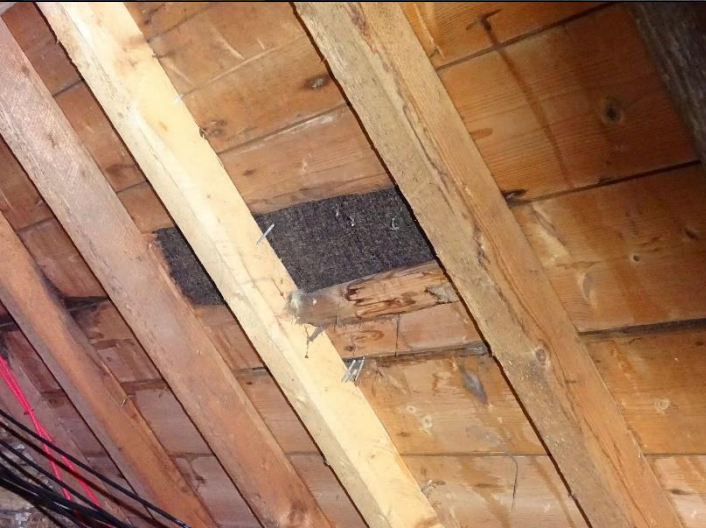
A photograph showing the interior of a roof void. The timber cladding is heavily stained with brown water marks, indicating historical penetrating damp. The staining is particularly visible on the horizontal wooden planks. The structure appears aged and shows signs of long-term moisture exposure.
Water staining to closeboarding in three-storey annex's roof void.	44

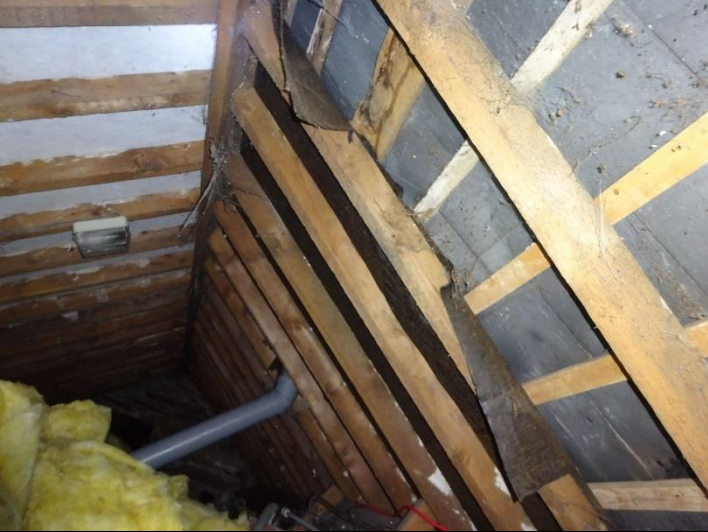
Comments	File	Photograph
Area of missing sarking layer (two-storey annex).	45

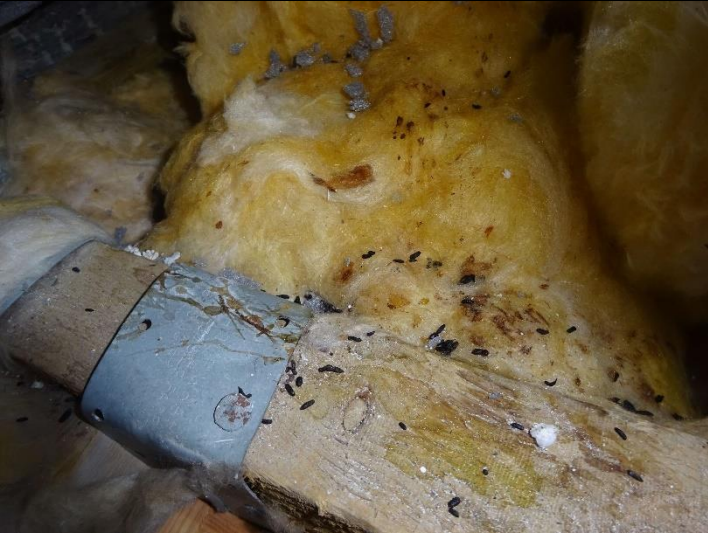
Mouse droppings in roof void.	46

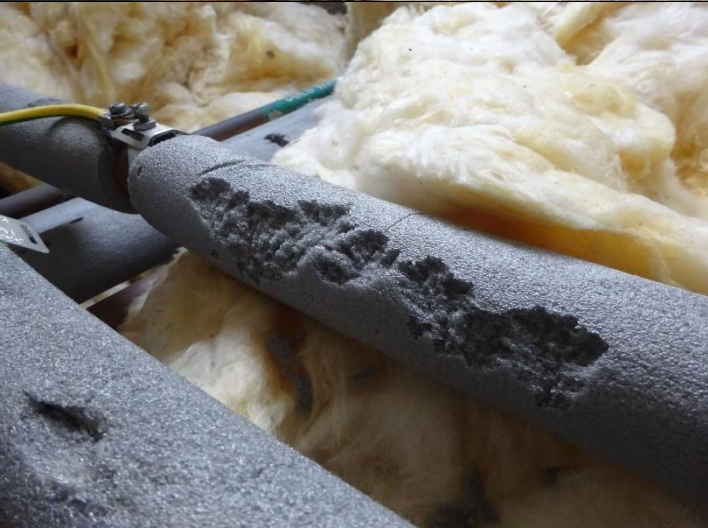
Gnawed lagging suggestive of vermin infestation within roof void.	47

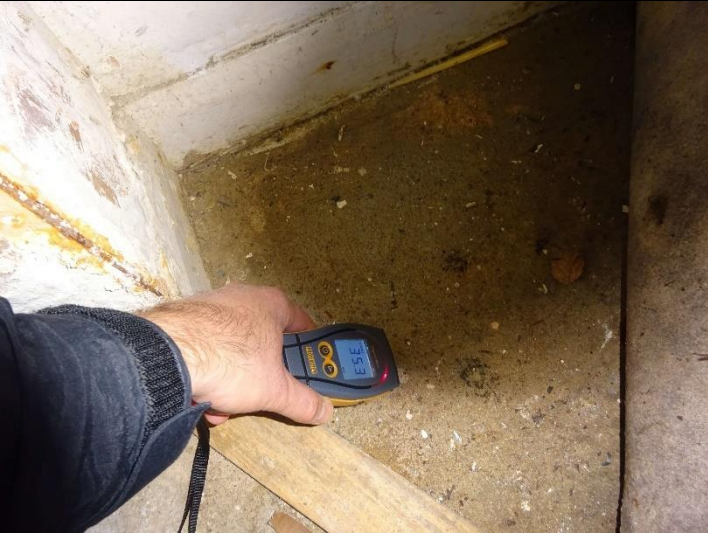
Comments	File	Photograph
Woodworm over timber lintel to window W18.	48	 
Dampness to floor screed in caretaker's flat.	49

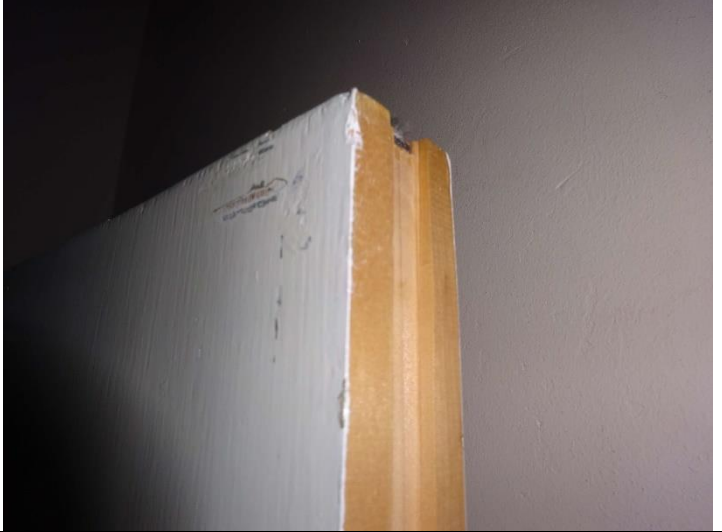
Comments	File	Photograph
Example of missing cold smoke seal / intumescent strip to fire door.	51

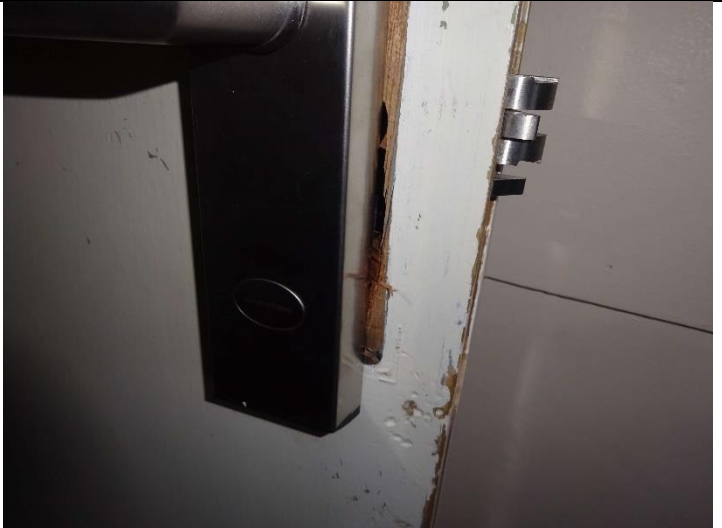
Example of gap in fire door due to replacement door furniture.	52
