**BUILDING SURVEY
CHALET BUILDING
PLAS TAN Y BWLCH
MAENTWROG
BLAENAU FFESTINIOG
LL41 3YU**

Our Ref: LST/SM/212167

Date: November 2021

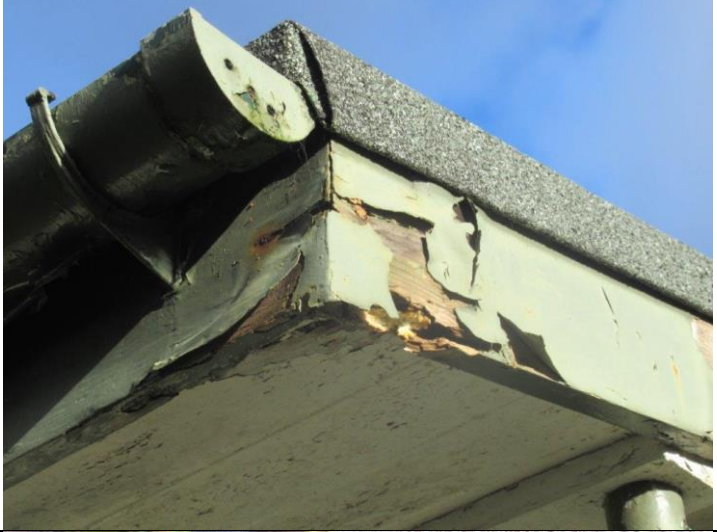
SCHEDULE OF PHOTOGRAPHS AND COMMENTS - Chalet – Plas Tan Y Bwlch		
Comments	File	Photograph
Further deterioration to fascia and bargeboard in need of repair and further investigation.	IMG_739 1

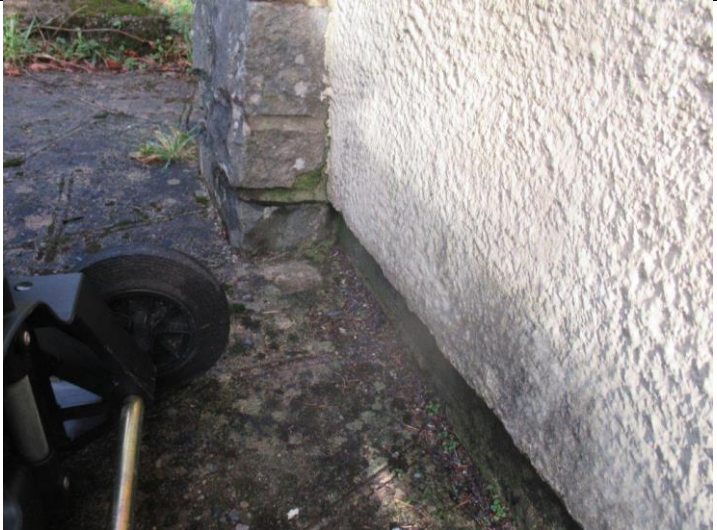
View to front left-hand corner and level from dpc to ground level approximately 100mm.	IMG_739 6

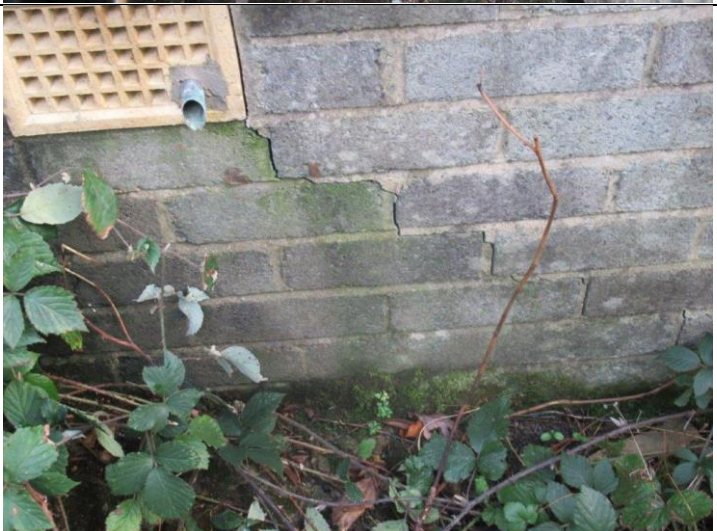
To the front elevation, to one side of the entrance door, near to the front door at an air brick there is some stepped cracking which extends within the common brickwork below the render bell bead down to ground level which again should be pointed up and monitored formally over the next 12-18 months.

One side to main entrance to front door, floor vent set below render bell bead. Stepped cracking extending down to ground level, requires monitoring as reported.	IMG_740 2

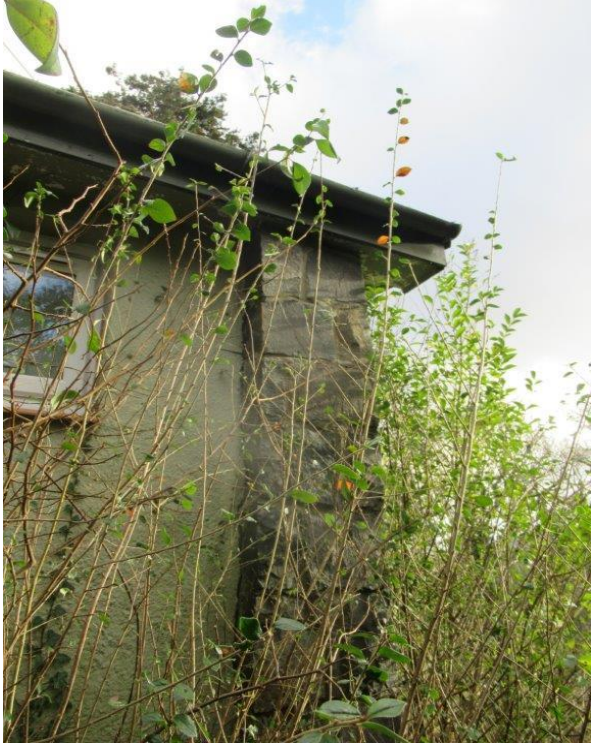
To the front elevation, as viewed facing the main entrance door to the premises, there is to the right hand side corner at the position of the stone granite buttress and masonry panel some horizontal cracking and internally at mid-way to the wall, there is some rucking within the wallpaper lining and some cacking at the pitched ceiling to wall position. This should be monitored, pointed up and reviewed under inspection to see how progressive the movement is or not. A full monitoring process should be set up. The building does relate to a sloping site.

SCHEDULE OF PHOTOGRAPHS AND COMMENTS - Chalet – Plas Tan Y Bwlch		
Comments	File	Photograph
Vertical cracking to junction of stone pillar, granite and masonry panel requires structural engineer monitoring. As reported.	IMG_740 6

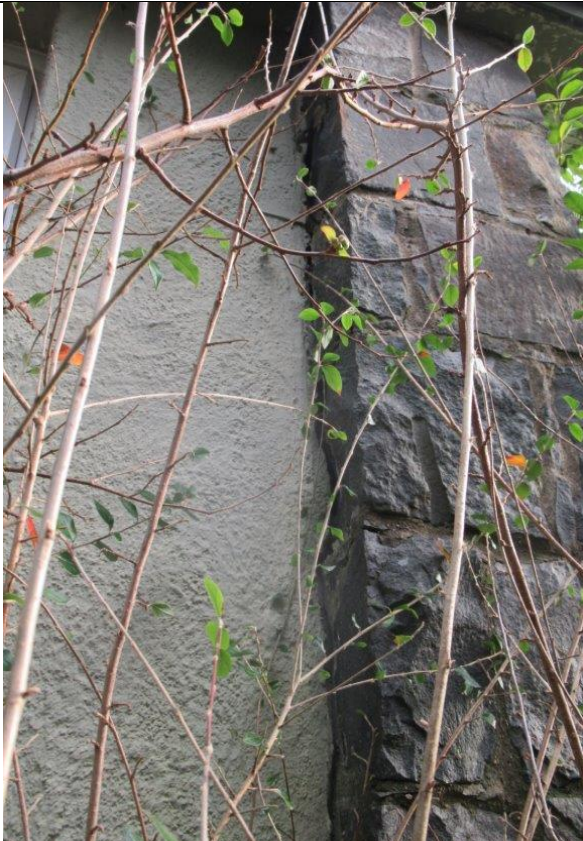
Further view of the above.	IMG_740 8

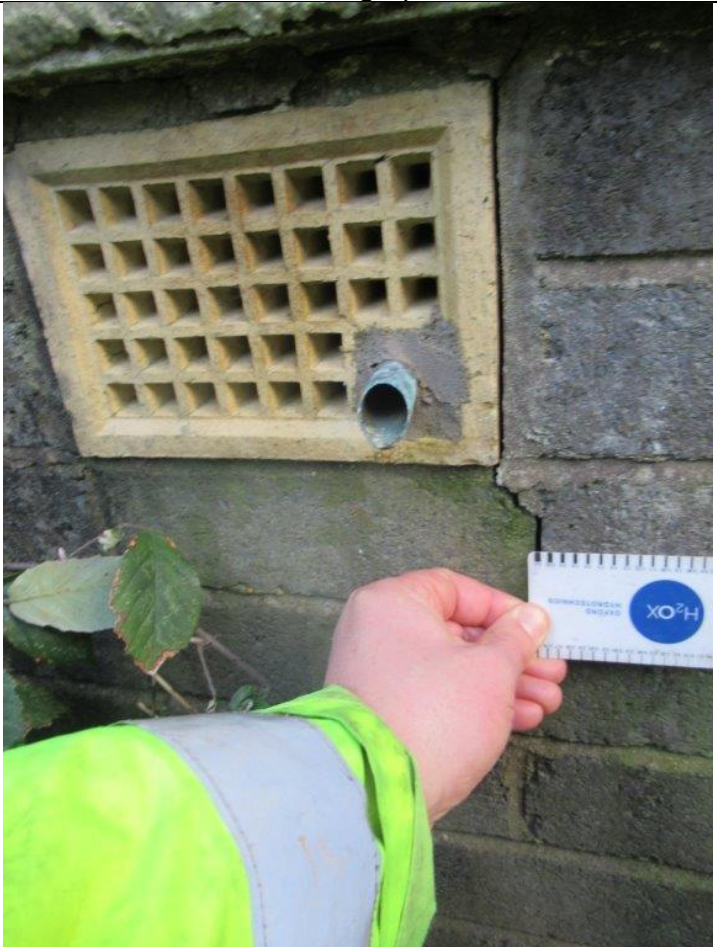
SCHEDULE OF PHOTOGRAPHS AND COMMENTS - Chalet – Plas Tan Y Bwlch		
Comments	File	Photograph
Image of cracking as reported.	IMG_741 0

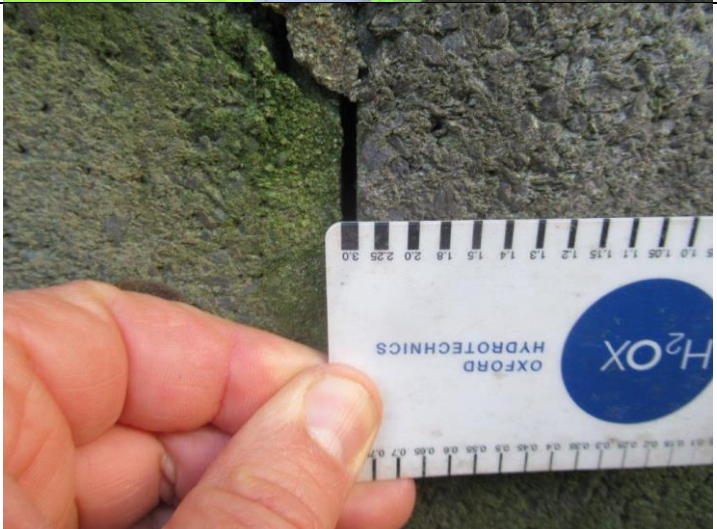
Image of the above and further view. Cracking at 3mm at upper part and then diminishes through the stepped cracking at ground level to be hairline.	IMG_741 1

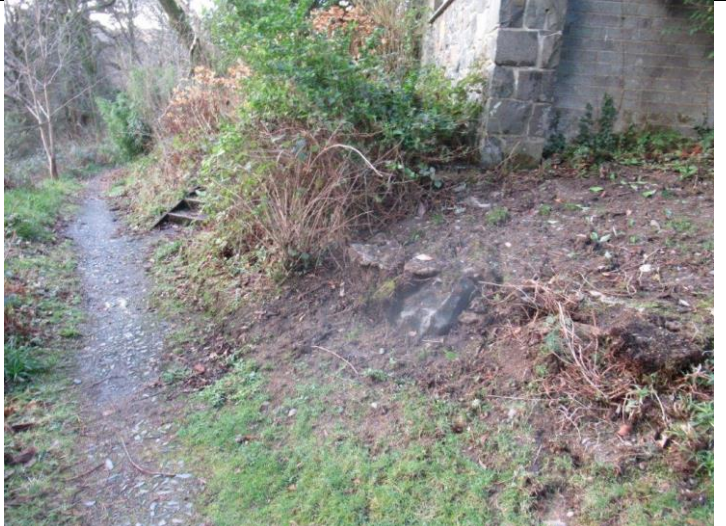
We did not inspect any below ground drainage as this was not accessible based upon our inspection. However, from discussion with Alun Williams it was evident within close proximity of the building some drainage repairs had been undertaken previously near to the rear right hand corner of the building. We are not aware of any other issues.

Image of rear right-hand corner at ground level. From discussion with Alan of Snowdonia National Park, some drainage repairs associated to foul drainage has been undertaken here and this issue has been resolved. No further comment.	IMG_7420

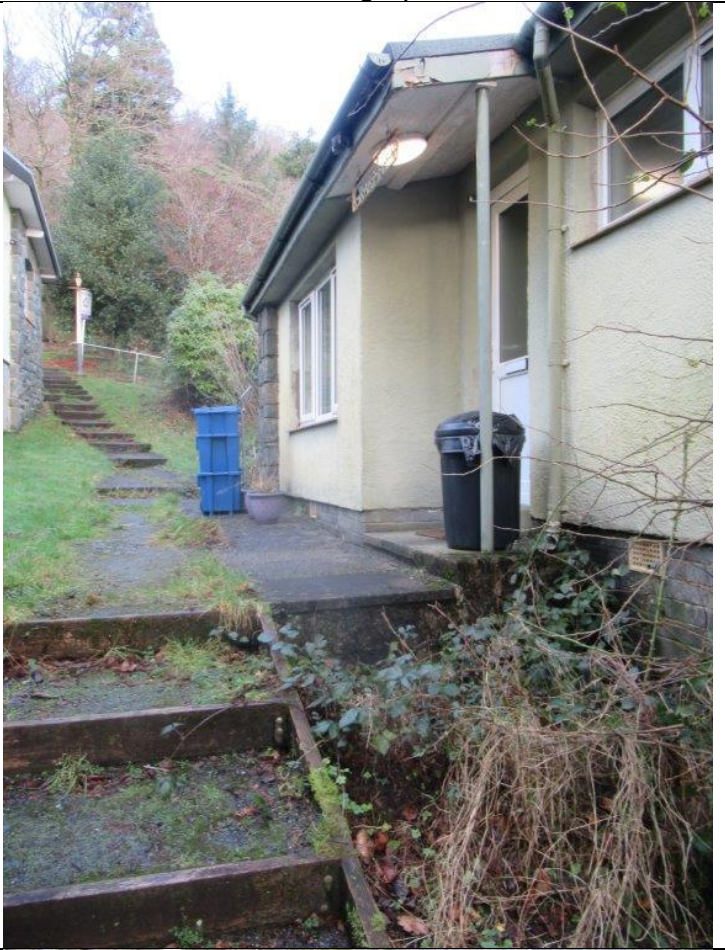
The lighting related to the paths which lead to this building and around the building externally is limited and we would recommend that these are enhanced for safety purposes.

SCHEDULE OF PHOTOGRAPHS AND COMMENTS - Chalet – Plas Tan Y Bwlch		
Comments	File	Photograph
Gravel and to dust timber steps leading up to the property and carrying on. Limited external lighting in this area and other areas to the property.	IMG_742 9

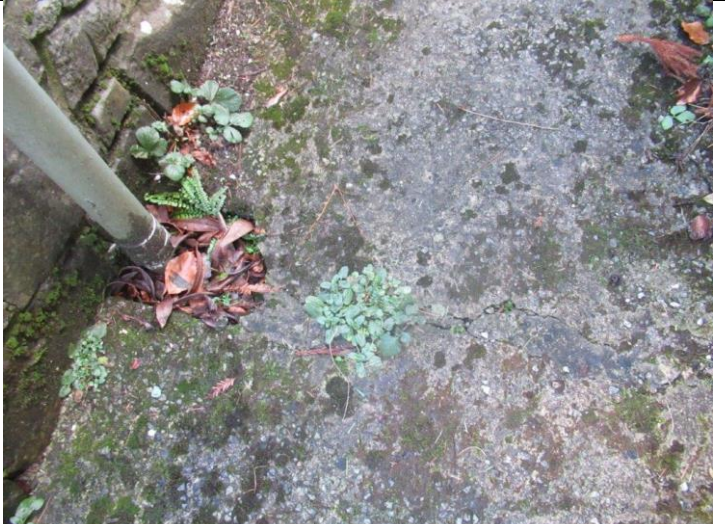
The property is set on a sloping site with the building set into the bank and at one end the ground level to finish floor level height in within a couple of hundred millimetres. However, on the other side of the building this is within one and half metres. Therefore, the slope to the site is quite extensive. There are concrete paths formed to the building and some timber steps with granular fill forming the steps and paths to other areas. The vegetation to the concrete paths, moss growth, should be cleaned off and some localised concrete repairs undertaken. We did note, associated to the rainwater pipe to the rear left corner of the property, a downpipe and some cracking within the path at this location which corresponded with a downpipe to the adjoining property within a meter of this building to the neighbouring building at the downpipe position. We would recommend that this section of pipe is investigated, and the crack made good associated to the concrete path.

Cracking in path to the left-hand side path between this building and the adjoining building at the position of the downpipes. Investigate and repair.	IMG_743 8

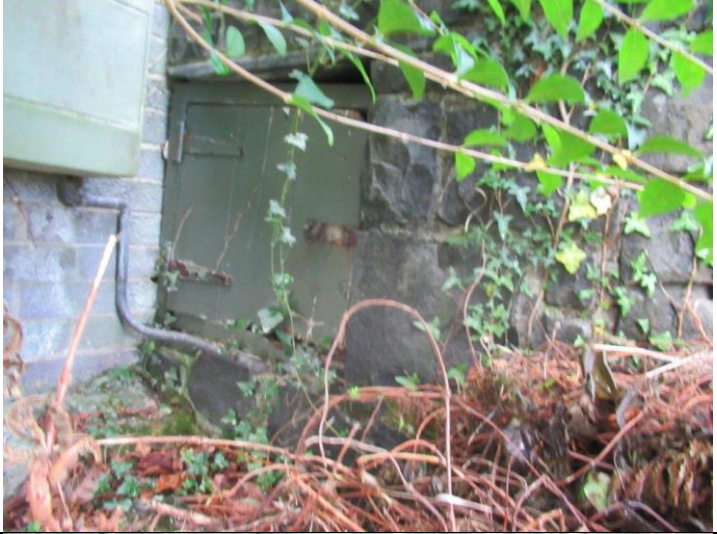
- We were unable to gain access to the following locations – did not access undercroft below rear balcony, which were locked at the time of inspection and therefore limited our inspection in regards to these areas.

SCHEDULE OF PHOTOGRAPHS AND COMMENTS - Chalet – Plas Tan Y Bwlch		
Comments	File	Photograph
Undercroft below balcony. Door in poor order and frame needs replacement. Undercroft not inspected	IMG_744 4

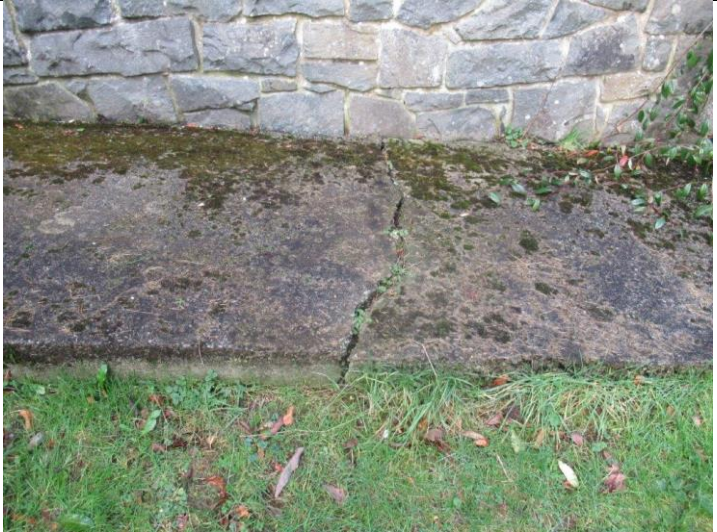
Cracking to path to left-hand side.	IMG_744 5

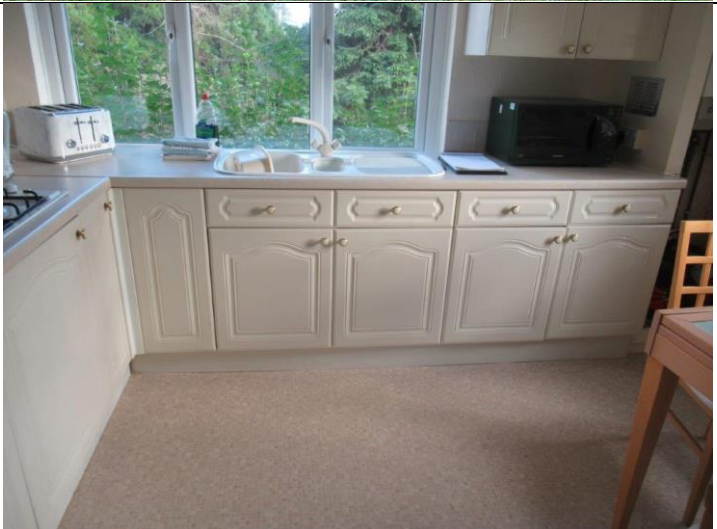
that the kitchen sink position did not have any splashback and the window position was set lower than the sink and kitchen unit position. This is not ideal. Consideration to adjustment of the window so that this is higher than the kitchen sink position should be considered. This would help with any issues when the kitchen is reset in the future and new units put in this would be the appropriate time to deal with this.

View to kitchen. Note, kitchen sink set above window sill not ideal.	IMG_744 8

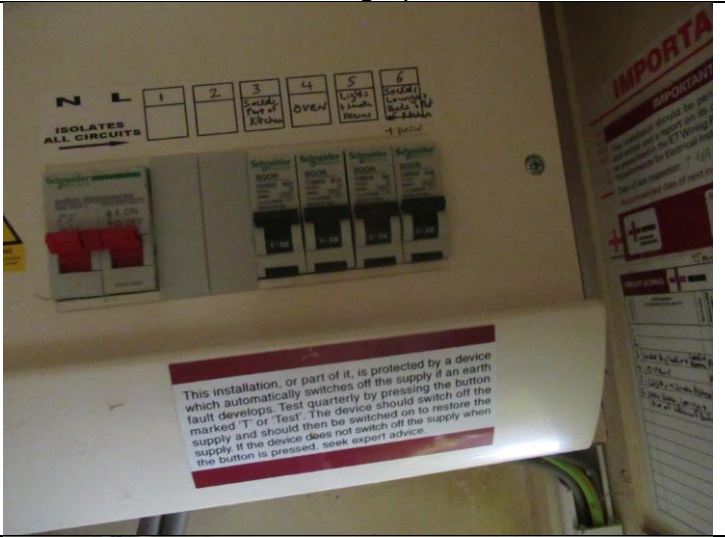
SCHEDULE OF PHOTOGRAPHS AND COMMENTS - Chalet – Plas Tan Y Bwlch		
Comments	File	Photograph
<p>Electrics fairly modern however no obvious RCD, due for testing in February 2022, therefore, undertake testing.</p>	<p>IMG_745 7</p>

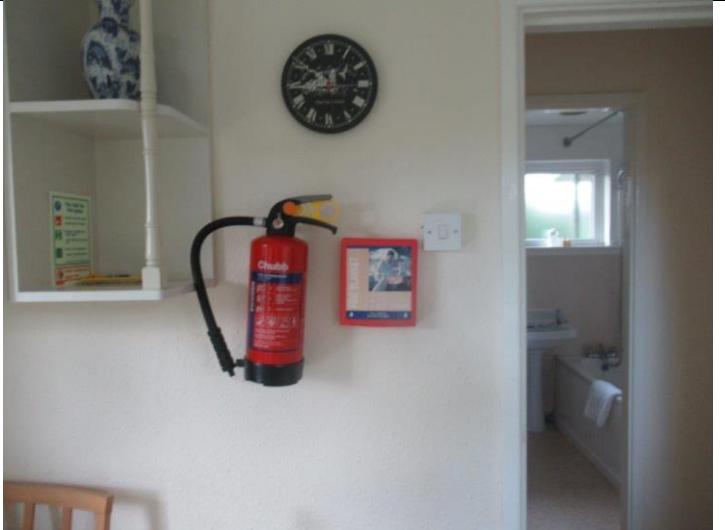
There is no kitchen door which should be provided as a half hour rated fire door as the kitchen poses the most risk of fire in most dwellings.

<p>View of extinguisher and fire blanket for kitchen although no fire door. Provide fire door for kitchen. And inspect periodically</p>	<p>IMG_746 0</p>

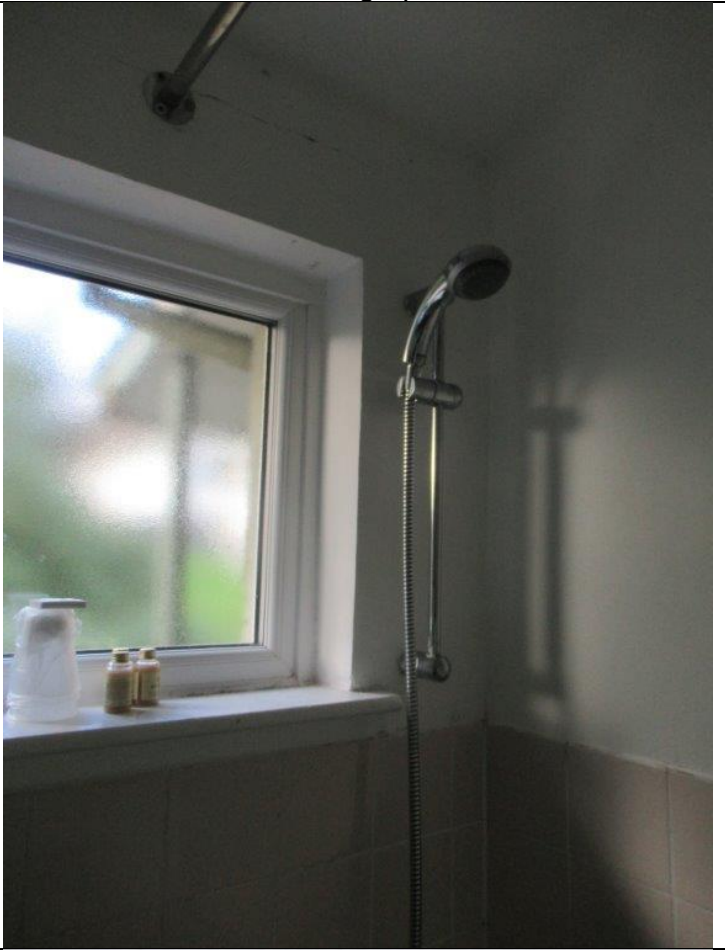
The bathroom sanitary is functional, although dated. The arrangement and layout is not ideal. The shower crossed by the window position. Adjustment here would be ideal at a future date when the bathroom fitment and sanitary is renewed within the coming years would be an appropriate time to reset the bathroom to a new layout. This could be to reposition the radiator and allow for new sanitaryware and consider possibly just fitting a shower arrangement detail and relocate the radiator and therefore setting the shower the other side.

SCHEDULE OF PHOTOGRAPHS AND COMMENTS - Chalet – Plas Tan Y Bwlch		
Comments	File	Photograph
Shower position within bathroom. Note window to shower position is not ideal and crosses the window position. Ideally the bathroom should be rearranged and layout reset to more enhanced layout.	IMG_746 6

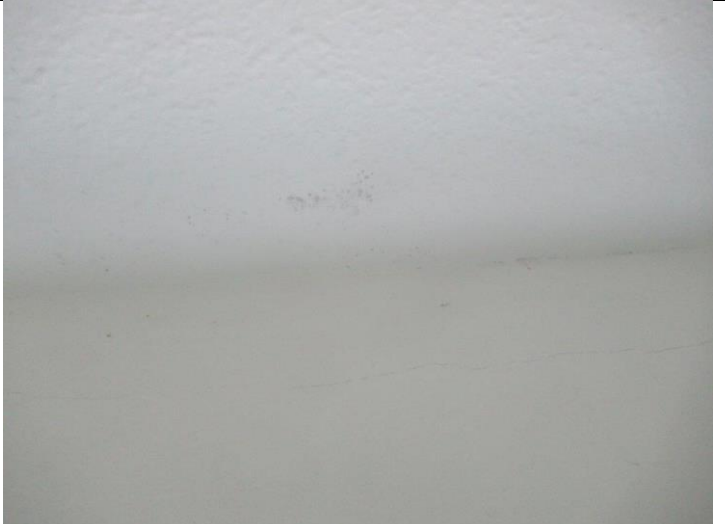
There are signs within the property of condensation and particularly at the front master bedroom to the front wall location there are signs of condensation at the pitched roof and external wall junction. It was noted externally that the facing boards were deteriorating with some woodworm at this location and vegetation set within the gutters. The fascia boards here will require repair. The roof to this area, at closer inspection in dealing with the gutter vegetation clearance ,some patch repair to the mineral felt at this location will be required when undertaking the fascia, barge board repairs.

Some condensation to ceiling within bathroom.	IMG_747 3

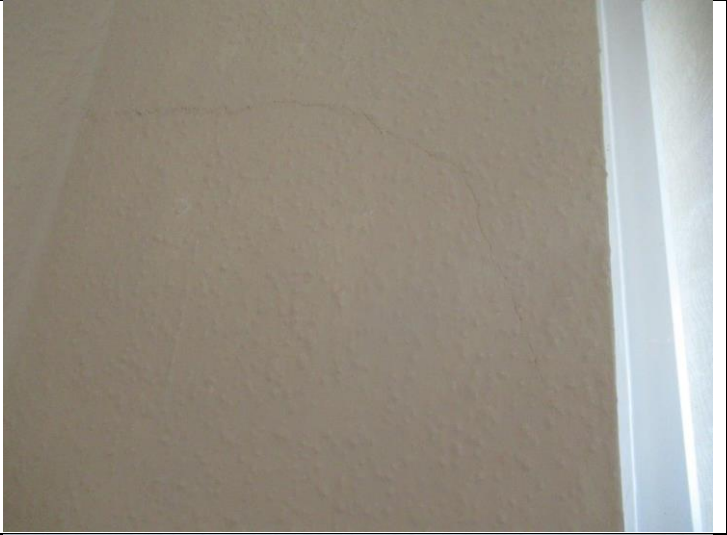
Front right-hand bedroom, the paper is rucking at the midpoint somewhat.	IMG_747 8

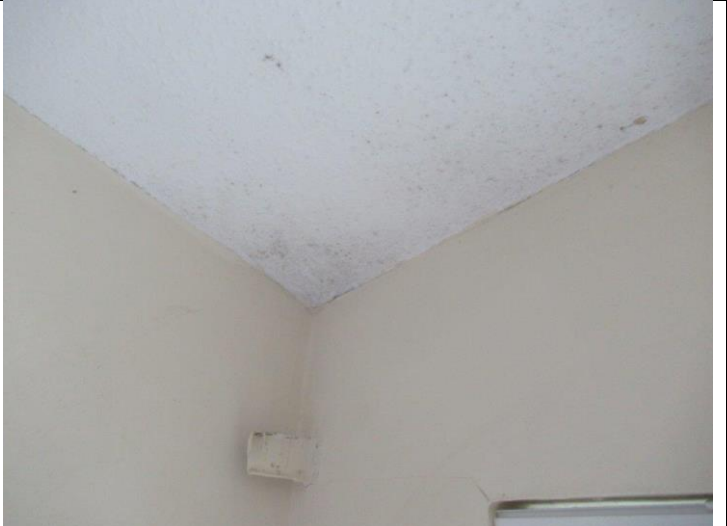
View of some condensation to front right-hand bedroom.	IMG_749 7

It would also assist where the condensation has formed within these rooms to remove the areas of plasterboard to the ceiling and consider reboarding these ceilings in their entirety with an insulated plasterboard and with an integral vapour check which will also help deal with these condensation issues and raise the surface temperature of the material and make it less susceptible to condensation.

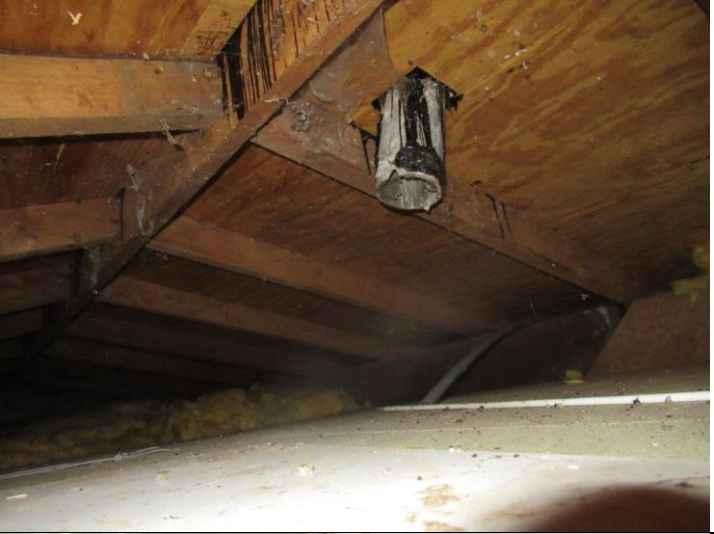
There was no formal eaves or soffit ventilation. There is, within the roof void, what appears to be one informal vent set to the pitched roof. However, for a

We did not note any obvious asbestos within the property except the flue which extended to the rear roof pitch that appeared to be ventilating the roof void to some extent. When the roof covering is replaced, this should be replaced with a modern roof vent, mushroom type, and this disposed of in accordance with Asbestos Regulations.

SCHEDULE OF PHOTOGRAPHS AND COMMENTS - Chalet – Plas Tan Y Bwlch		
Comments	File	Photograph
View to loft space. Limited ventilation to loft. Asbestos flue helping to serve and ventilate loft.	IMG_750 3

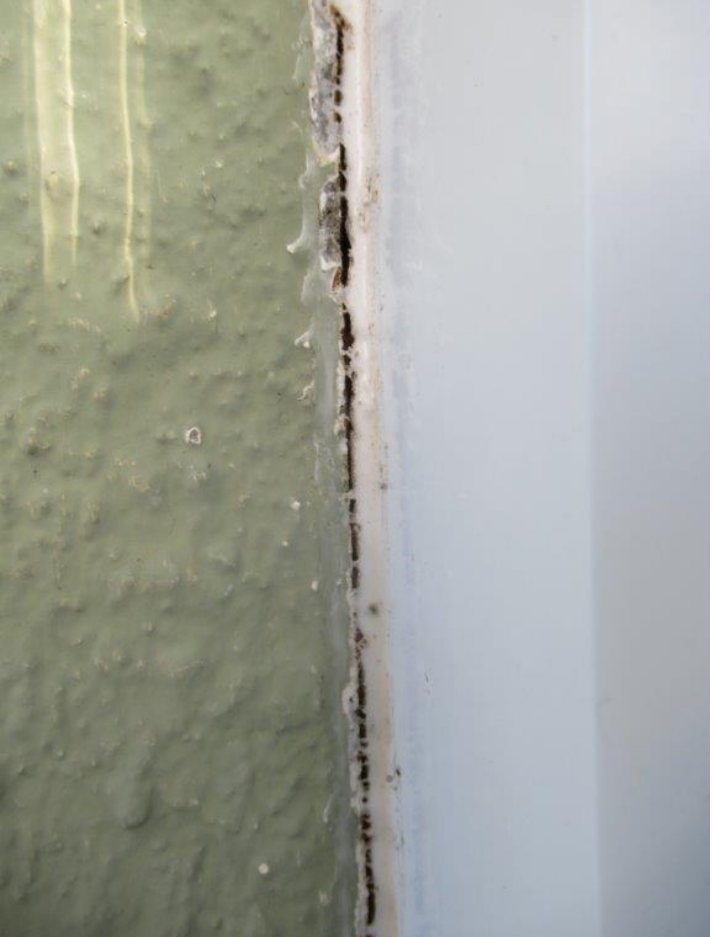
Mastic resealing to main door at front entrance required.	IMG_751 1

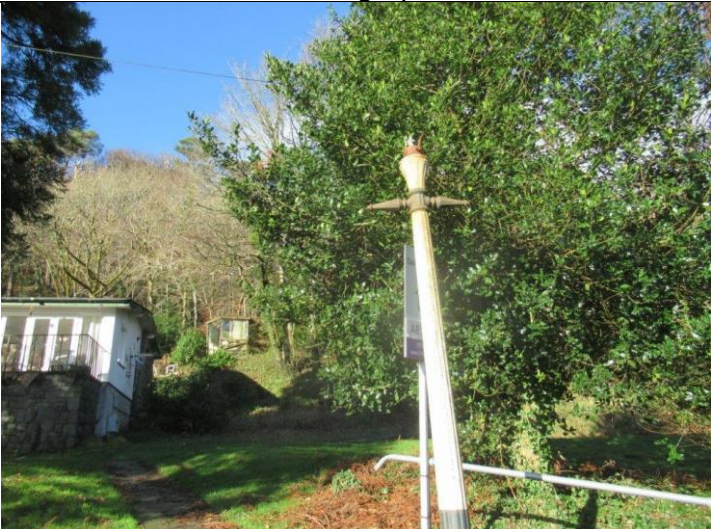
The authority should also confirm where their liabilities associated to the path arrangements to the property ends so that this is clear in terms of their responsibilities.

SCHEDULE OF PHOTOGRAPHS AND COMMENTS - Chalet – Plas Tan Y Bwlch		
Comments	File	Photograph
Broken external light. Limited external lighting on path and around property? Responsibility? Authority to confirm.	IMG_7513
