**BUILDING SURVEY  
PLAS TAN Y BWLCH  
MAENTWROG  
BLAENAU FFESTINIOG  
LL41 3YU**

**Our Ref: LST/SM/212167**

**Date: November 2021**

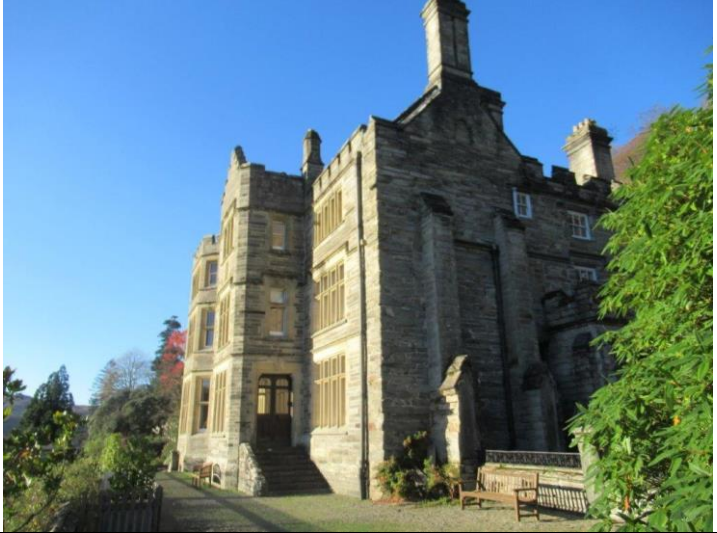
Associated to the previous image above at the door position where the stepped entrance on this elevation. Stepped cracking leading to door and the side at the reveal. Cracking is extending through the masonry. Previous tell tail has been removed.	IMG_548 0

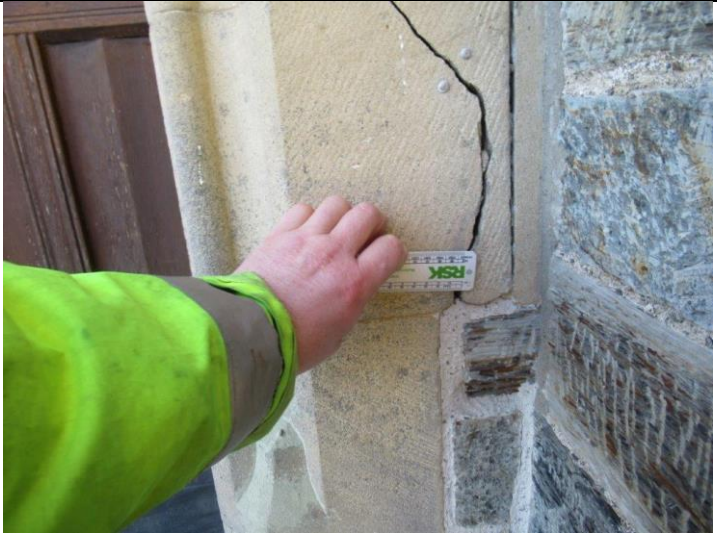
The crack width at this position is 6mm.	IMG_548 1

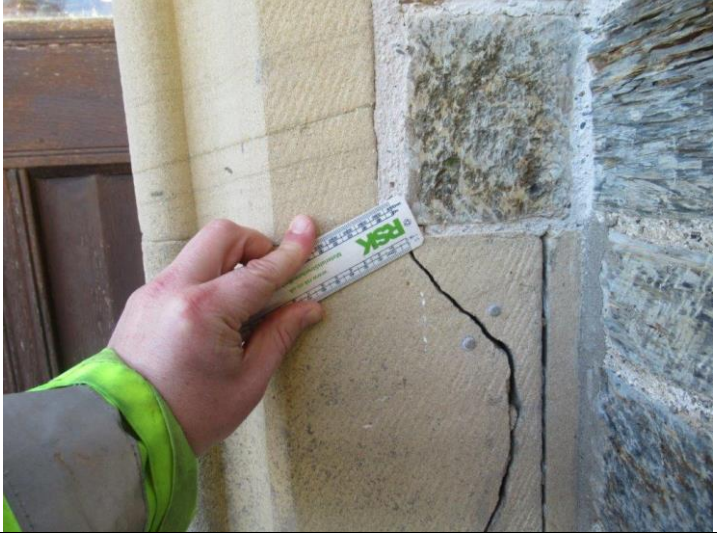
<p>Cracking extends through the head lintel to this door opening. Tell tails are still in place at the lintel position.</p>	<p>IMG_548 3</p>

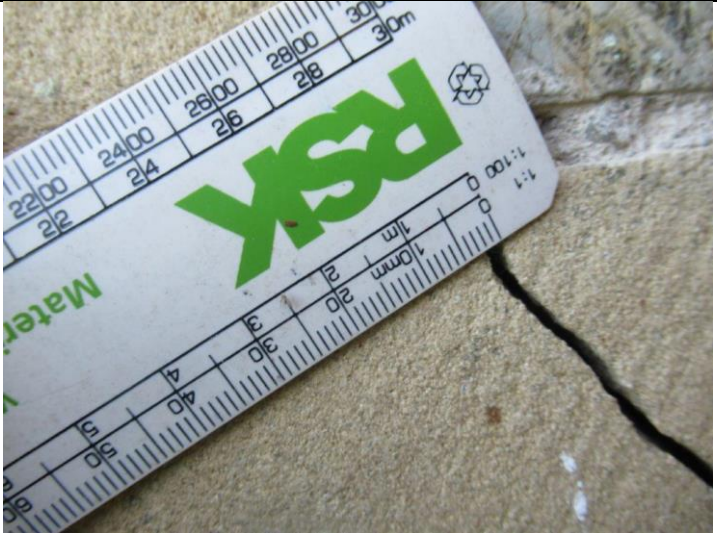
<p>View to cracking at head of the lintel to this door position. Tell tails still in place.</p>	<p>IMG_548 4</p>

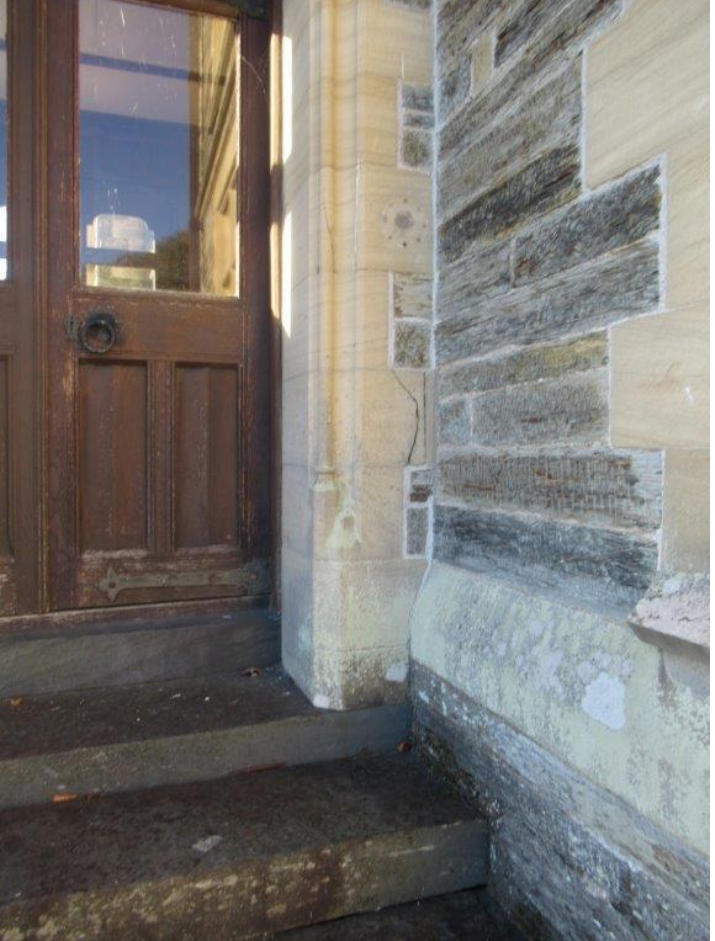
Window adjacent to this door opening. Cracking extends at the quoins through the reveal and also continues to the lintel bearing at one side.	IMG_548 7

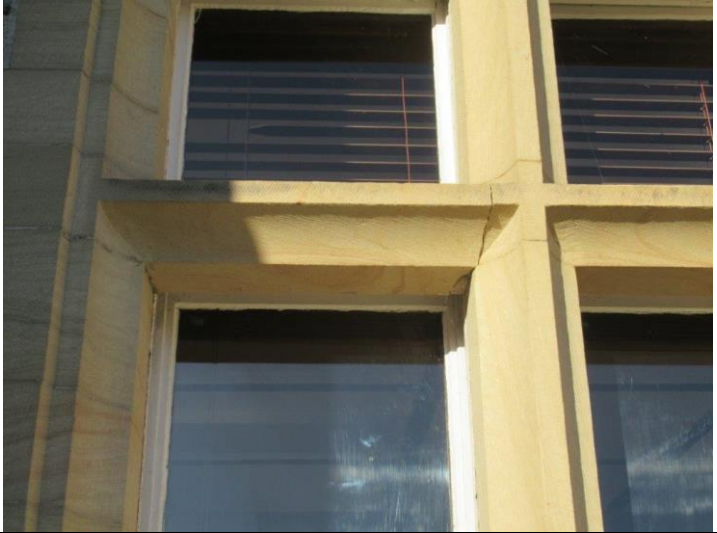
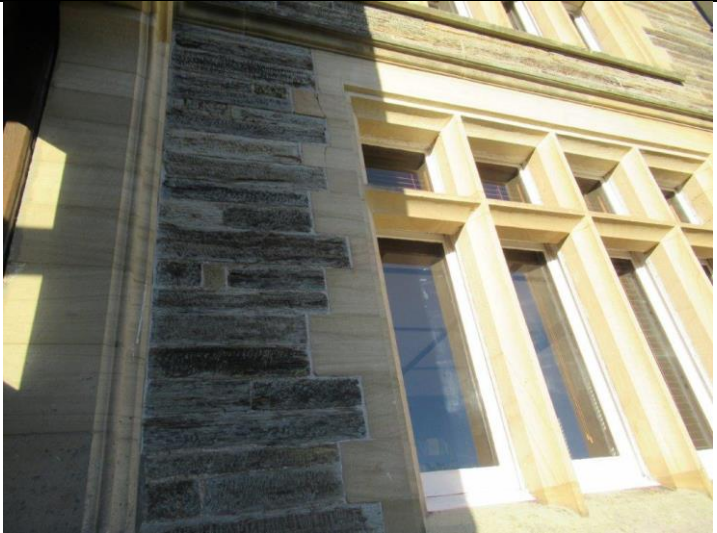
General view to the window within close proximity of the door opening referred to above.  See cracking to one side and to the nearest transom to this side of the opening related to comments above.	IMG_5489

Further view to above.  View to transom from below.	IMG_5490

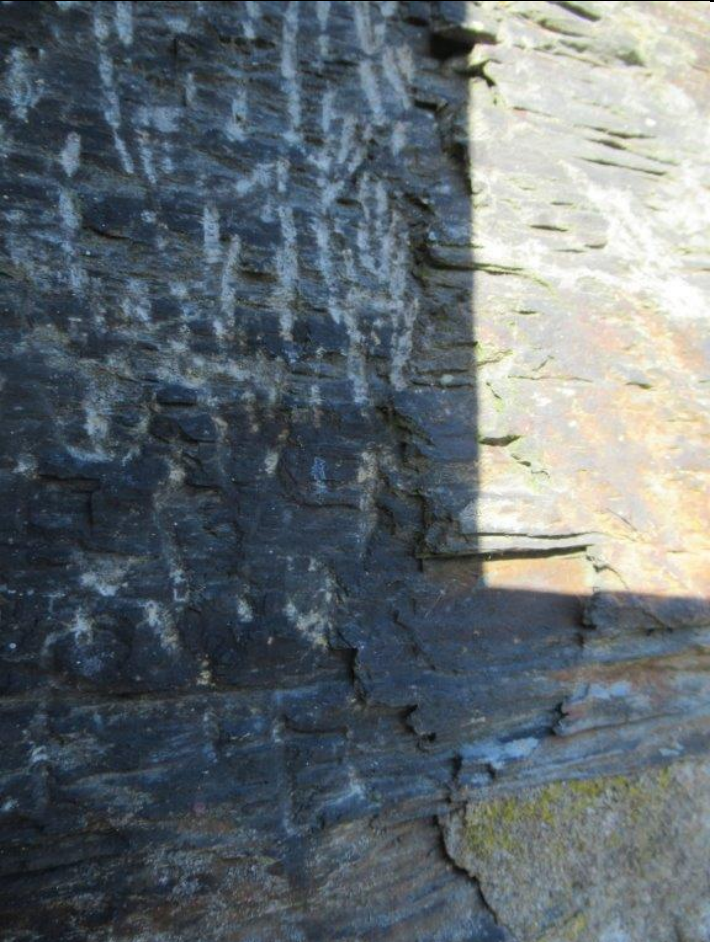
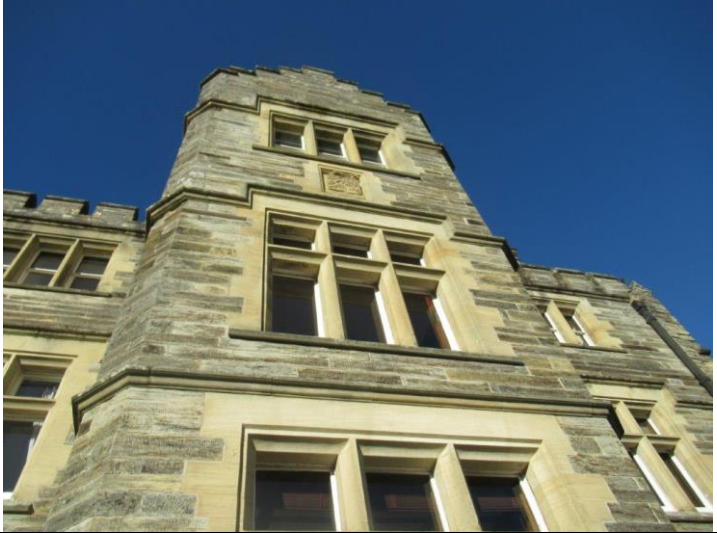
BARSCHEDULE OF PHOTOGRAPHS AND COMMENTS - Plas Tan y Blwch, Maentwrog, Blaenau Ffestiniog LL41 3YU - Snowdonia National Park Authority		
Comments	File	Photograph
Date:		
<p>View to right hand side outrigger to front elevation extending to 3 floors.</p> <p>View to upper area at corner below string course – stone repair required.</p>	IMG_550 0

<p>Closer view.</p>	IMG_550 1

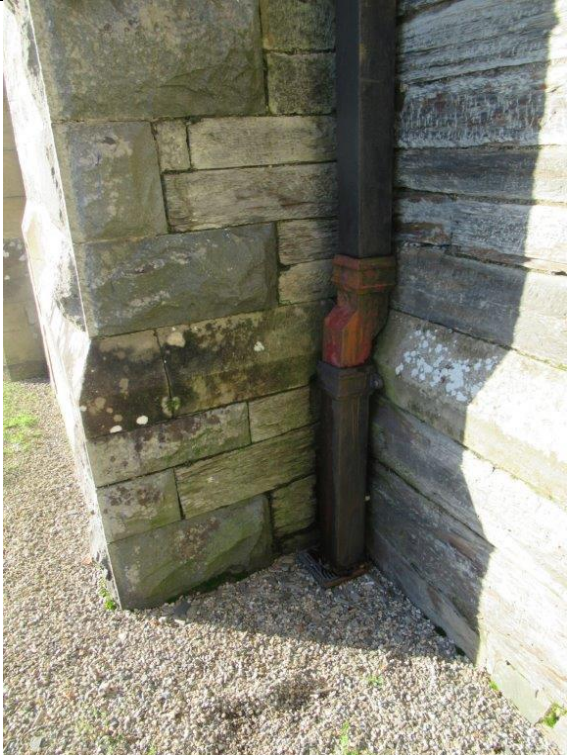
BARSCHEDULE OF PHOTOGRAPHS AND COMMENTS - Plas Tan y Blwch, Maentwrog, Blaenau Ffestiniog LL41 3YU - Snowdonia National Park Authority		
Comments	File	Photograph
Date:		
<p>View to inner corner referred to above.</p> <p>Note area of vertical junction between this outrigger and the main elevation. Repointing is required to a considerable width circa 50 – 70mm or so, displaced and in need of piecing in with stone in this location. Consideration of Structural Engineers advice about creating structural connectivity between this junction with Cintex or helifix repairs at this location.</p>	<p>IMG_550 7</p>

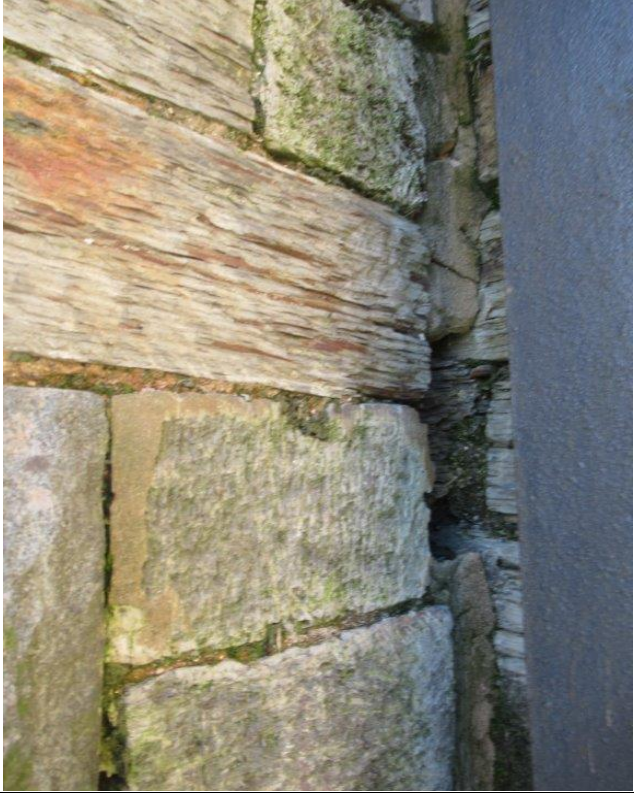
<p>Further view.</p> <p>Note stonework does not course through and therefore structure generally not tied at this position. This relates to the corner left hand side outrigger to the main front elevation.</p>	<p>IMG_551 5</p>

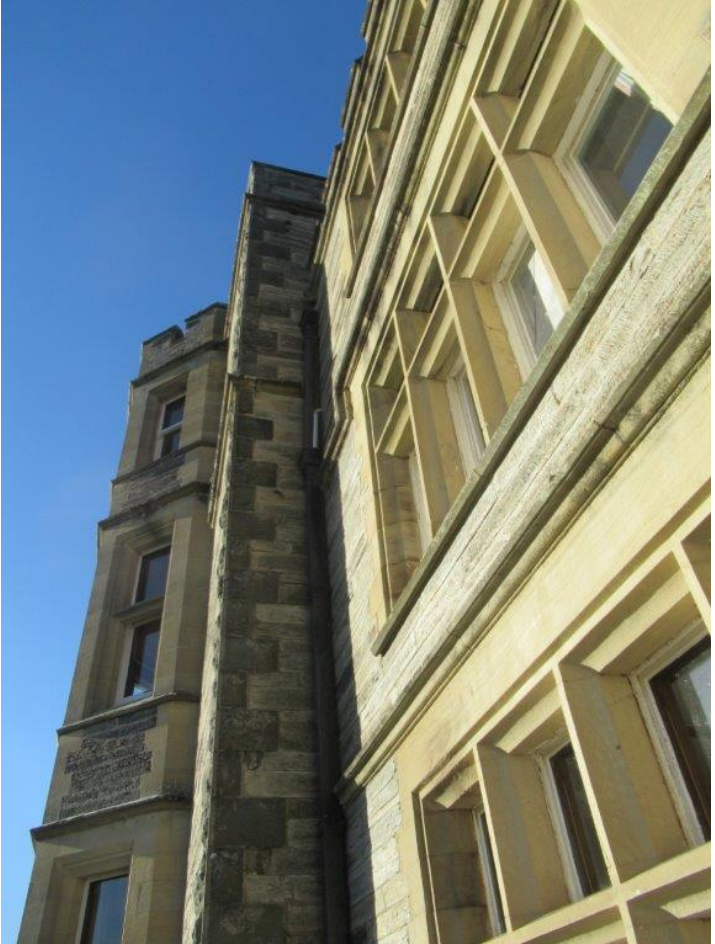
Indication of area where stonework repair required - in close proximity of this location.	IMG_551 8

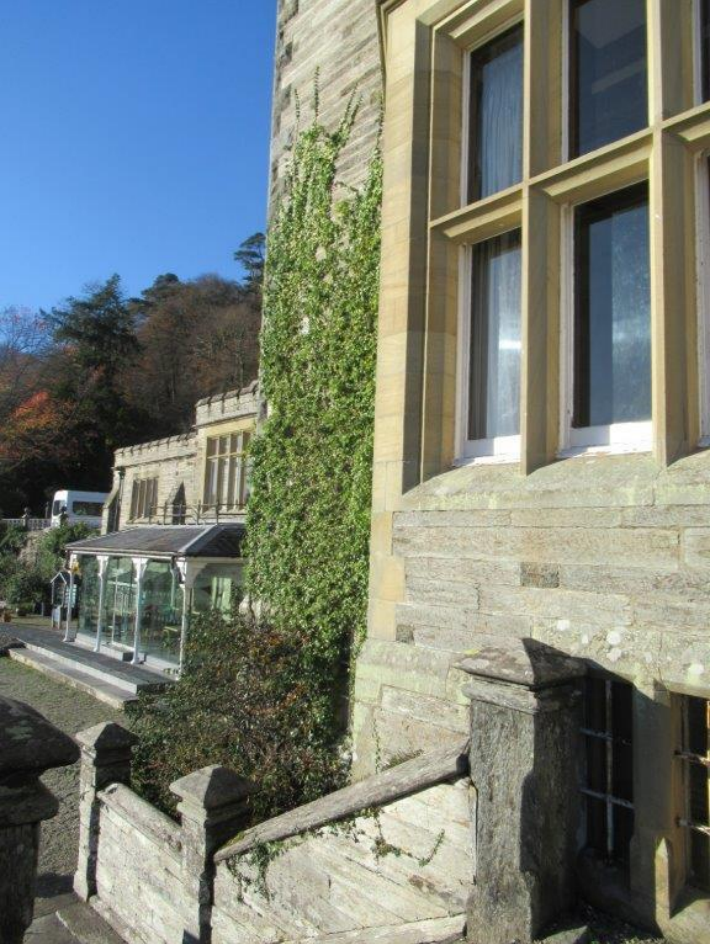
<p>Stairs to the main elevation A1 to the principle elevation at the front that lead down to the lower terrace.</p> <p>Note disruption to stone balustrade, packing and pointing required here for repair.</p>	<p>IMG_553 0</p>

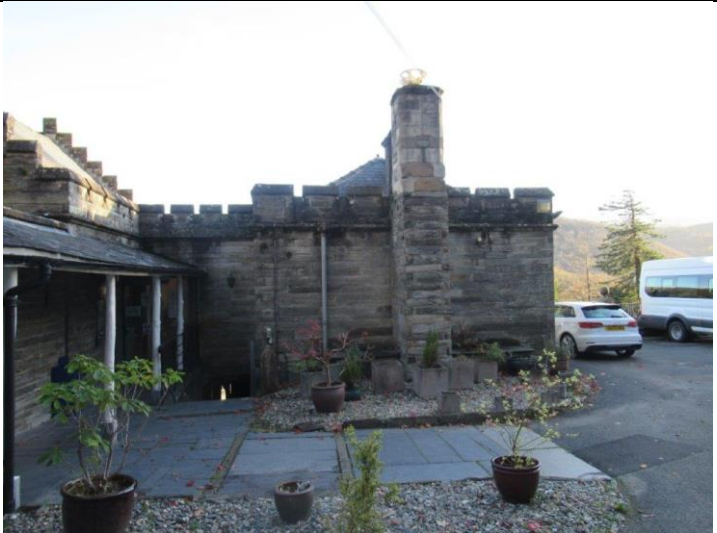
View to return to elevation C2 back to inner corner. Parapet is saturated, various moss growth due to the saturation. The slate / shale stone is worn with various fishers to it. The upper copings are sandstone and are fairing far better than the poor quality slate that has been utilised for these wall construction at the outer facing work.	IMG_559 1

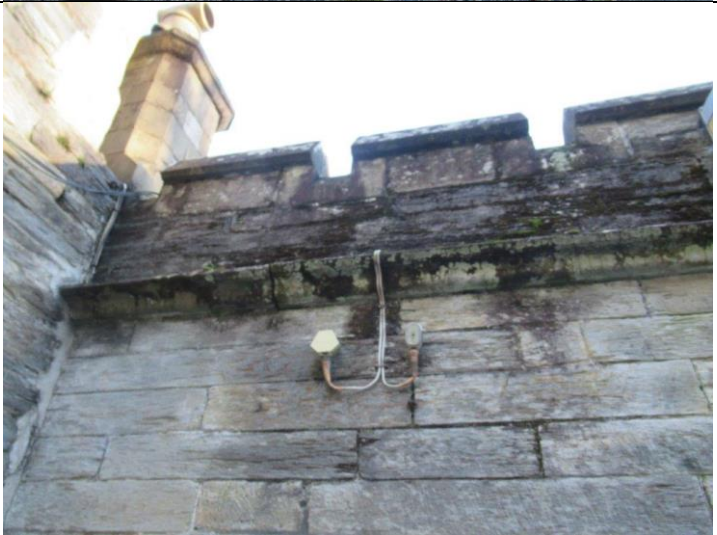
BARSCHEDULE OF PHOTOGRAPHS AND COMMENTS - Plas Tan y Blwch, Maentwrog, Blaenau Ffestiniog LL41 3YU - Snowdonia National Park Authority		
Comments	File	Photograph
Date:		
Continuation of elevation C2 to return at inner corner. Large area of sand cement pointing is becoming detached from the corner, roughly 50mm or so in width. This requires repointing in lime and consideration of connectivity to be formed between the structure at this junction as the masonry is not formally coursed together. Therefore a Cintex or helifix cross stitching to the masonry possibly required engineer to advise.	IMG_560 6

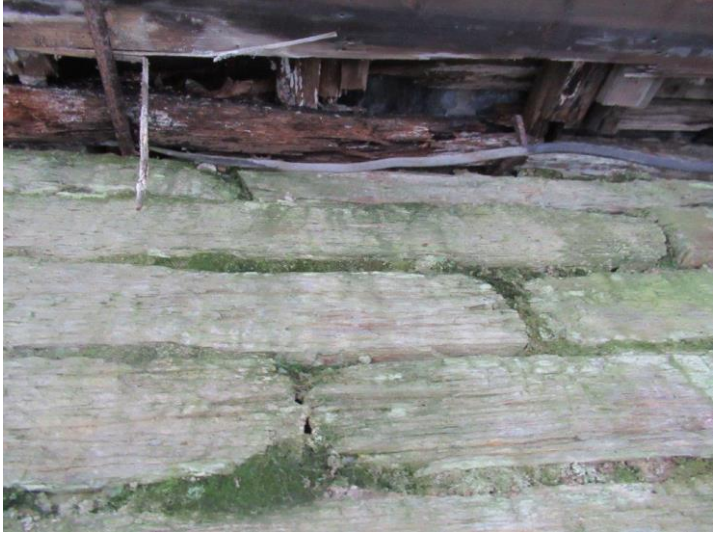
<p>View to rear of the wall to the lean-to structure associated to elevation C3 and the saturation and poor condition of the wall is evident which needs various re-pointing and repairs as commented on earlier.</p>	<p>IMG_563 9</p>

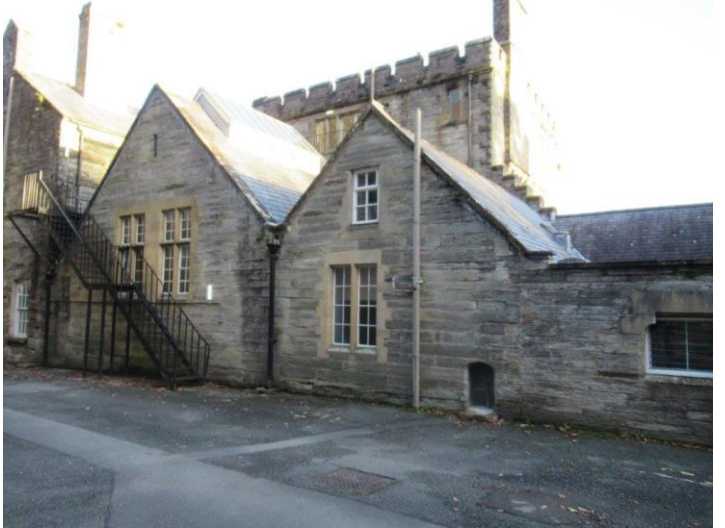
There is at elevation D1, to the upper part of the tower, some missing stone blocks which will require to be reinserted and where some services have been extended through the wall the block has been taken out entirely. The wall is open at these points for water penetration which will be causing issues internally and will need to be resolved. The store area near to the rear escape off the landing was not inspected and this could be an area that is affected by such water penetration.

Rear castlement detail to tower area to elevation D1 at second floor area. Note two areas where stone repair is required where a flue has been put through the wall and the masonry left open for water penetration at this location. This needs resolving. It is evident that there is	IMG_564 6

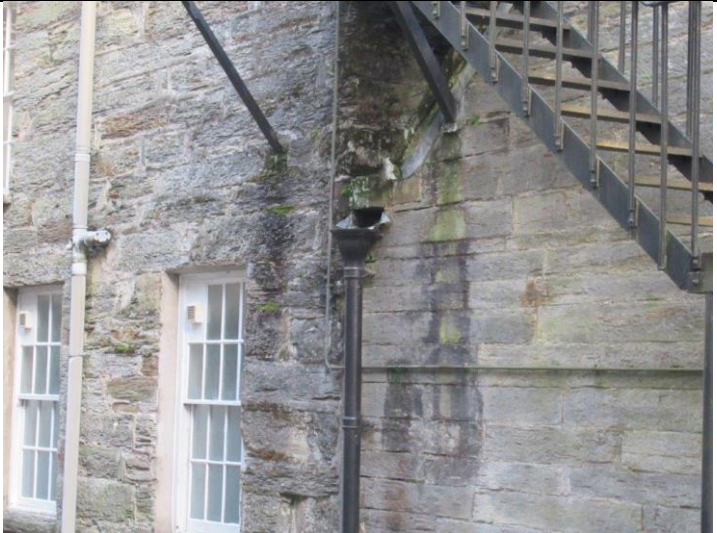
BARSCHEDULE OF PHOTOGRAPHS AND COMMENTS - Plas Tan y Blwch, Maentwrog, Blaenau Ffestiniog LL41 3YU - Snowdonia National Park Authority		
Comments	File	Photograph
Date:		
<p>Elevation D1 continuation of view to rear elevation towards junction with Elevation D2. Stonework here is worn and not as good quality as to other locations to the building. As can be seen at high level, there are lots of saturation to the upper gable area and vegetation growth and repointing and stone repairs at this level will be required, as reported. Please refer to the Indicative Maintenance Plan.</p>	<p>IMG_566 0</p>

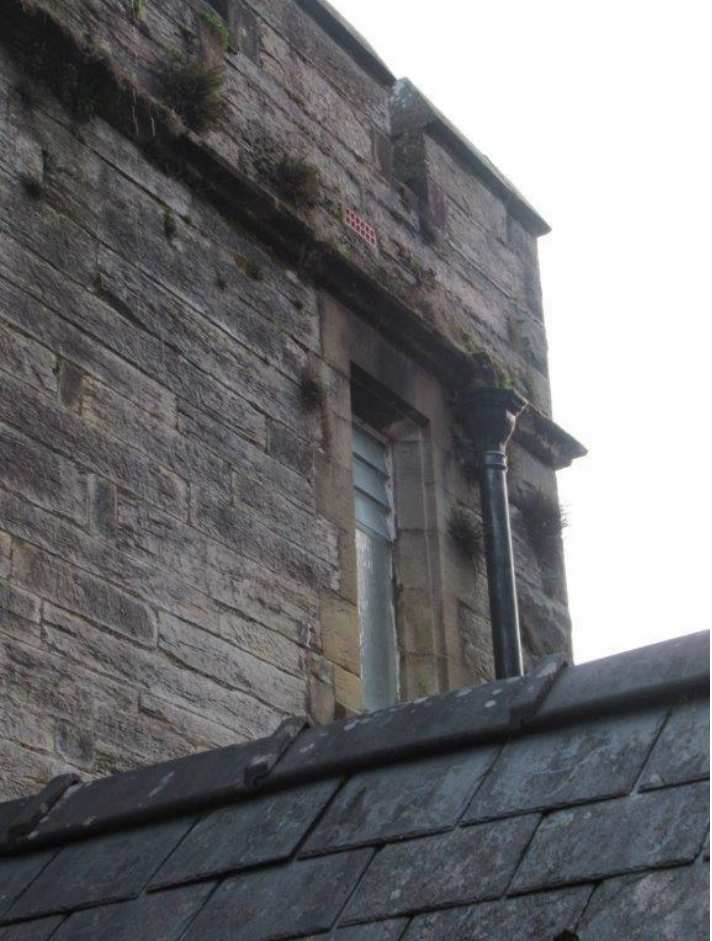
<p>View of roof slope R12 fascia board with woodworm and some cracking at the cement flush pointing to below the kneeler that should be raked out and re-pointed in lime and flush pointed. Cast iron gutter requires decoration, as reported. The stonework to the gable, as can be seen at the end here, is worn.</p>	<p>IMG_570 4</p>

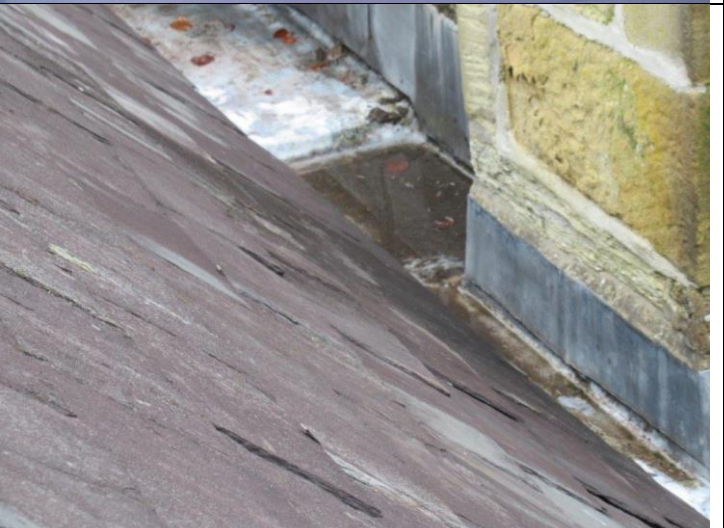
BARSCHEDULE OF PHOTOGRAPHS AND COMMENTS - Plas Tan y Blwch, Maentwrog, Blaenau Ffestiniog LL41 3YU - Snowdonia National Park Authority		
Comments	File	Photograph
Date:		
location which indicates the gutter is not formed to a good fall.		
Further view of roof slope R5 box gutter and at chimney position CH5. Some localised lime repointing to some patch locations have been done here previously however, the majority is in sand and cement pointing which is for the most part intact. However, some of the sandstone is deteriorating as can be seen to the block in the image just above the flashings. There are signs of water penetration issues to the chimney breast and external wall at this location to the room below. This relates to rooms 10.	IMG_578 5	 
View of sandstone block with some deterioration to the face.	IMG_578 6

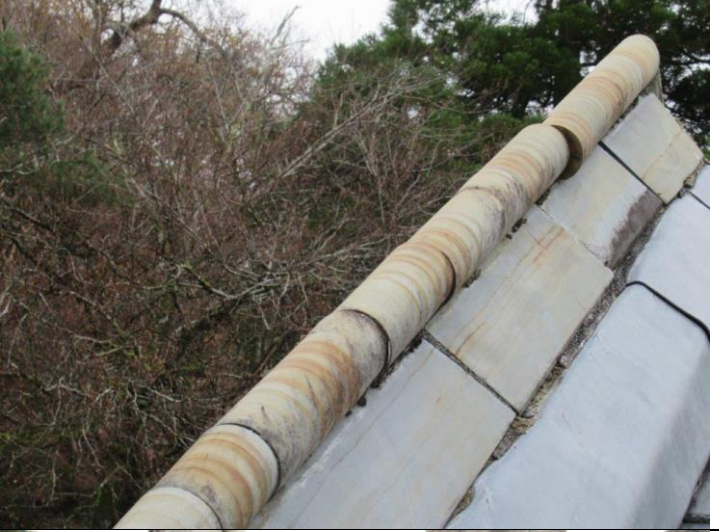
The slate roll top detail continues to the gable to roof slope R10 at the gable position over the original poor slate copings which now have various fractures and fissures together with vegetation growth and saturation evident. These coping details will require remedial works as reported.	IMG_582 4

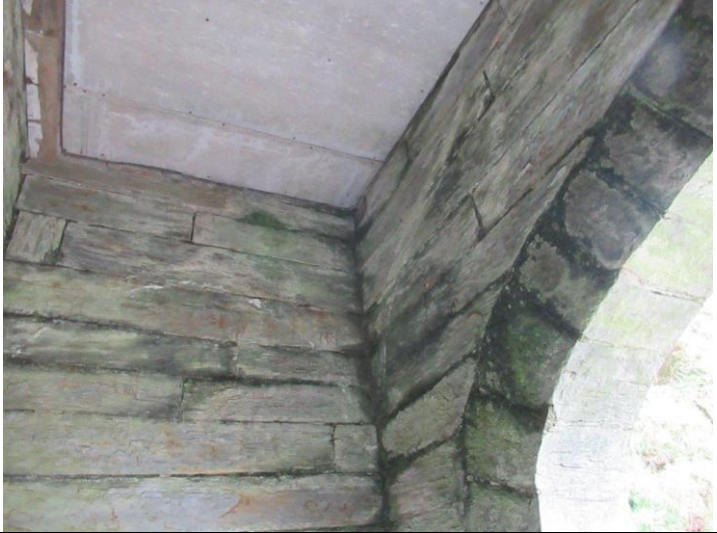
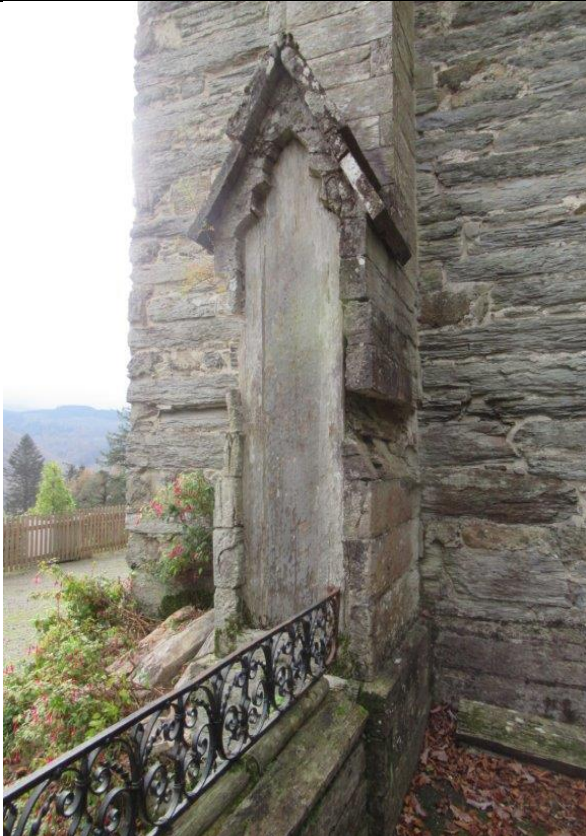
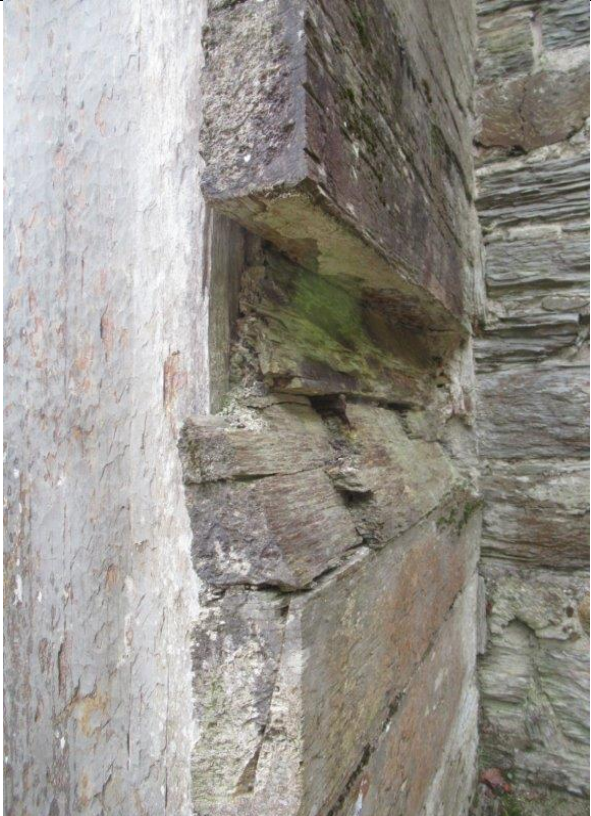
Elevation B1 and buttress type detailing set onto the elevation and poor condition of the stonework at the lower end of the buttress and note comments in report.	IMG_612 5

BARSCHEDULE OF PHOTOGRAPHS AND COMMENTS - Plas Tan y Blwch, Maentwrog, Blaenau Ffestiniog LL41 3YU - Snowdonia National Park Authority		
Comments	File	Photograph
Date:		
Further view related to the above. Areas of stone have failed, delaminated and iron fixings that are deteriorating to further compound the defects at this location. In need of repair – see report.	IMG_612 6

Further view related to the above.	IMG_612 8

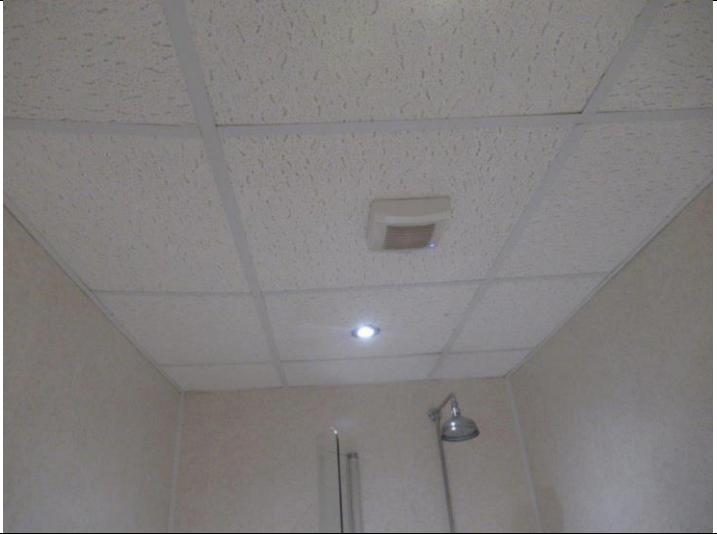
Note above suspended ceiling line to ensuite to this room (Room 3) penetration into void above firebreak disturbed associated to the lath and plaster ceiling. This needs to be made good. Also note extraction just discharges above the suspended ceiling and does not expel externally or connect to slate vent or any other detail.	IMG_617 9

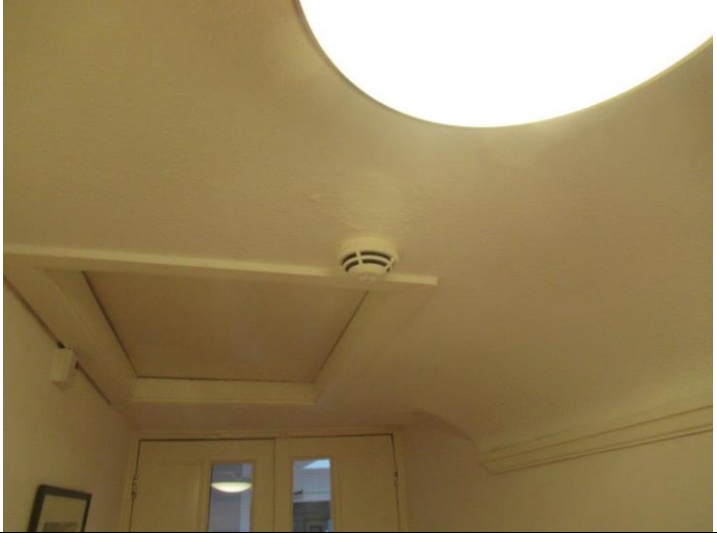
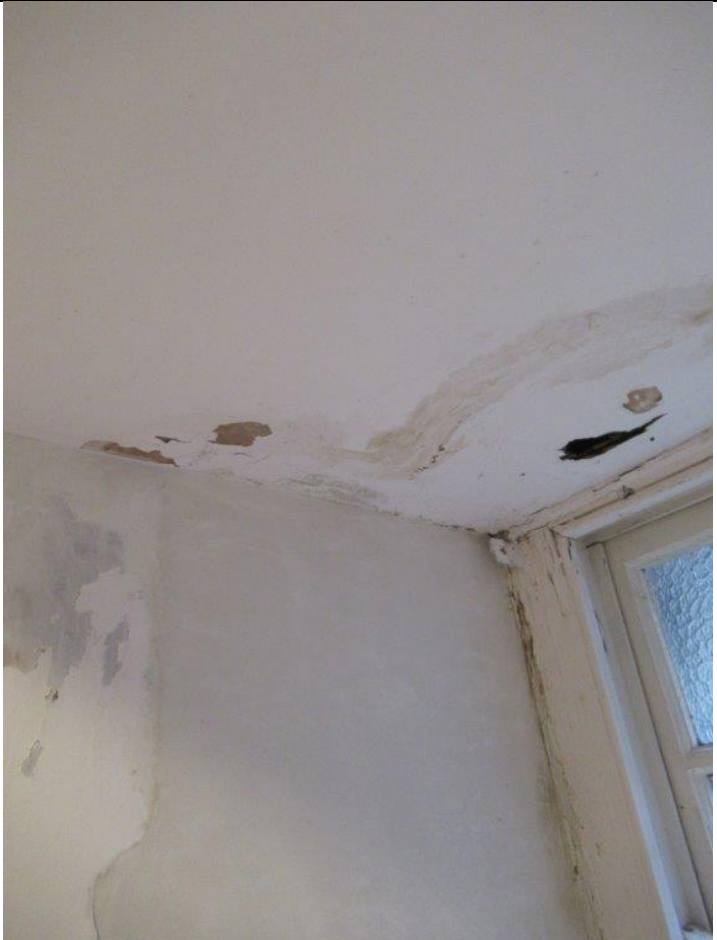
Corridor window at this level related to elevation D6. Note this has been previously lime plastered to the reveals but dampness continues at the head and some deterioration is occurring in this location.	IMG_632 7

BARSCHEDULE OF PHOTOGRAPHS AND COMMENTS - Plas Tan y Blwch, Maentwrog, Blaenau Ffestiniog LL41 3YU - Snowdonia National Park Authority		
Comments	File	Photograph
Date:		
Further view related to the above.	IMG_6328

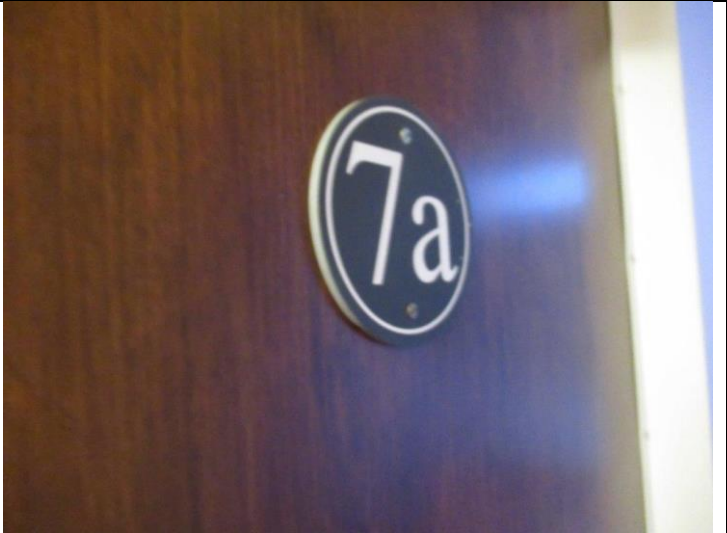
Related to room 7a note gap behind receiver to door. No intumescent packer or the like or backfilling to ensure fire integrity at door lock position. This requires resolving.	IMG_635 1

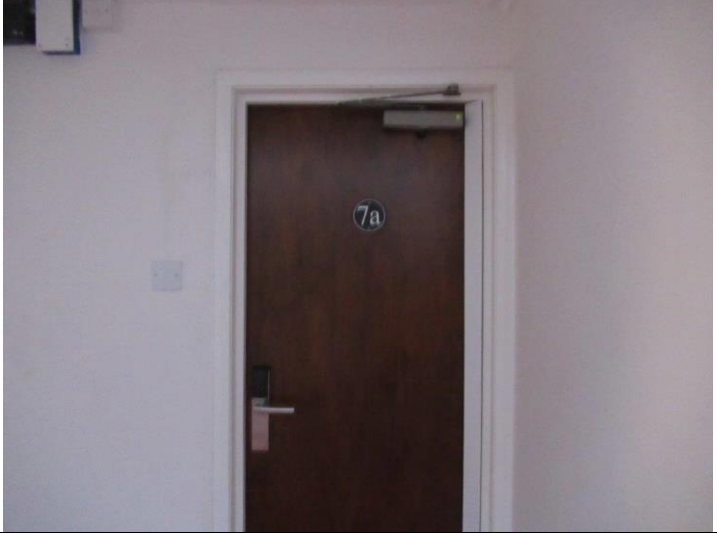
Related to glazed roof light to room 7a. Water penetration at this location needs investigation at roof level. Strip back slate and investigate – see report.	IMG_636 5	 
Water penetration related to the above.	IMG_636 6

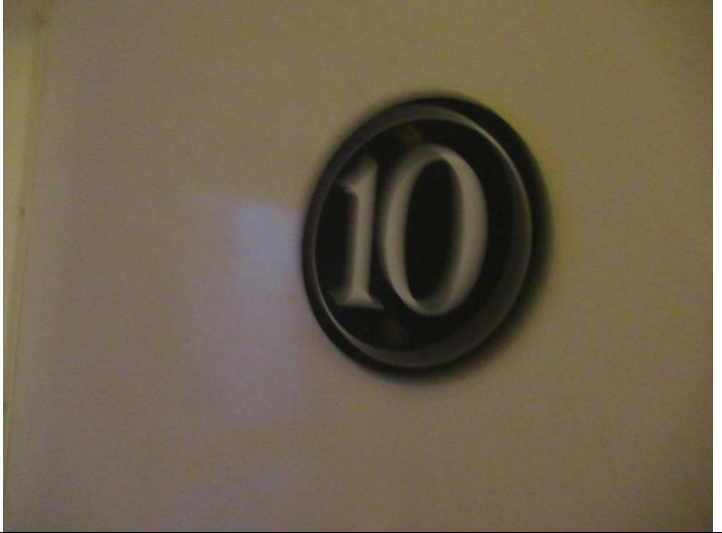
Room 10 and valley gutter position in roof void above. No obvious signs of water penetration here however, issues are occurring and require investigation at high level, as reported.	IMG_639 7

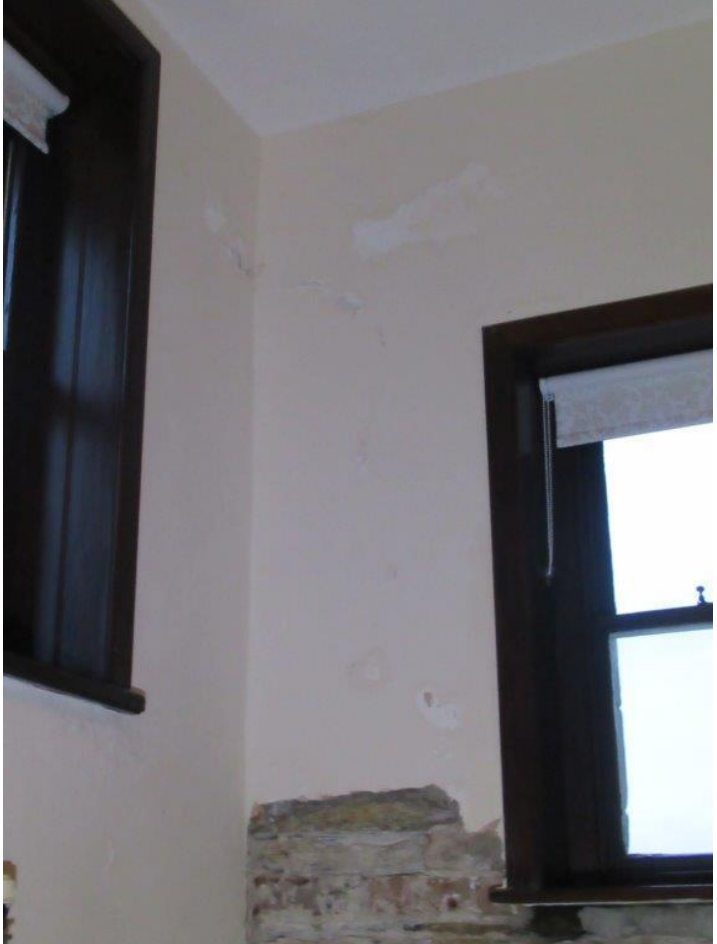
Dampness to external wall in room 10.	IMG_640 4

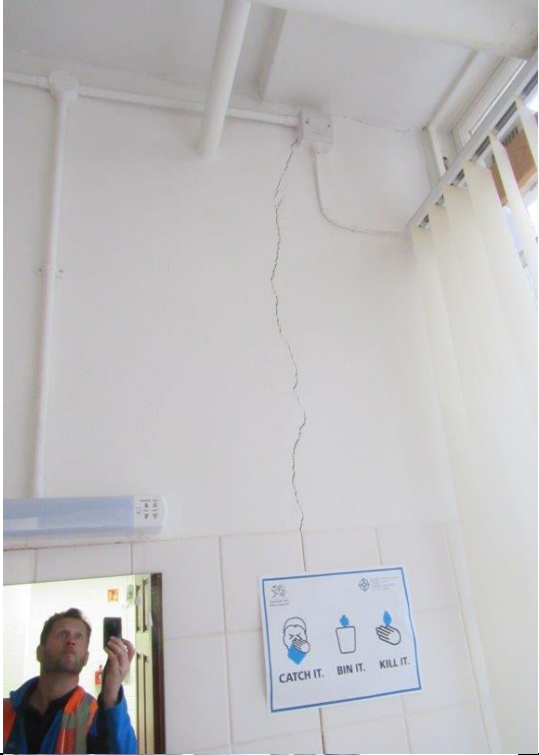
<p>View of elevation related to the above ground floor toilet where cracking extends to the spine wall extending off this external wall.</p>	<p>IMG_673 9</p>

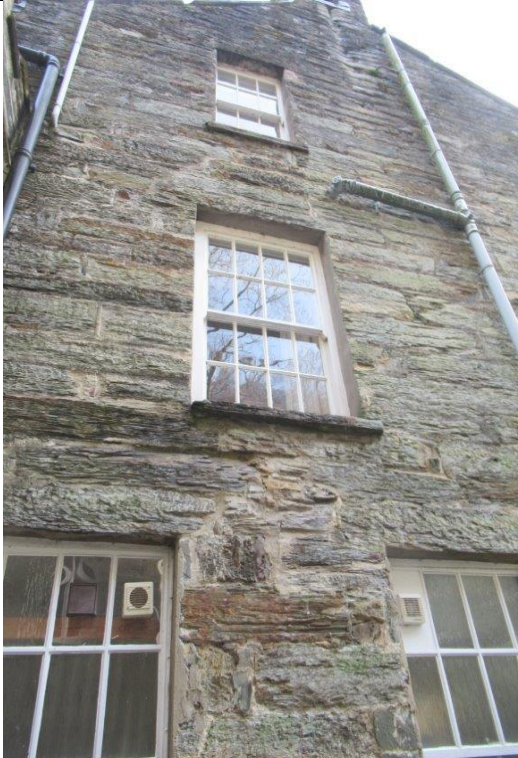
There is evidence of damp staining and water penetration to the external wall of the ground floor male toilet. This is particularly noted to the D1 elevation and this area of stonework associated to the external structure to the toilets at ground floor and then as the external wall continues up to the first floor. The quality of the stone in terms of the shale/poor quality slate stone utilised here is of low quality, a lot of the area is pointed in cement which will only exacerbate any issues where water penetration occurs and the lack of breathability. Repointing to this location should be considered and an allowance for such in the indicative maintenance schedule (refer to the maintenance schedule).

BARSCHEDULE OF PHOTOGRAPHS AND COMMENTS - Plas Tan y Blwch, Maentwrog, Blaenau Ffestiniog LL41 3YU - Snowdonia National Park Authority		
Comments	File	Photograph
Date:		
Male Toilet ground floor	IMG_674 2

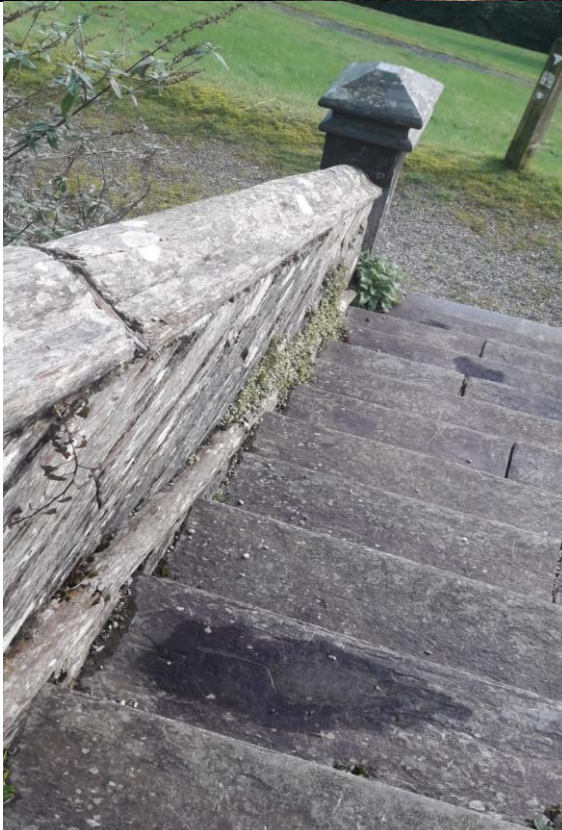
SCHEDULE OF PHOTOGRAPHS AND COMMENTS - Plas Tan Y Blwch		
Comments	File	Photograph
Guarding in poor order and fall unprotected to ancillary building near to the junction of elevations K and J. Needs immediate repair.	17d56f54-4724-4e06-9727-3cba4338832b	 
View of parapet to retaining wall to upper terrace, elevation A1. Upper parapet in poor order, extensive areas requiring repair and reconstruction. The height of the parapet is also questionable at circa 750mm, screen off with simple post and wire fencing at lower level with signage to keep guests/visitors from being directly below	26d7914d-a8aa-498b-952b-3a47b10b7135

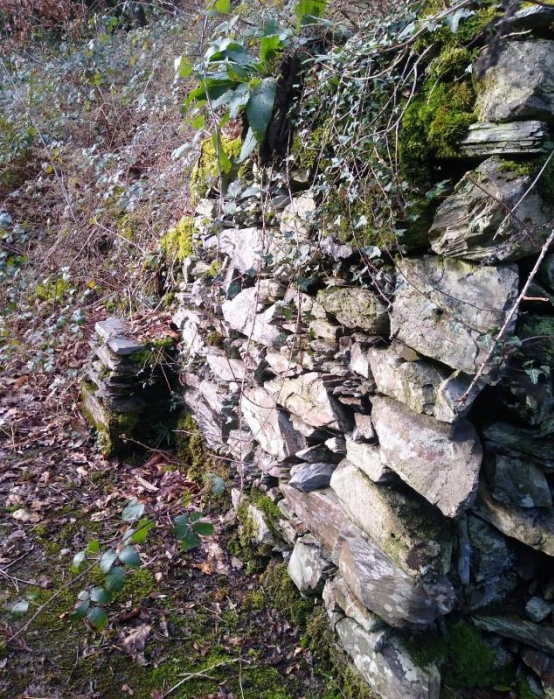
<p>Lower terrace retaining wall at one of the buttress positions. Some of the buttresses require repair due to weathering.</p>	<p>36b351f1-8b26-4bf7-928e-dac4df0c6967</p>

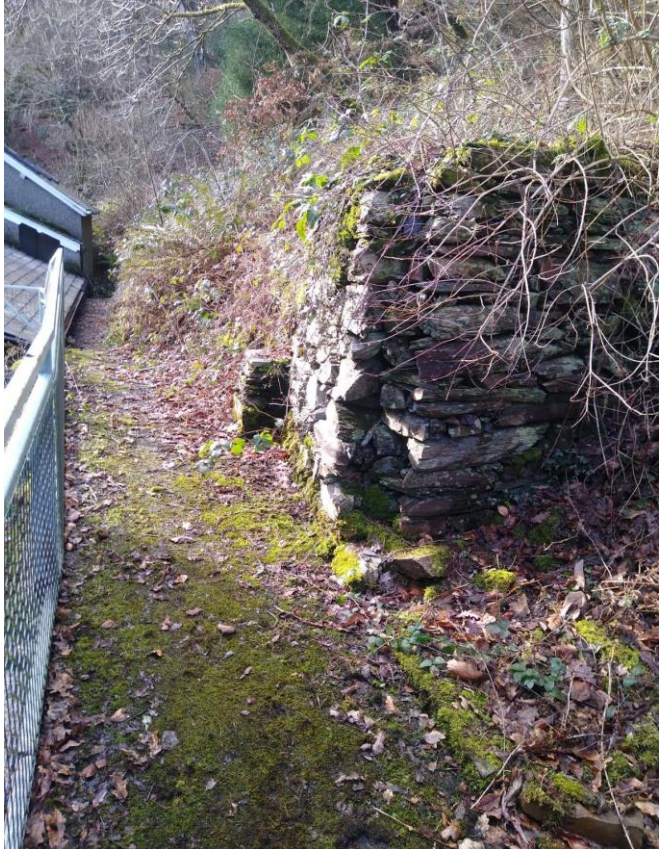
Area of ground opposite elevation B1 close to the steps to this locality and the ground is somewhat disturbed and would benefit from some ground matting and anchoring. structural advice and opinion on this should be commented upon when engineers inspect building for other matters.	479abf3f-6111-4412-b87f-f80be0a3b790

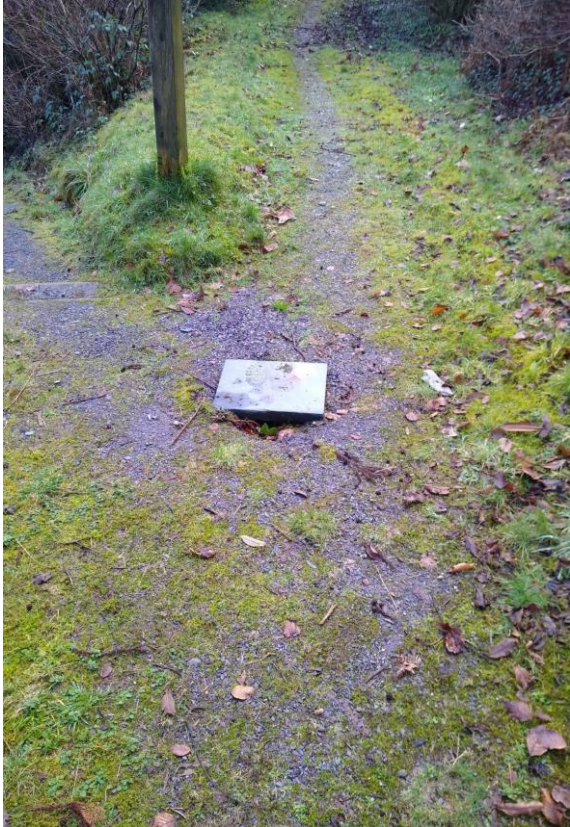
Foliage and leaf fall associated to road gully needs clearing or susceptible to blockage.	c141342f-8b81-46e0-bacd-6ccade94572a
