**BUILDING SURVEY
CHALET BUILDING
PLAS TAN Y BWLCH
MAENTWROG
BLAENAU FFESTINIOG
LL41 3YU**

Our Ref: LST/SM/212167

Date: November 2021

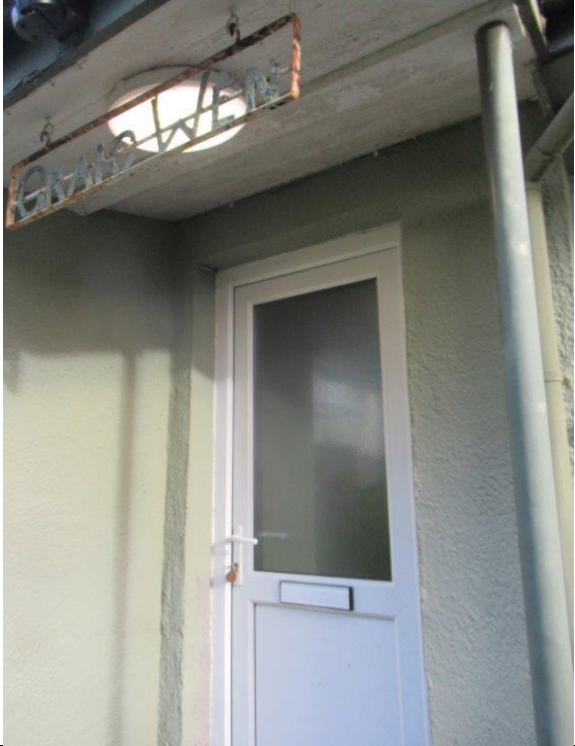
SCHEDULE OF PHOTOGRAPHS AND COMMENTS - Chalet – Plas Tan Y Bwlch		
Comments	File	Photograph
View to front door.	IMG_741 5

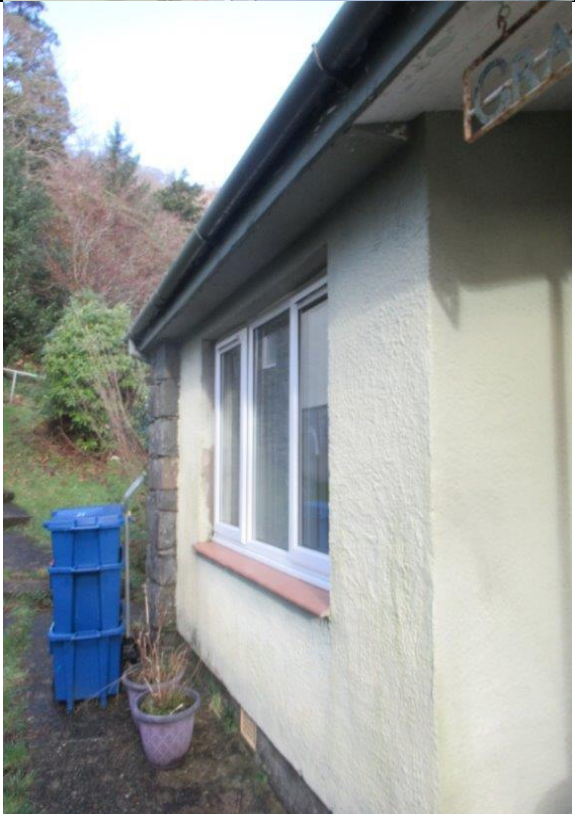
Image to front left-hand bedroom window.	IMG_741 6

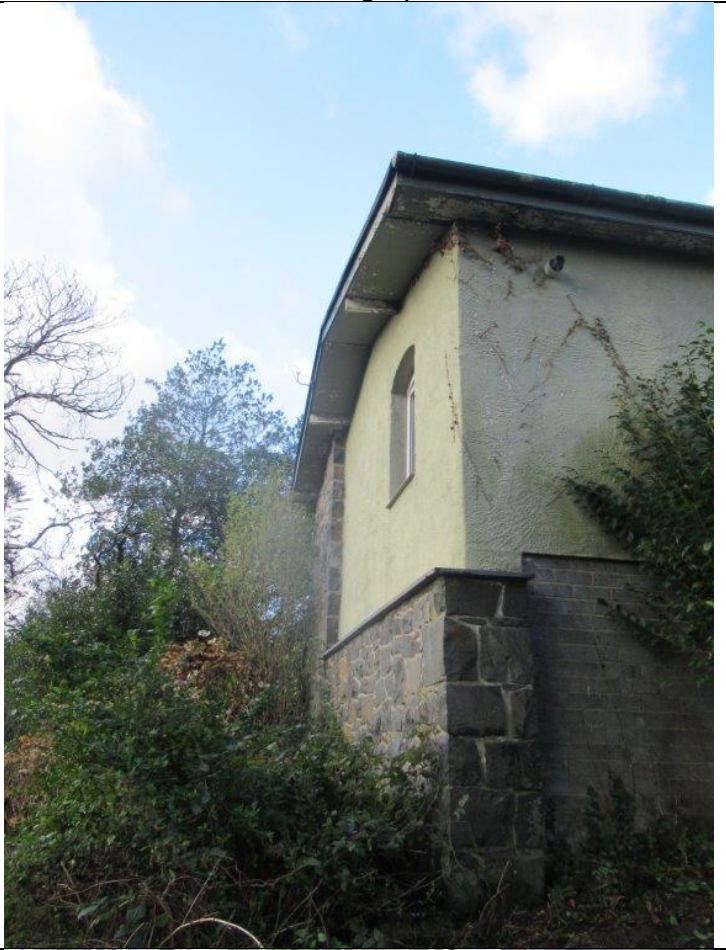
SCHEDULE OF PHOTOGRAPHS AND COMMENTS - Chalet – Plas Tan Y Bwlch		
Comments	File	Photograph
Image to rear right-hand corner.	IMG_7417

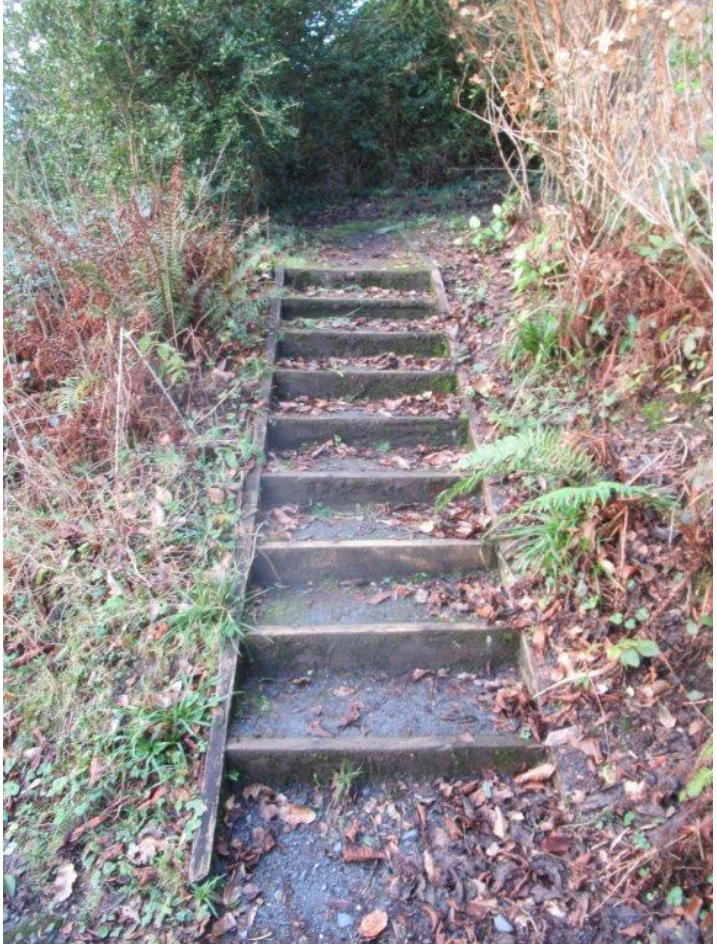
SCHEDULE OF PHOTOGRAPHS AND COMMENTS - Chalet – Plas Tan Y Bwlch		
Comments	File	Photograph
Timber and gravel to dust steps near to property.	IMG_742 4

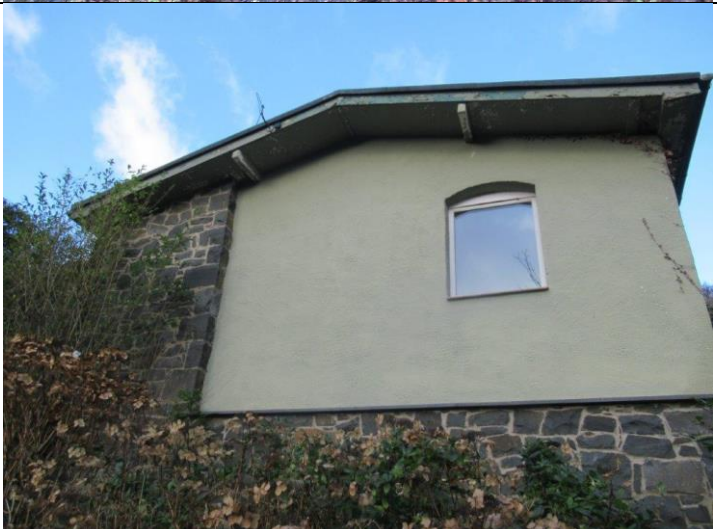
Right-hand elevation.	IMG_742 5

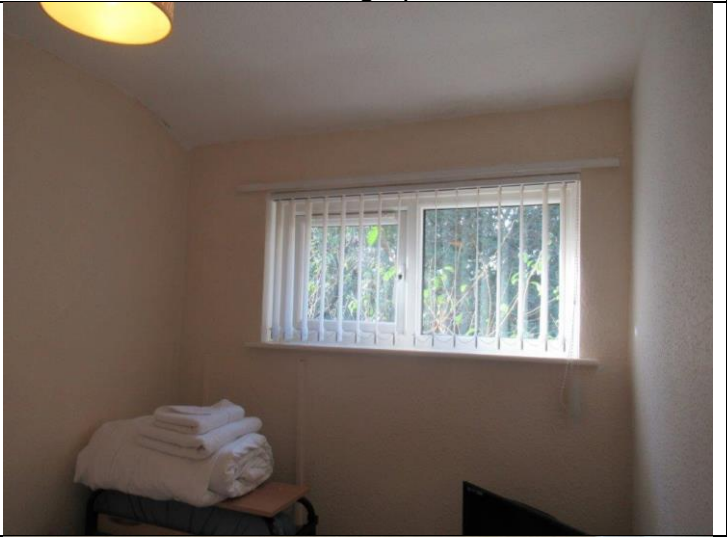
SCHEDULE OF PHOTOGRAPHS AND COMMENTS - Chalet – Plas Tan Y Bwlch		
Comments	File	Photograph
Front right-hand bedroom.	IMG_747 6
