**BUILDING SURVEY  
PLAS TAN Y BWLCH  
MAENTWROG  
BLAENAU FFESTINIOG  
LL41 3YU**

**Our Ref: LST/SM/212167**

**Date: November 2021**

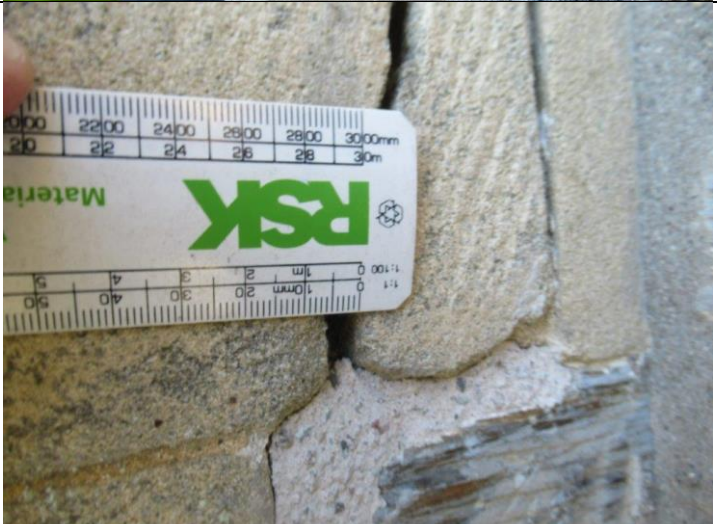
BARSCHEDULE OF PHOTOGRAPHS AND COMMENTS - Plas Tan y Blwch, Maentwrog, Blaenau Ffestiniog LL41 3YU - Snowdonia National Park Authority		
Comments	File	Photograph
Date:		
<p>Cracking extending and continuing through this stone, reduces to 2mm at the head of the block.</p> <p>Some localised lime repointing has been undertaken in the last couple of years.</p>	<p>IMG_548 2</p>

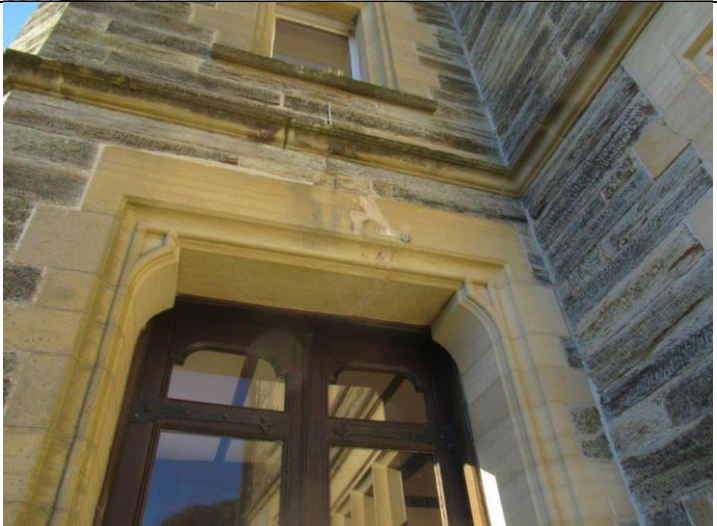
Comments	File	Photograph
Date:		
General view to doorway and location of cracking to blockwork to one side of door opening.	IMG_548 5

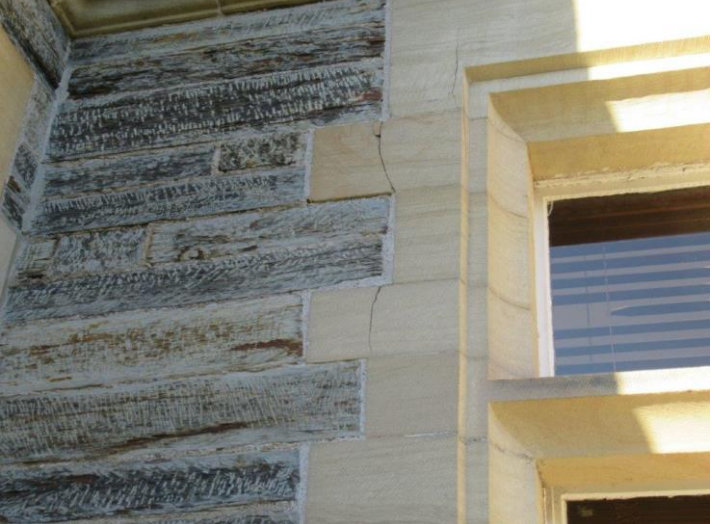
BARSCHEDULE OF PHOTOGRAPHS AND COMMENTS - Plas Tan y Blwch, Maentwrog, Blaenau Ffestiniog LL41 3YU - Snowdonia National Park Authority		
Comments	File	Photograph
Date:		
The transom has sheered at the junction with the stone mullion associated to the above location.	IMG_5488

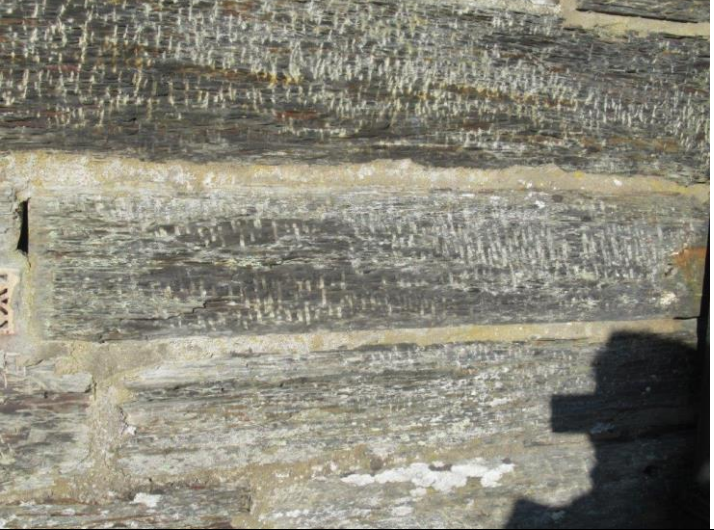
View of where the dressing to the original stone face, has been extended to but not carried on at one location to the front right hand corner.	IMG_549 7

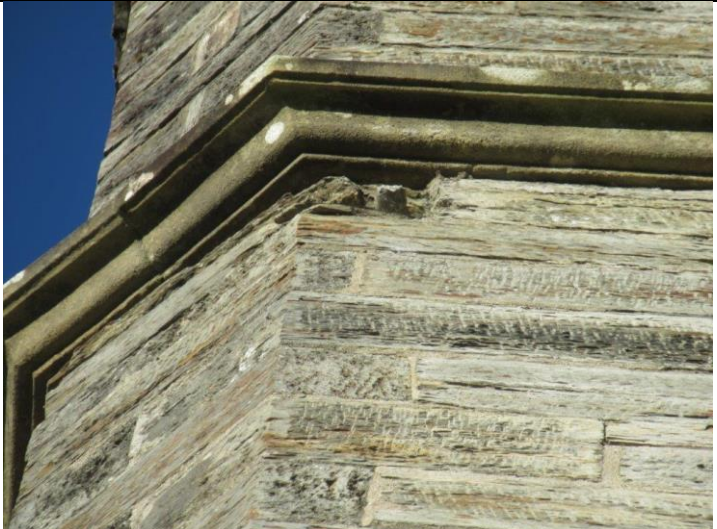
BARSCHEDULE OF PHOTOGRAPHS AND COMMENTS - Plas Tan y Blwch, Maentwrog, Blaenau Ffestiniog LL41 3YU - Snowdonia National Park Authority		
Comments	File	Photograph
Date:		
View to front elevation A1 left hand side outrigger.	IMG_550 5

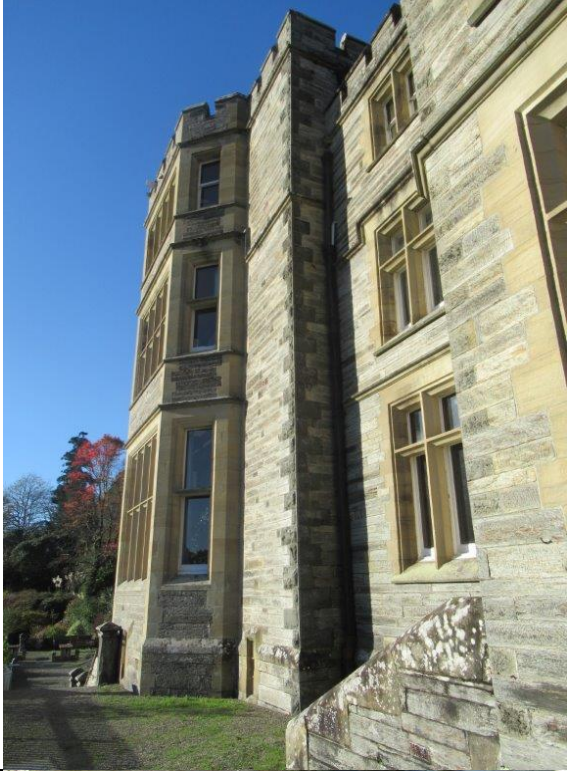
View to inner corner where downpipe position at elevation A1  Note in need of redecoration. Pointing is receding at corner in numerous locations.	IMG_550 6

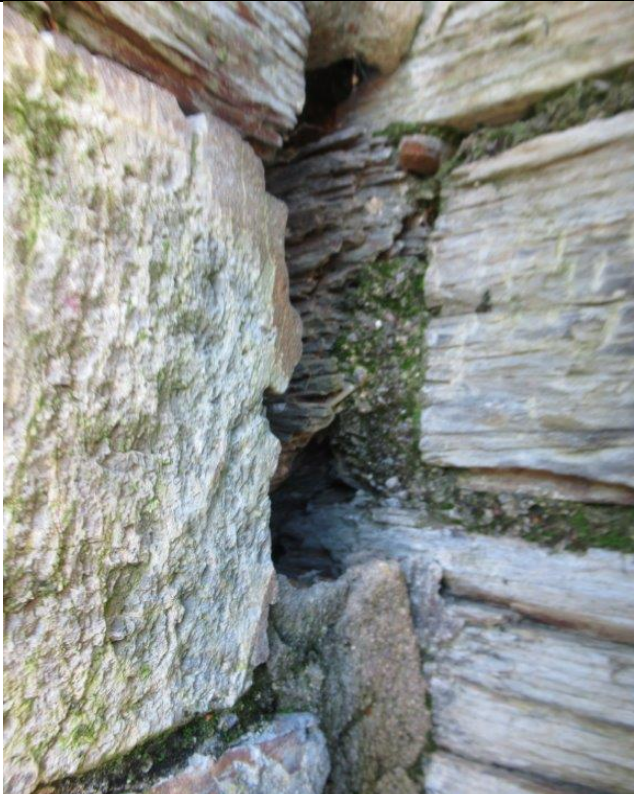
BARSCHEDULE OF PHOTOGRAPHS AND COMMENTS - Plas Tan y Blwch, Maentwrog, Blaenau Ffestiniog LL41 3YU - Snowdonia National Park Authority		
Comments	File	Photograph
Date:		
Further view of inner corner referred to above.	IMG_551 7

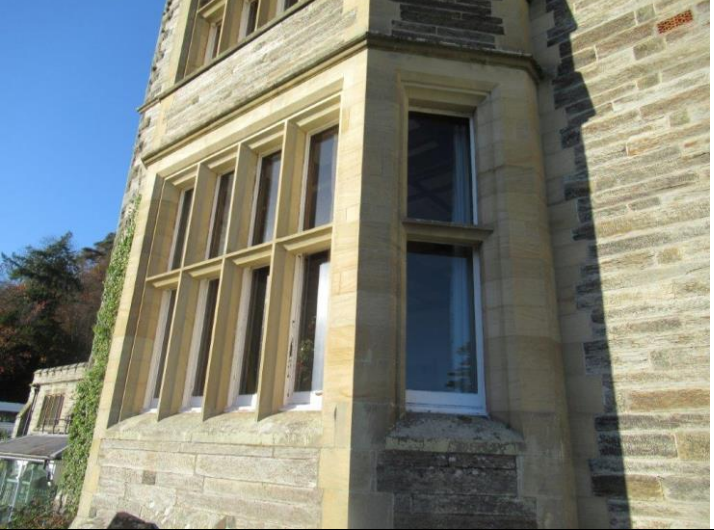
Note transom window at ground floor where the stone transom has sheered to the mullion to left hand bay to elevation A1.	IMG_552 2

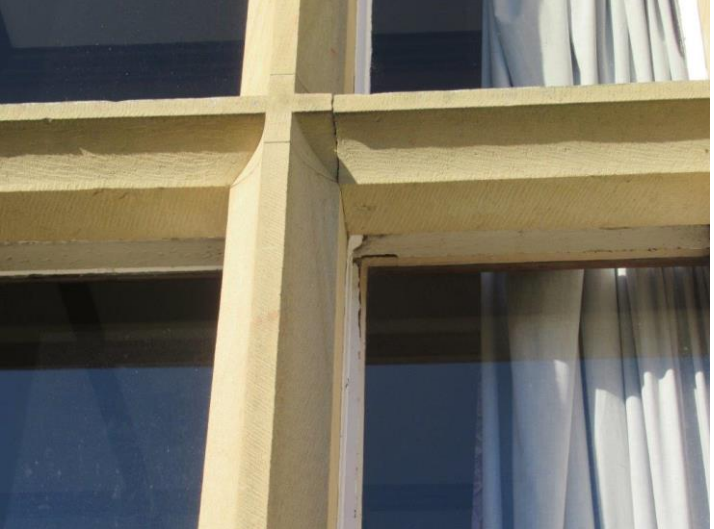
BARSCHEDULE OF PHOTOGRAPHS AND COMMENTS - Plas Tan y Blwch, Maentwrog, Blaenau Ffestiniog LL41 3YU - Snowdonia National Park Authority		
Comments	File	Photograph
Date:		
Cracking to the mullion at this location also.	IMG_552 4

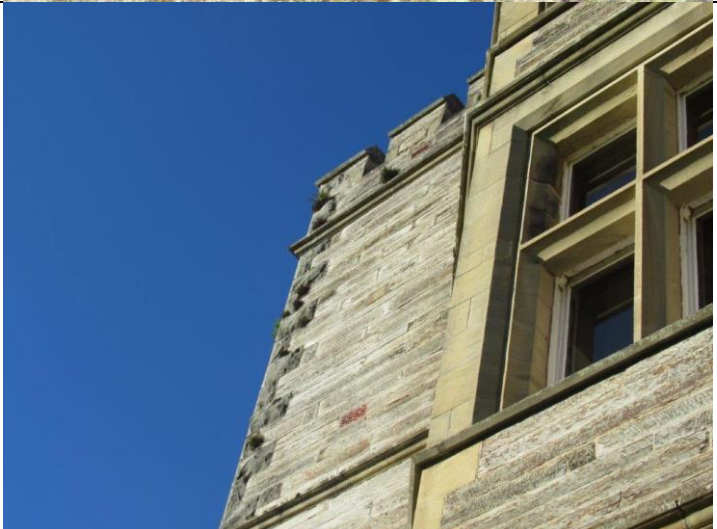
BARSCHEDULE OF PHOTOGRAPHS AND COMMENTS - Plas Tan y Blwch, Maentwrog, Blaenau Ffestiniog LL41 3YU - Snowdonia National Park Authority		
Comments	File	Photograph
Date:		
<p>Front elevation – left hand side to the main elevation A1.</p> <p>Note ivy growth at this location.</p>	<p>IMG_552 8</p>

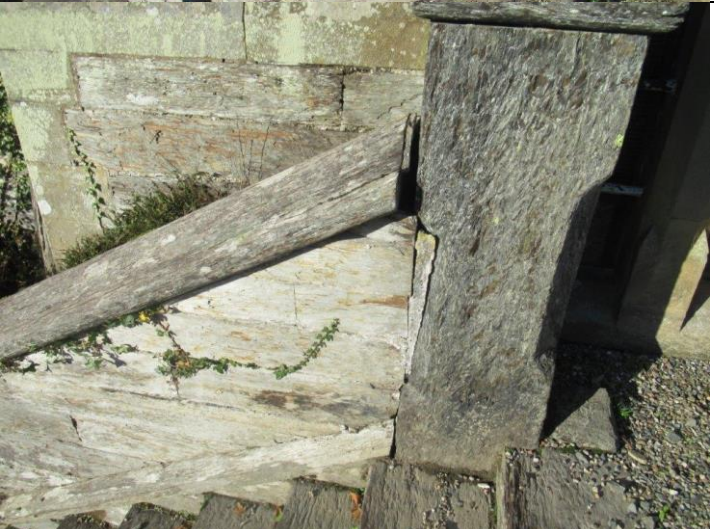
Comments	File	Photograph
Date:		
<p>Continuation of main elevation carrying across the lower ground floor and to the lower GF terrace. Elevation A2.</p>	<p>IMG_553 2</p>

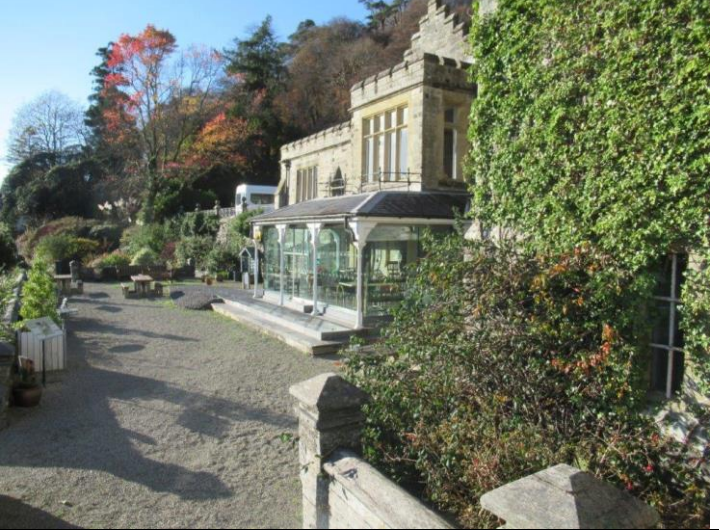
<p>View of front lower terrace back towards principle upper terrace and front elevation, front left corner and left hand elevation A3.</p>	<p>IMG_553 3</p>

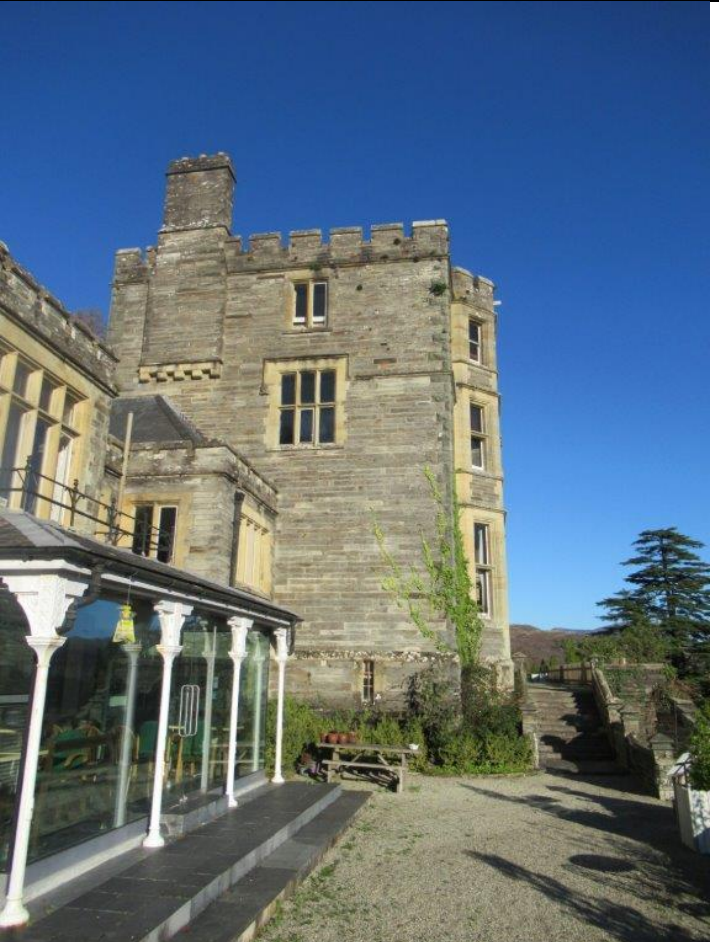
BARSCHEDULE OF PHOTOGRAPHS AND COMMENTS - Plas Tan y Blwch, Maentwrog, Blaenau Ffestiniog LL41 3YU - Snowdonia National Park Authority		
Comments	File	Photograph
Date:		
<p>Elevation A3 referre to plans for clarity.</p> <p>Note vegetation growth to upper area and evidence of saturation above window at upper high level to this area. Also at chimney at upper level with vegetation growth.</p>	<p>IMG_553 4</p>

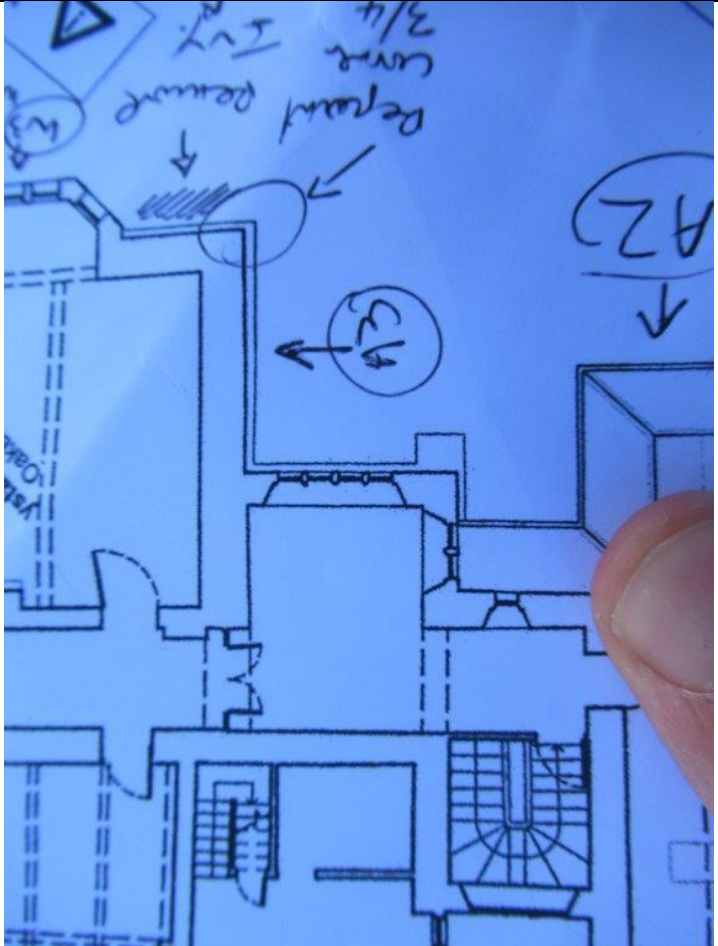
<p>Closer view to elevation A3 at front left corner.</p> <p>Note vent put in to external wall related to lead box valley gutter void and roof void. Various areas of vegetation growth in this area, indicative of saturation and pointing receding.</p>	<p>IMG_553 5</p>

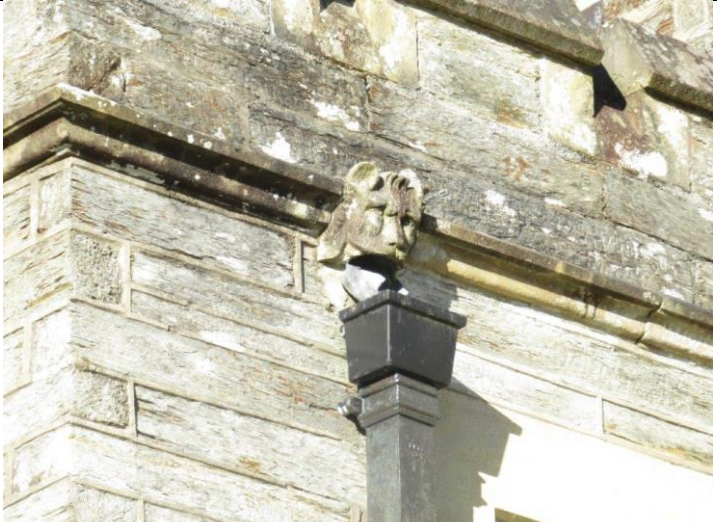
BARSCHEDULE OF PHOTOGRAPHS AND COMMENTS - Plas Tan y Blwch, Maentwrog, Blaenau Ffestiniog LL41 3YU - Snowdonia National Park Authority		
Comments	File	Photograph
Date:		
Further view of other similar arrangements to left hand corner of elevation A2 at high level.	IMG_555 2

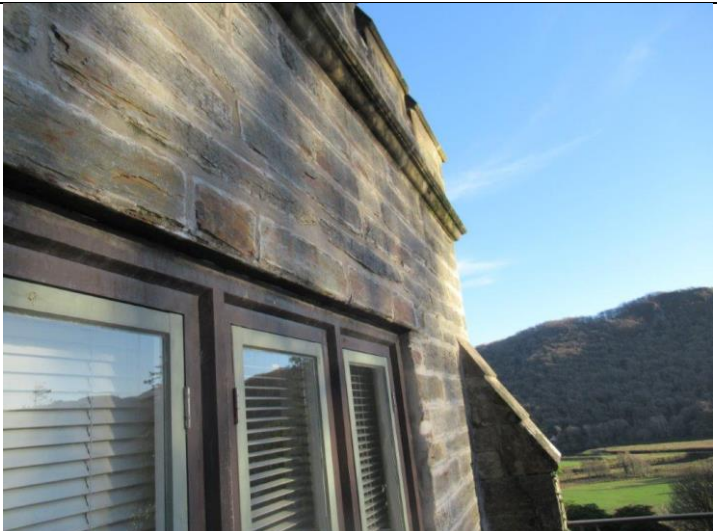
<p>Elevation C1 at window position.</p> <p>Note repointing work have been carried out here previously, however at the time this was repointed the steel beam to the window openings was not decorated or treated with regards to rusting to the beam and this is required.</p>	<p>IMG_558 6</p>

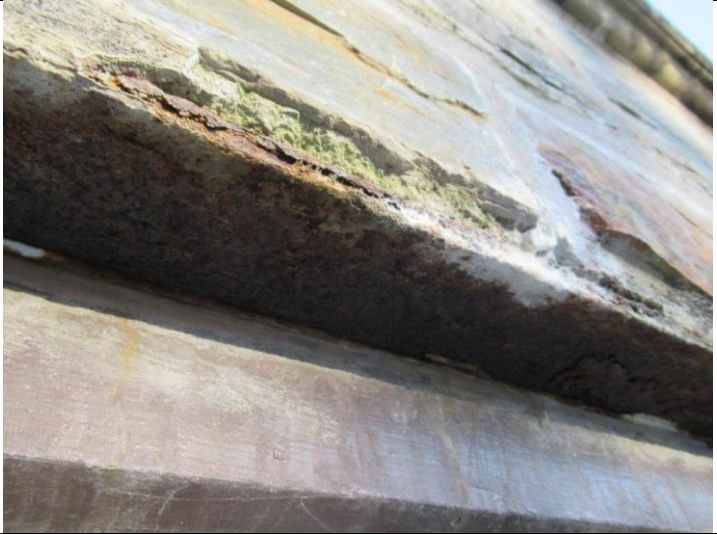
BARSCHEDULE OF PHOTOGRAPHS AND COMMENTS - Plas Tan y Blwch, Maentwrog, Blaenau Ffestiniog LL41 3YU - Snowdonia National Park Authority		
Comments	File	Photograph
Date:		
Related to the above.	IMG_558 7

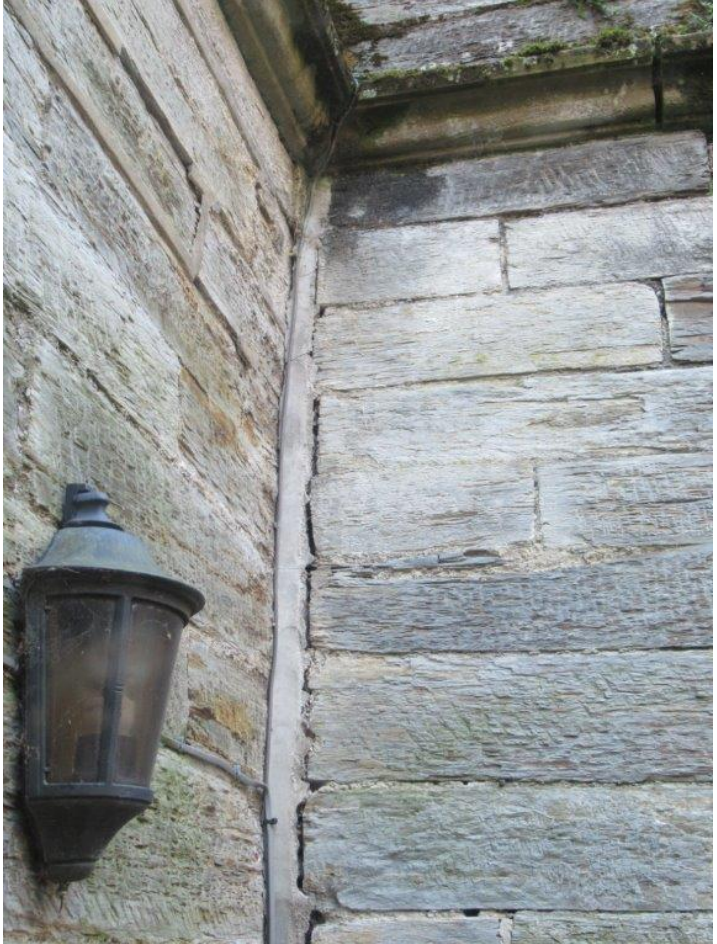
BARSCHEDULE OF PHOTOGRAPHS AND COMMENTS - Plas Tan y Blwch, Maentwrog, Blaenau Ffestiniog LL41 3YU - Snowdonia National Park Authority		
Comments	File	Photograph
Date:		
Continuation of elevation C2 to return at inner corner. Large area of sand cement pointing is becoming detached from the corner, roughly 50mm or so in width. This requires repointing in lime and consideration of connectivity to be formed between the structure at this junction as the masonry is not formally coursed together. Therefore a Cintex or helifix cross stitching to the masonry possibly required engineer to advise.	IMG_560 6

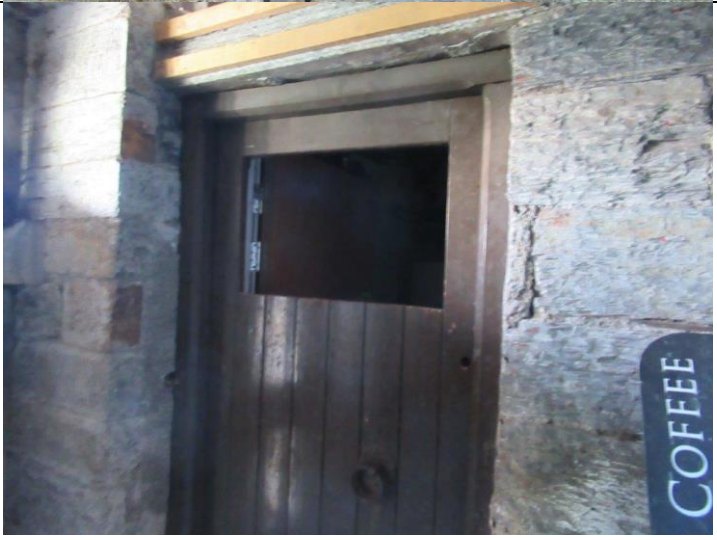
Door to boiler room.  Note the top hatch is open. This does not appear to be the most secure arrangement regarding the equipment in this location. Also, a vented louver detail in this area should be considered. With consideration of any bats as necessary to the detail.	IMG_561 3

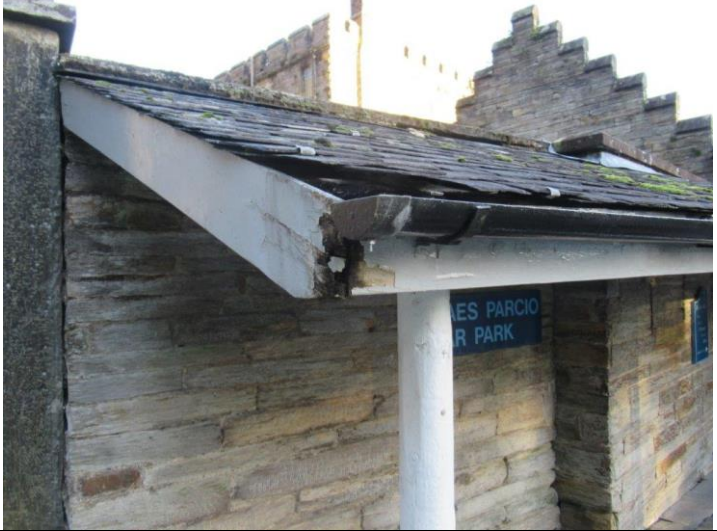
BARSCHEDULE OF PHOTOGRAPHS AND COMMENTS - Plas Tan y Blwch, Maentwrog, Blaenau Ffestiniog LL41 3YU - Snowdonia National Park Authority		
Comments	File	Photograph
Date:		
<p>Elevation C3</p> <p>An area of the slate is missing at the verge to eaves junction. This requires repair and is causing timber deterioration at this location.</p>	<p>IMG_562 4</p>

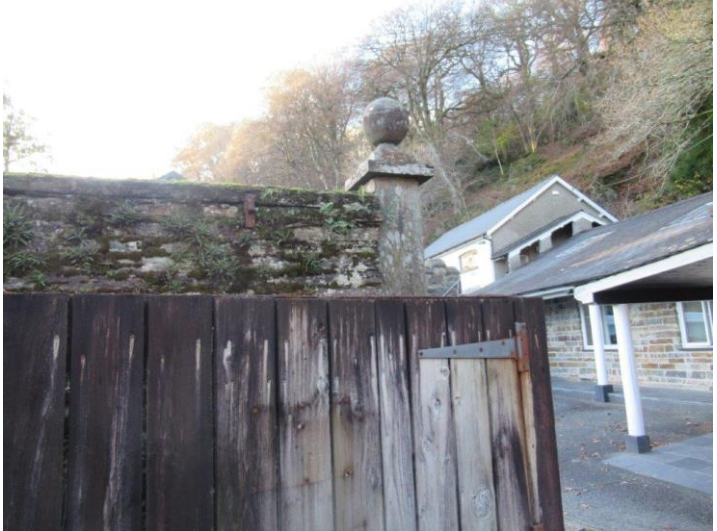
<p>View to rear wall to the elevation C3 that forms part of the supporting structure to the lean-to roof.</p> <p>Note this wall is saturated due to water penetration at the roof junction. Also due to the poor detailing associated to the coping over the wall and the porousness of the stone. Hence the significant vegetation growth. This requires repointing and some re-detailing and masonry repairs</p>	<p>IMG_562 9</p>

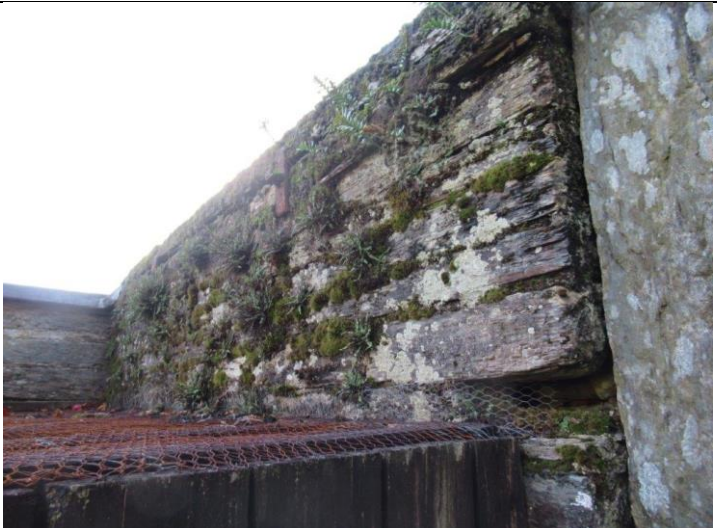
<p>View to rear of the wall to the lean-to structure associated to elevation C3 and the saturation and poor condition of the wall is evident which needs various re-pointing and repairs as commented on earlier.</p>	<p>IMG_563 9</p>

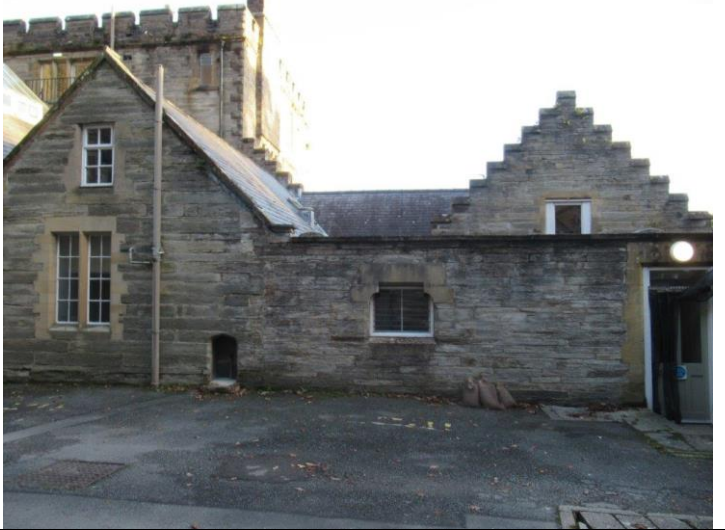
BARSCHEDULE OF PHOTOGRAPHS AND COMMENTS - Plas Tan y Blwch, Maentwrog, Blaenau Ffestiniog LL41 3YU - Snowdonia National Park Authority		
Comments	File	Photograph
Date:		
Elevation D1 at the kitchen side of the building and kitchen door entrance with external light is shown to one side.	IMG_564 1

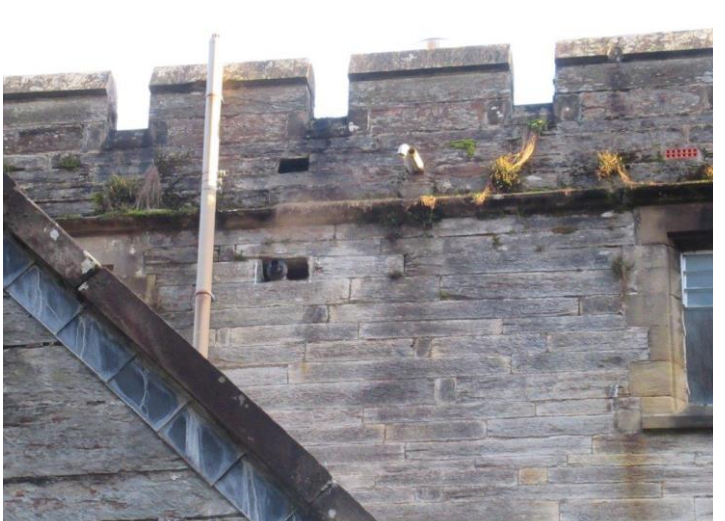
Rear castlement detail to tower area to elevation D1 at second floor area. Note two areas where stone repair is required where a flue has been put through the wall and the masonry left open for water penetration at this location. This needs resolving. It is evident that there is	IMG_564 6

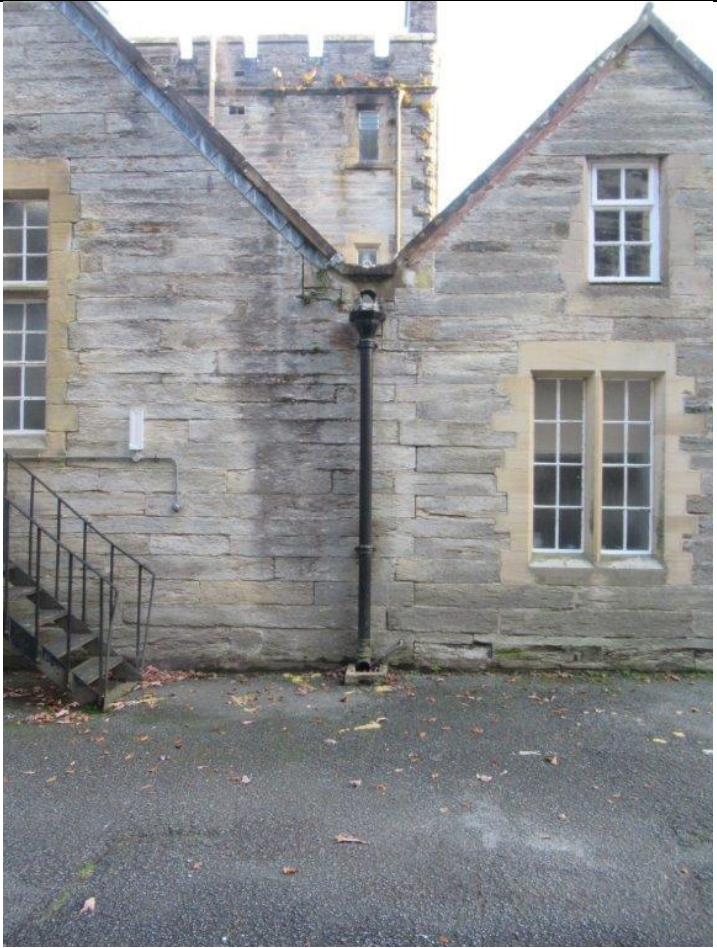
BARSCHEDULE OF PHOTOGRAPHS AND COMMENTS - Plas Tan y Bwlch, Maentwrog, Blaenau Ffestiniog LL41 3YU - Snowdonia National Park Authority		
Comments	File	Photograph
Date:		
also saturation to the upper wall castlement and various areas of re-pointing required here.		
Elevation D1 position of the lead valley gutter set between R12 roof slope and R14 roof slope exits through the outlet to the gable to the hopper - saturation is evident here and vegetation growth and re-pointing works need resolving at this location. Furthermore with some enhanced detailing at the outlet to ensure it is less susceptible to blockage as due to the trees and fall of foliage here during certain times of the year this makes it more susceptible to blockage due to inadequate detailing. Therefore, adjust the detailing to make this more robust and less susceptible to blockages.	IMG_564 8

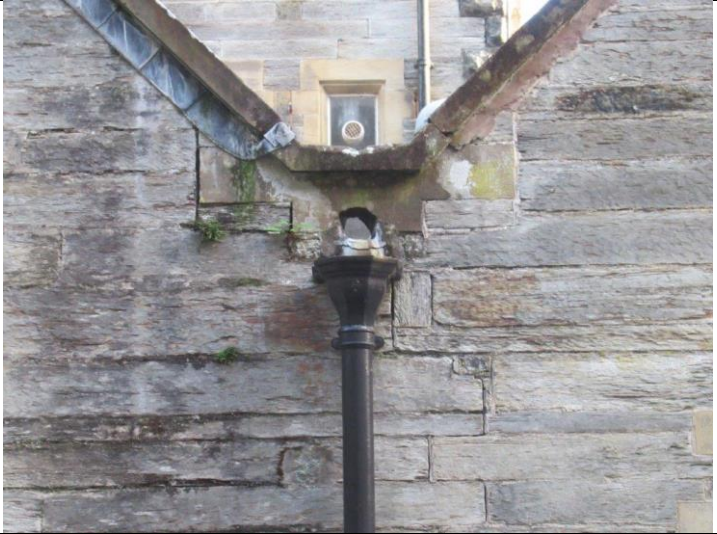
BARSCHEDULE OF PHOTOGRAPHS AND COMMENTS - Plas Tan y Blwch, Maentwrog, Blaenau Ffestiniog LL41 3YU - Snowdonia National Park Authority		
Comments	File	Photograph
Date:		
Close up of the above.	IMG_565 2

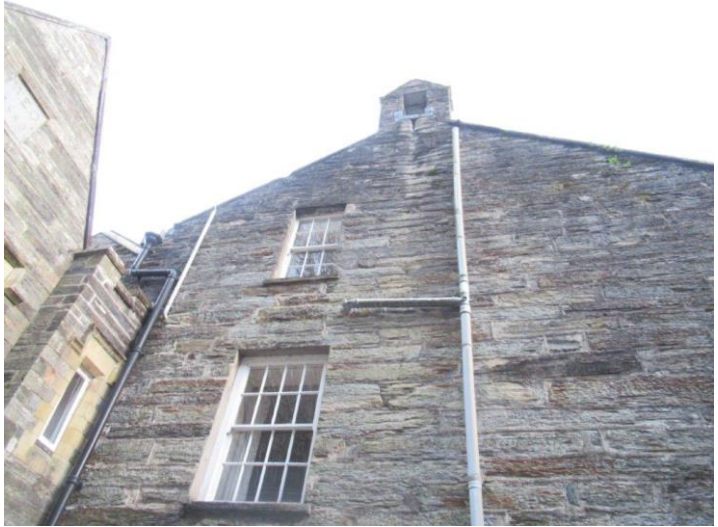
BARSCHEDULE OF PHOTOGRAPHS AND COMMENTS - Plas Tan y Blwch, Maentwrog, Blaenau Ffestiniog LL41 3YU - Snowdonia National Park Authority		
Comments	File	Photograph
Date:		
<p>Elevation D1 continuation of view to rear elevation towards junction with Elevation D2. Stonework here is worn and not as good quality as to other locations to the building. As can be seen at high level, there are lots of saturation to the upper gable area and vegetation growth and repointing and stone repairs at this level will be required, as reported. Please refer to the Indicative Maintenance Plan.</p>	<p>IMG_566 0</p>

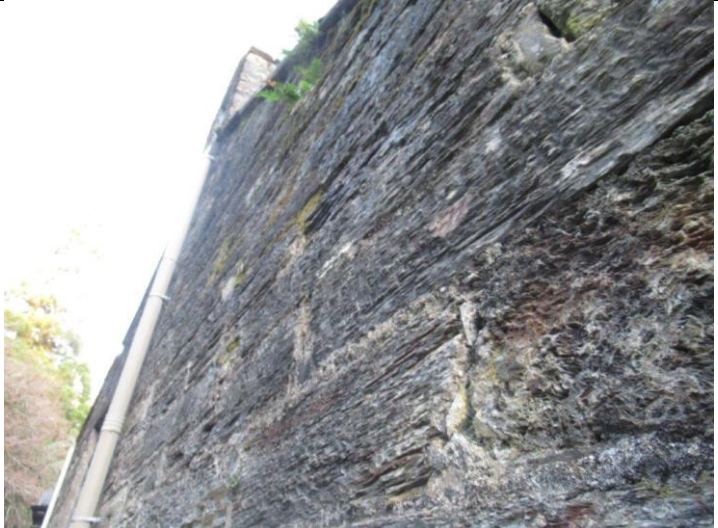
<p>Further view of this area to the gable that relates to roof slope R7. Note some of the fissures to the stonework.</p>	<p>IMG_566 6</p>

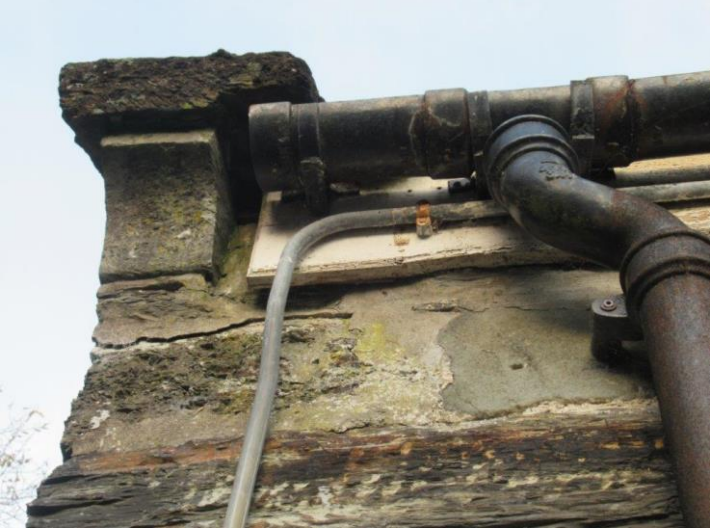
<p>View of roof slope R12 fascia board with woodworm and some cracking at the cement flush pointing to below the kneeler that should be raked out and re-pointed in lime and flush pointed. Cast iron gutter requires decoration, as reported. The stonework to the gable, as can be seen at the end here, is worn.</p>	<p>IMG_570 4</p>

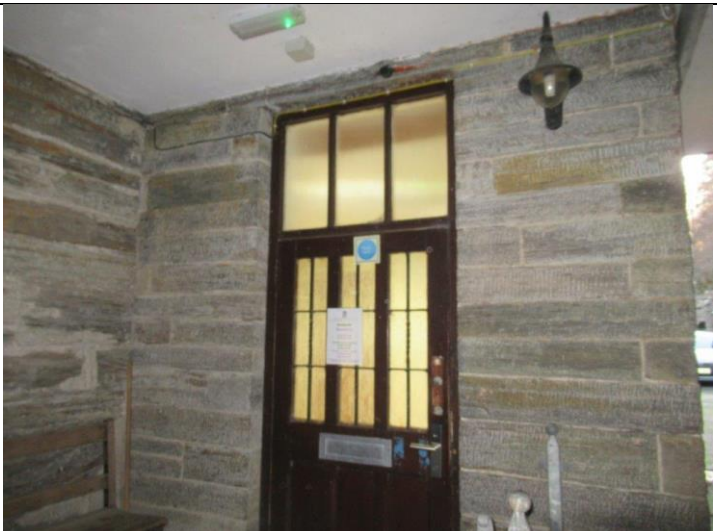
<p>View of elevation D3 where entrance into the building for the ramp which leads from car park to the right hand side elevation of the building to gain entry. There is no access comms at this position or signage for assistance for disabled access or clarity of any visiting persons</p>	<p>IMG_571 5</p>

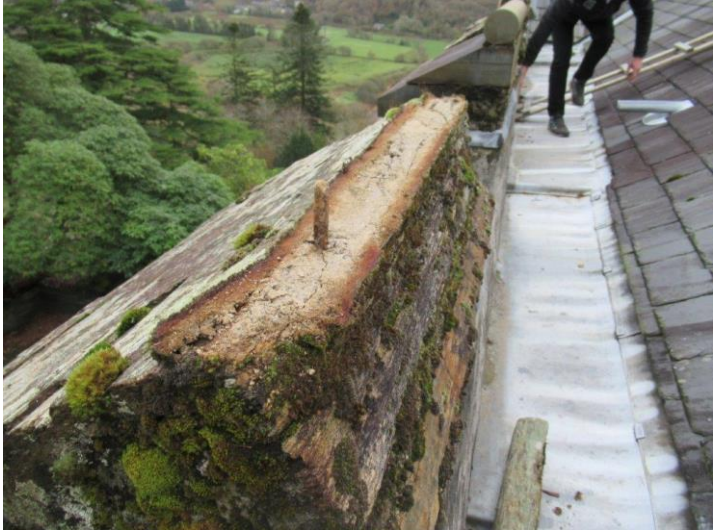
BARSCHEDULE OF PHOTOGRAPHS AND COMMENTS - Plas Tan y Blwch, Maentwrog, Blaenau Ffestiniog LL41 3YU - Snowdonia National Park Authority		
Comments	File	Photograph
Date:		
to the castlements which will; require repair as reported on.		
Further view to the above. Also note the height of the steps to this box gutter are minimal and not to Lead Sheet Association manual detailing of a minimum of 65.	IMG_572 6

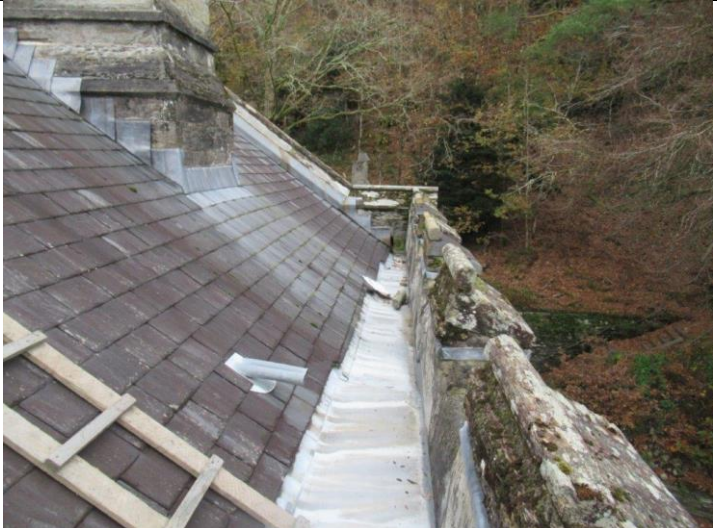
General view to valley box gutter related to roof slope R1.	IMG_572 9

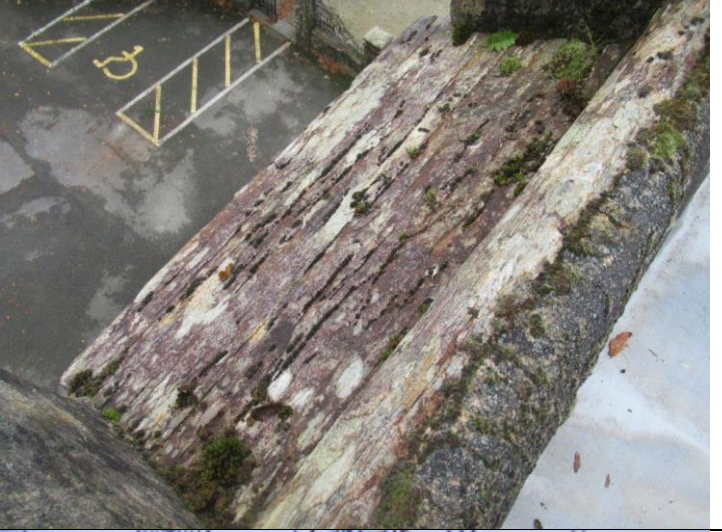
BARSCHEDULE OF PHOTOGRAPHS AND COMMENTS - Plas Tan y Blwch, Maentwrog, Blaenau Ffestiniog LL41 3YU - Snowdonia National Park Authority		
Comments	File	Photograph
Date:		
Close up view of stonework to castlement. Note various fissures to the stonework that are likely to delaminate over the coming years and also the vegetation growth to this and the need for repair in the near future as reported.	IMG_573 5

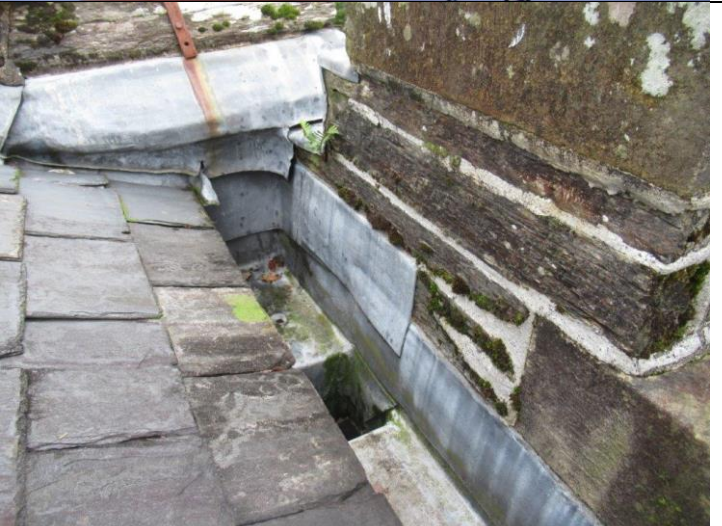
Roof slope R3 box gutter at outlet position typical to the upper roofs. The box gutter is narrow and susceptible to blockage at the outlet. The outlet catch pit formed is of minimal dimensions. There is no overflow detailing and this gutter is susceptible to becoming easily	IMG_576 1

BARSCHEDULE OF PHOTOGRAPHS AND COMMENTS - Plas Tan y Blwch, Maentwrog, Blaenau Ffestiniog LL41 3YU - Snowdonia National Park Authority		
Comments	File	Photograph
Date:		
blocked and backfilling and discharging into the building due to the narrowness of the detail and also the fact that there is no overflow does not help.		
Image relating to the above. The outlet that terminates through the castlement wall detail is at circa 50mm in diameter.	IMG_576 6

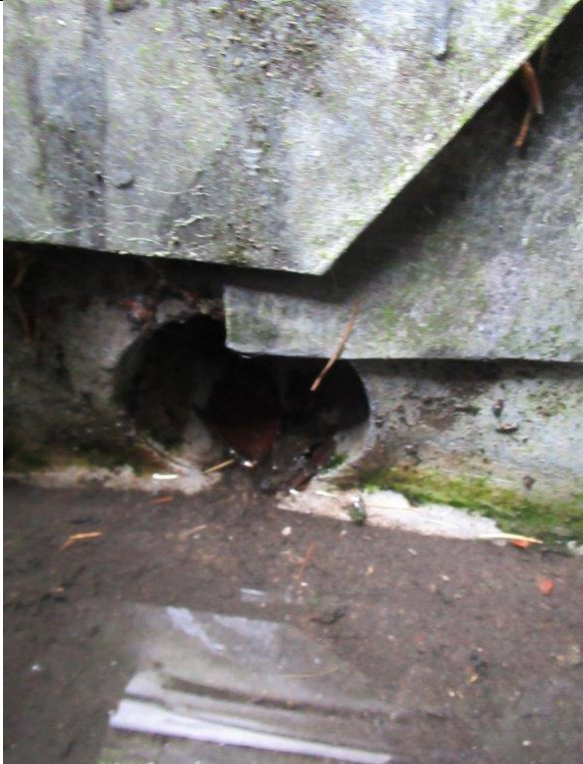
BARSCHEDULE OF PHOTOGRAPHS AND COMMENTS - Plas Tan y Blwch, Maentwrog, Blaenau Ffestiniog LL41 3YU - Snowdonia National Park Authority		
Comments	File	Photograph
Date:		
View of catchpit	IMG_576 7

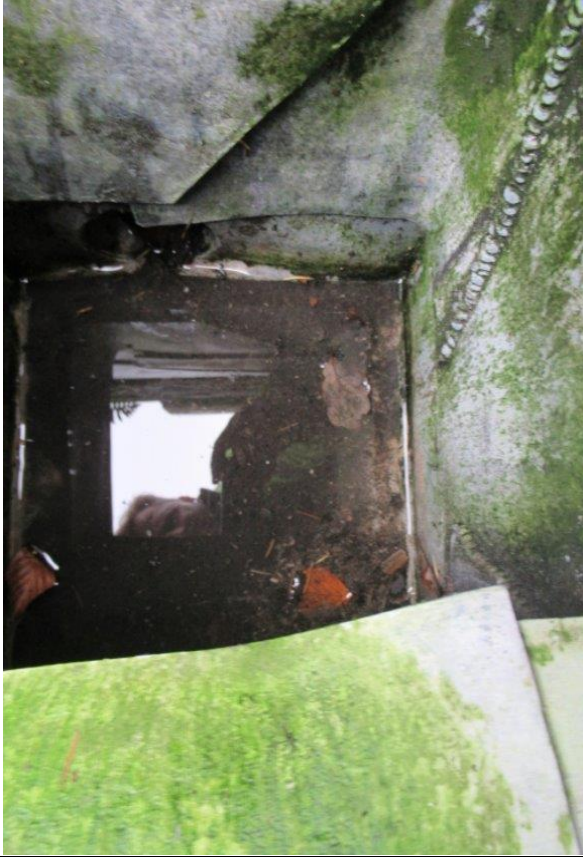
View of roof slope R3 box gutter detail generally. The stonework for the most part, except for the gable at the coping positions, is formed with sandstone which is in fair order.	IMG_577 1

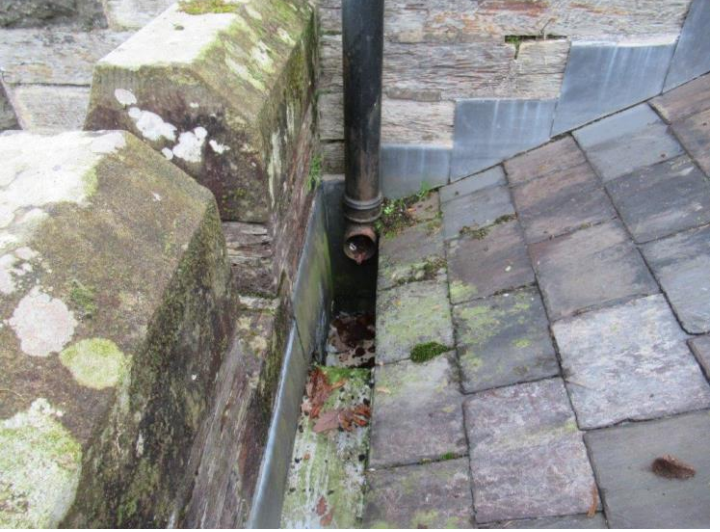
Comments	File	Photograph
Date:		
<p>Outlet position and catchpit associated to this box gutter at the junction with the tower external wall and downpipe that discharges from this tower roof slope R13 at this end onto roof slope R6 box gutter. Issues here the same as reported to roof slope R3 box gutter – no overflow, minimal dimensions etc</p>	<p>IMG_579 5</p>

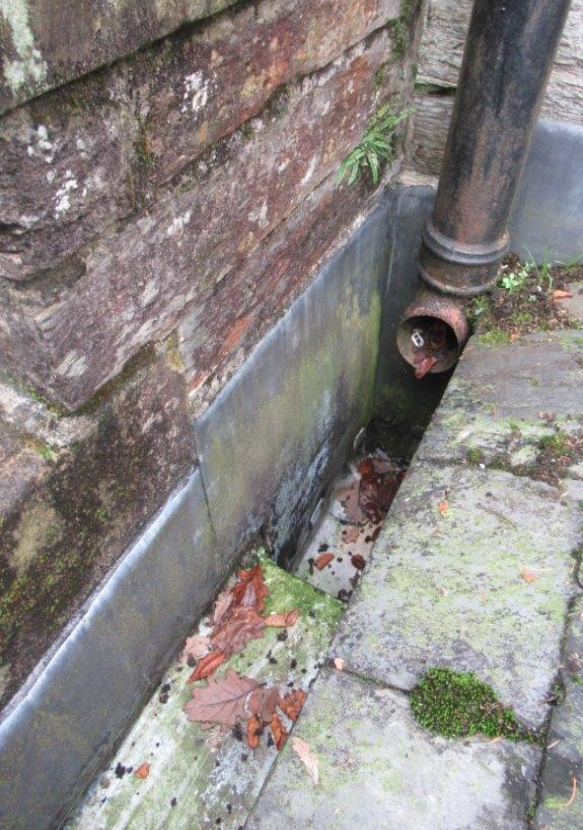
<p>Further view of the above.</p>	<p>IMG_579 6</p>

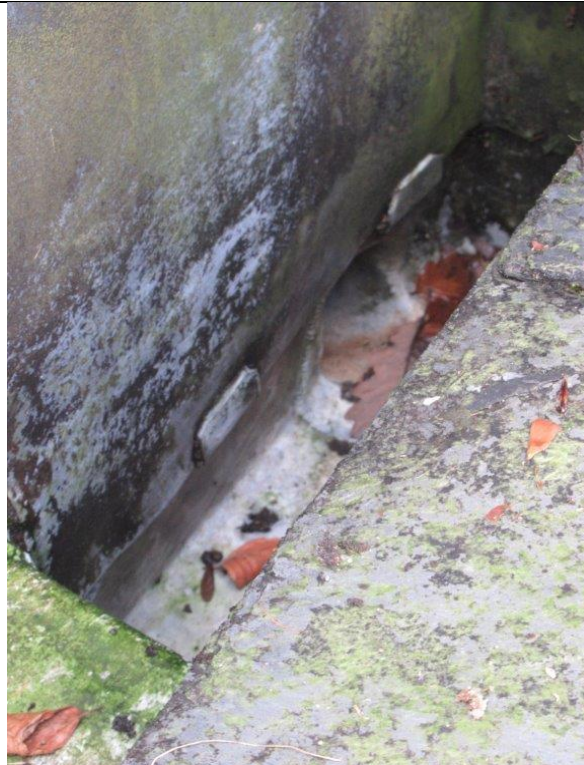
IMG\_579  
7

Close up view to outlet  
position at catchpit  
circa 50mm in  
diameter. Same  
issues as reported  
above.

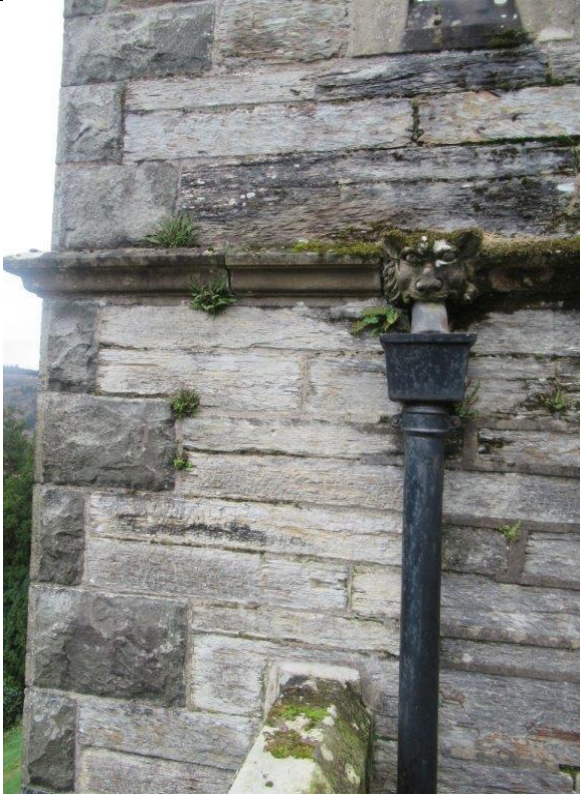
BARSCHEDULE OF PHOTOGRAPHS AND COMMENTS - Plas Tan y Blwch, Maentwrog, Blaenau Ffestiniog LL41 3YU - Snowdonia National Park Authority		
Comments	File	Photograph
Date:		
View of outlet from roof slope R13 near to roof slope R6 at hopper position. Note saturation to string course which is sandstone at this location and moss growth to the pointing. Majority of pointing in this location is sand and cement.	IMG_580 0

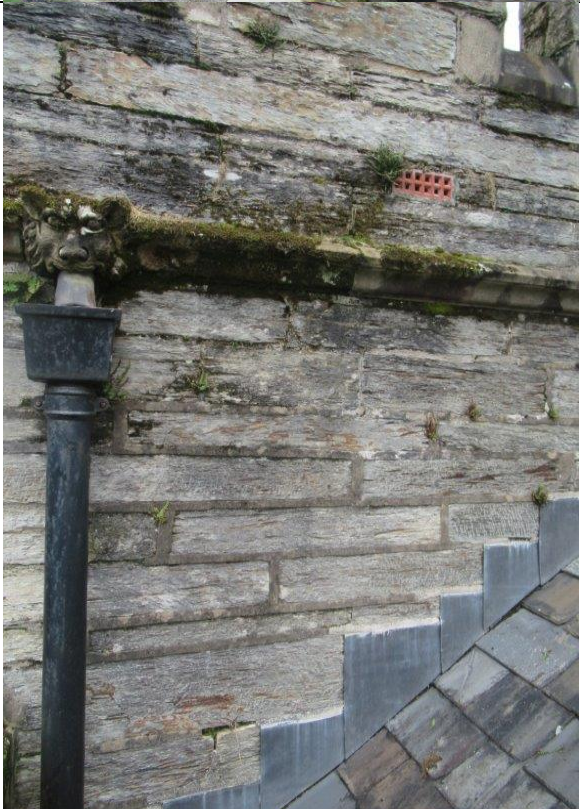
Continuation view associated to the above. Note also brick vent serving to ventilate the roof void we assume and the box gutter position.	IMG_580 1

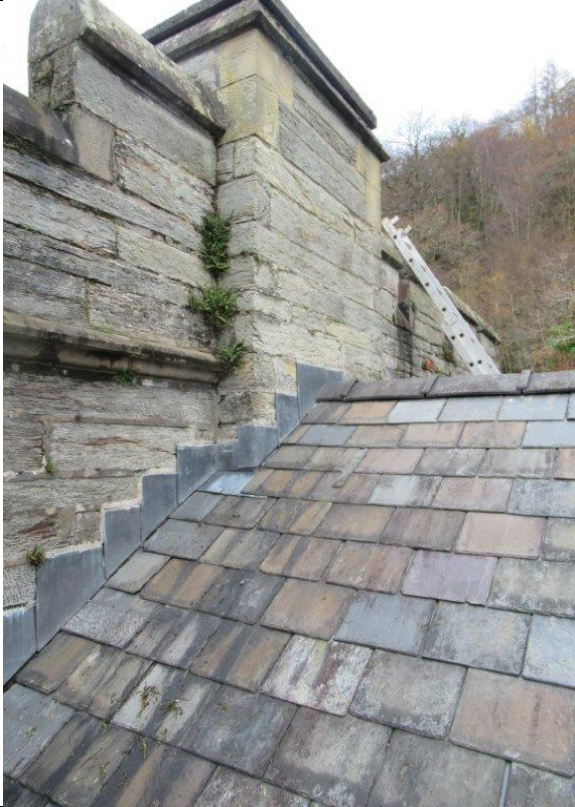
BARSCHEDULE OF PHOTOGRAPHS AND COMMENTS - Plas Tan y Blwch, Maentwrog, Blaenau Ffestiniog LL41 3YU - Snowdonia National Park Authority		
Comments	File	Photograph
Date:		
Further view of the above. Note vegetation growth at inner corner. This will require dealing with and the repointing to this area. Sandstone copings to the upper castlements generally in fair order.	IMG_580 2

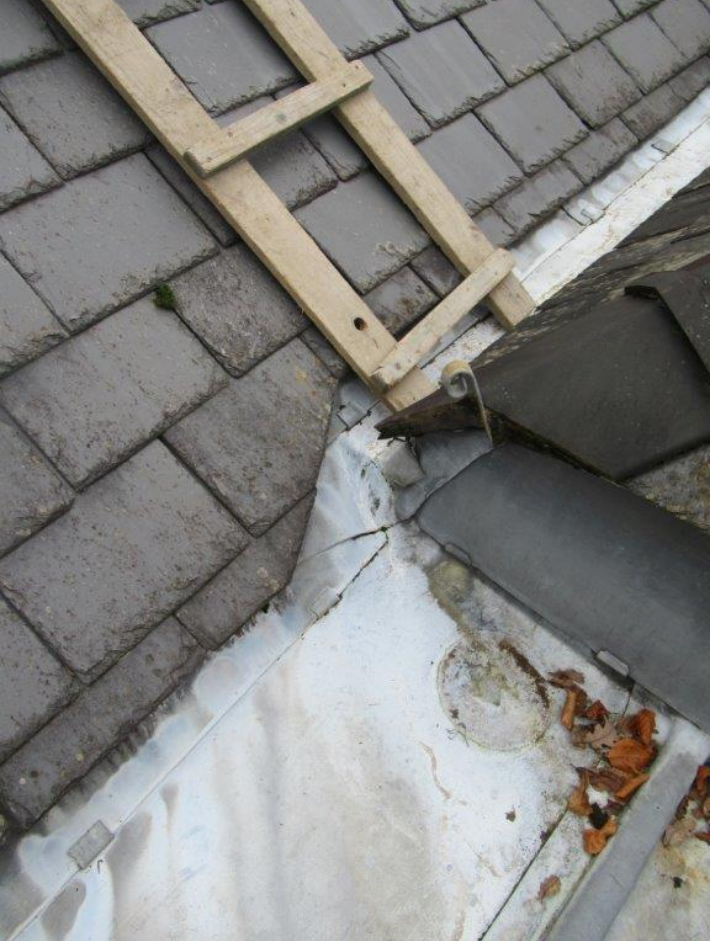
Comments	File	Photograph
Date:		
<p>View of valley gutter – lead valley gutter which extends form roof slope R9 and relates to roof slope R11 with glazed atrium and also roof slope R8. Junction shown relates to roof slope R10 and R11. Note narrowness of hip to lead valley gutter junction. This is not ideal but appears to be functional.</p>	<p>IMG_581 1</p>

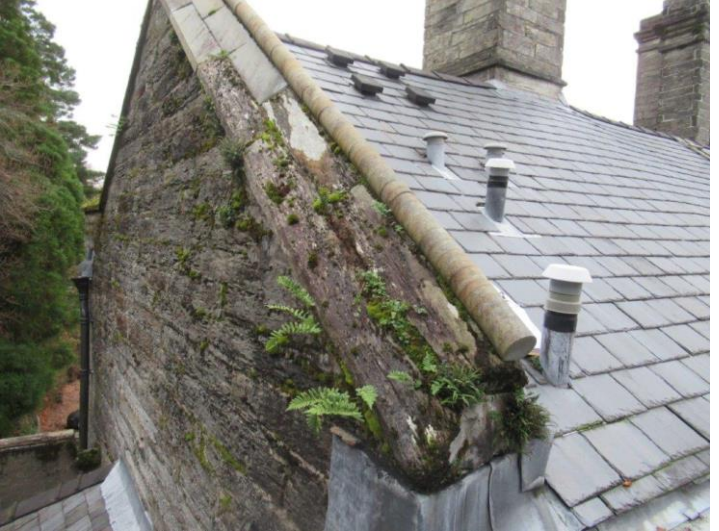
The slate roll top detail continues to the gable to roof slope R10 at the gable position over the original poor slate copings which now have various fractures and fissures together with vegetation growth and saturation evident. These coping details will require remedial works as reported.	IMG_582 4
