**BUILDING SURVEY  
PLAS TAN Y BWLCH  
MAENTWROG  
BLAENAU FFESTINIOG  
LL41 3YU**

**Our Ref: LST/SM/212167**

**Date: November 2021**

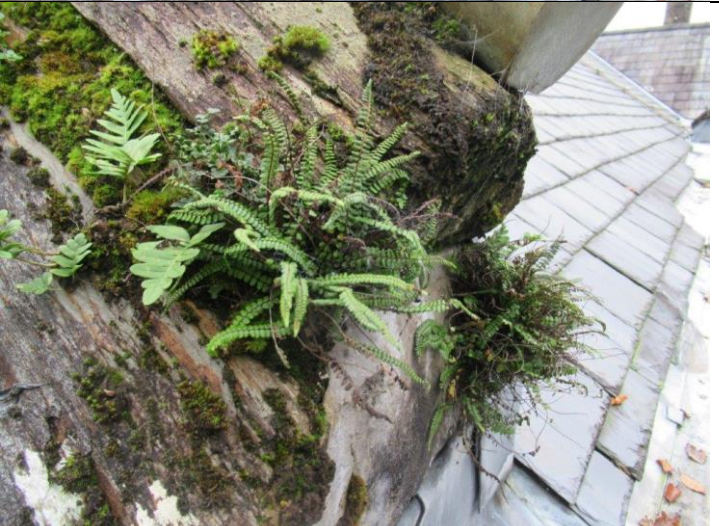
Further view related to the above at the base of the gable to coping position. Note poor condition of coping.	IMG_582 6

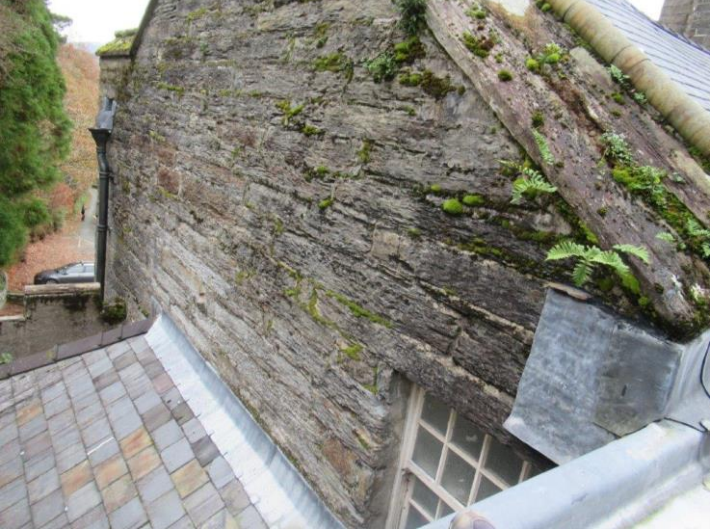
Comments	File	Photograph
Date:		
<p>Gable that extends to roof slopes R10 and R1 and view of elevation D6. Note fissures to stonework, majority pointed in sand and cement and some vegetation and moss growth to numerous locations. Remedial works will be required here as reported.</p>	<p>IMG_583 2</p>

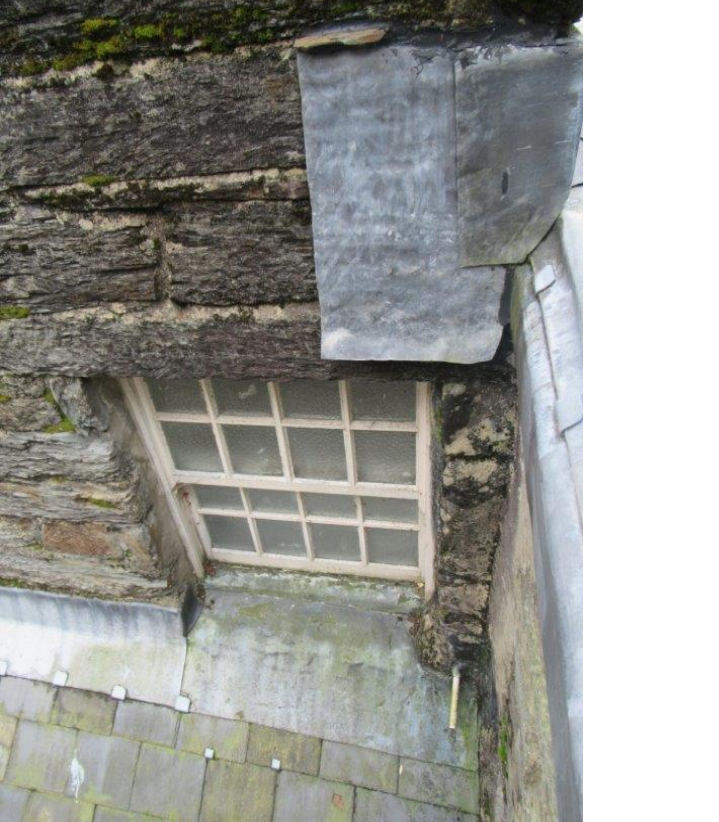
<p>Window to elevation D6 below copings that are in poor order to roof slope R10. Various signs of damp penetration to this window position internally. See report.</p>	<p>IMG_583 3</p>

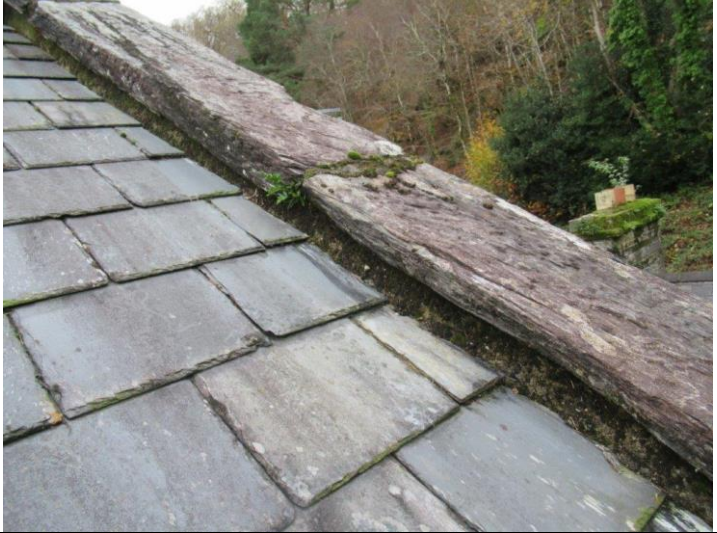
BARSCHEDULE OF PHOTOGRAPHS AND COMMENTS - Plas Tan y Blwch, Maentwrog, Blaenau Ffestiniog LL41 3YU - Snowdonia National Park Authority		
Comments	File	Photograph
Date:		
<p>Copings to roof slope R8 weathered, vegetation growth to the pointing. Any lead soakers at this position are likely to have a very minimal upstand to them an inch or so or less. There is no formal flashing detail. This detail is not ideal. See report for commentary.</p>	<p>IMG_583 6</p>

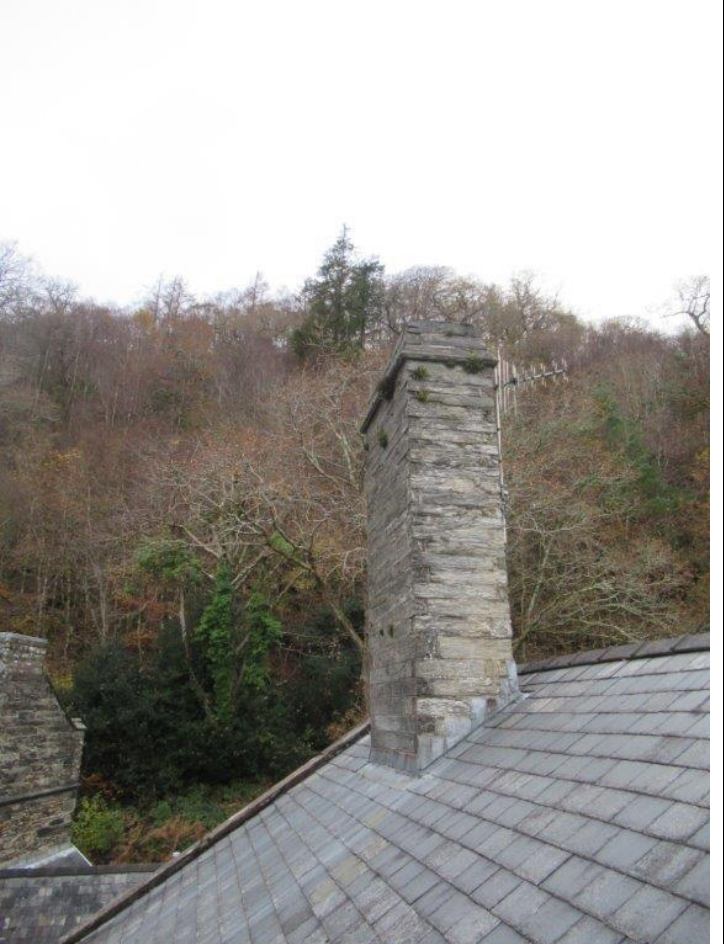
BARSCHEDULE OF PHOTOGRAPHS AND COMMENTS - Plas Tan y Blwch, Maentwrog, Blaenau Ffestiniog LL41 3YU - Snowdonia National Park Authority		
Comments	File	Photograph
Date:		
Chimney CH7  Note vegetation growth to upper quarter - see report on remedial works.	IMG_584 0

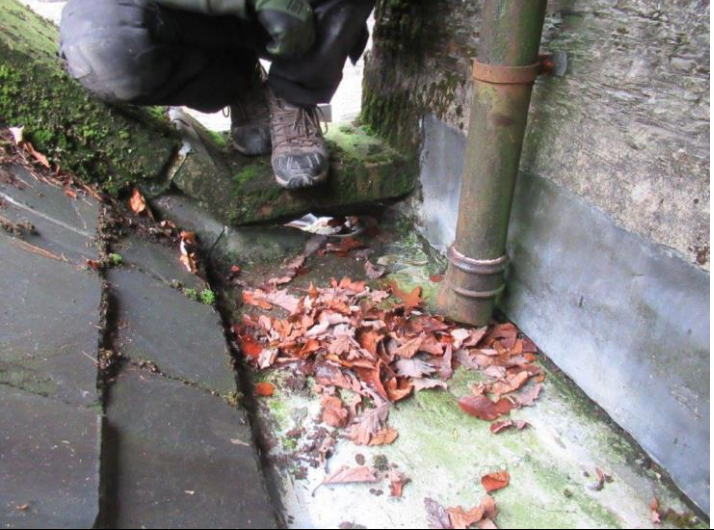
BARSCHEDULE OF PHOTOGRAPHS AND COMMENTS - Plas Tan y Blwch, Maentwrog, Blaenau Ffestiniog LL41 3YU - Snowdonia National Park Authority		
Comments	File	Photograph
Date:		
Outlet leading to hopper of roof slope R11. Very narrow and susceptible to blockage and also has water discharge from roof slope R7 leading to it.	IMG_5847

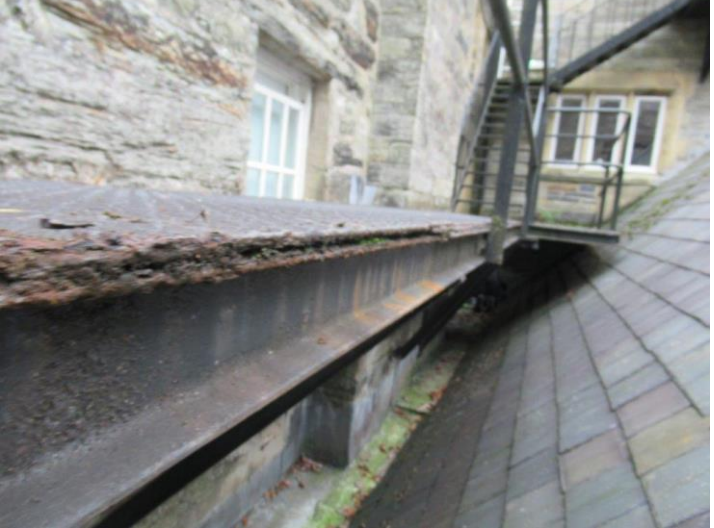
View to fire escape to rear elevation from second floor upper tower. Note rusting to edge of fire escape steel plate and also to steel beam.	IMG_5850

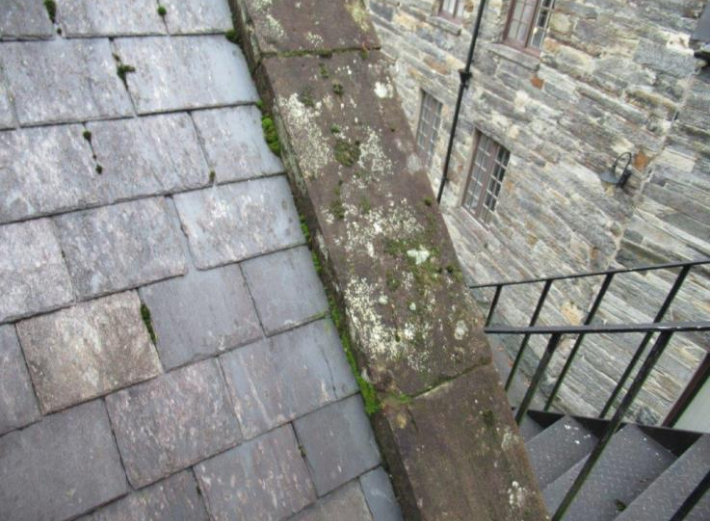
Roof slope R11 at gable position. Copings tight to the slate however, on view on image below leadwork appears to extend under the coping as a dpc and assume this continues from the soakers. All as one detail. However, without lifting the copings cannot confirm.	IMG_5855

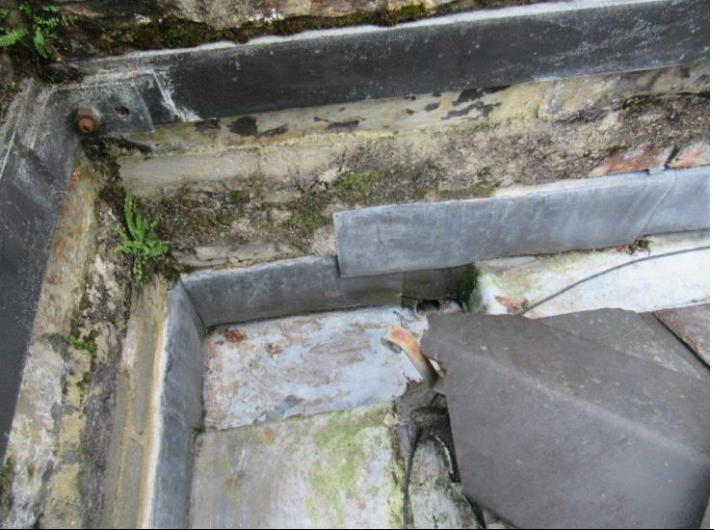
BARSCHEDULE OF PHOTOGRAPHS AND COMMENTS - Plas Tan y Blwch, Maentwrog, Blaenau Ffestiniog LL41 3YU - Snowdonia National Park Authority		
Comments	File	Photograph
Date:		
Relates to the above. Catchpit has minimal dimensions and outlet is only 50mm. Note saturation to castlment walls and vegetation growth. See report for remedial works.	IMG_586 6

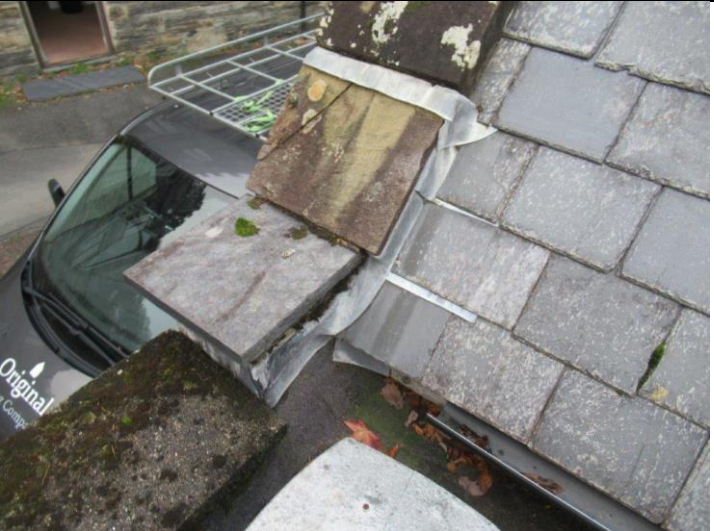
Roof slope R15 at junction with flat roof R19. Note sandstone coping is cracked and stone repair required here.	IMG_589 2

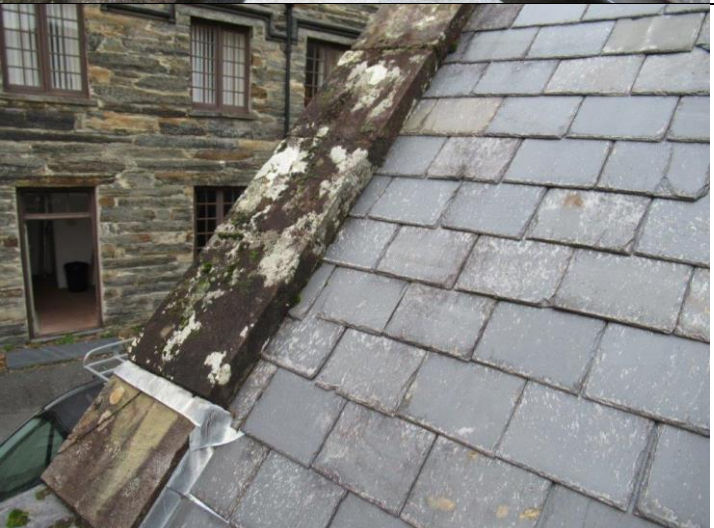
Further view of sandstone extending above the lower stone coping as noted in image above.	IMG_589 6

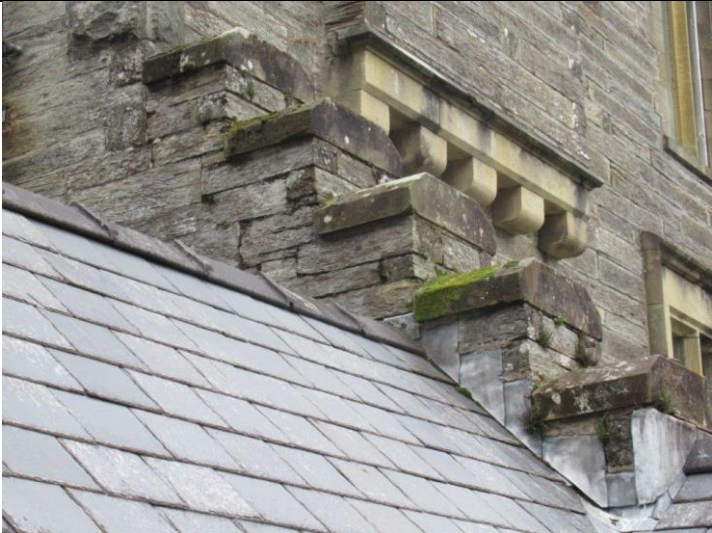
BARSCHEDULE OF PHOTOGRAPHS AND COMMENTS - Plas Tan y Blwch, Maentwrog, Blaenau Ffestiniog LL41 3YU - Snowdonia National Park Authority		
Comments	File	Photograph
Date:		
<p>Stepped copings extending from tower rear left corner above roof slope R14 and R15 and down to the ridge line of R16. Note copings generally in fair order however some cracked pointing and vegetation growth and area in need of re-pointing fully and some additional lead detailing work. See report.</p>	<p>IMG_590 4</p>

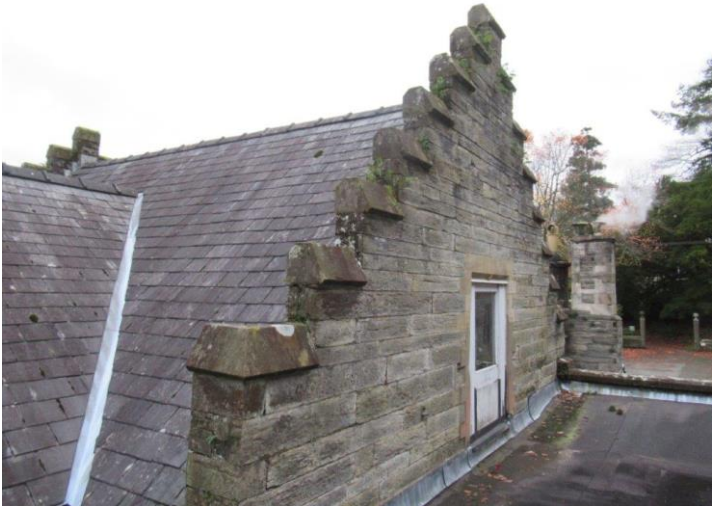
<p>Elevation D1 and stepped coping detailing to gable above roof slope R19 and relates to pitched roofs of R17 and R18. Lots of vegetation growth to the copings and saturation to the wall however the sandstone copings seem to be weathering to a fair order. The upper part of the parapet which extends above the pitched roof is narrow and circa 250-300mm in width. This area of the upper part of the gable following the pitch requires re-pointing on both sides. This is likely to lead to disturbance of the copings and some rebuilding to the</p>	<p>IMG_590 5</p>

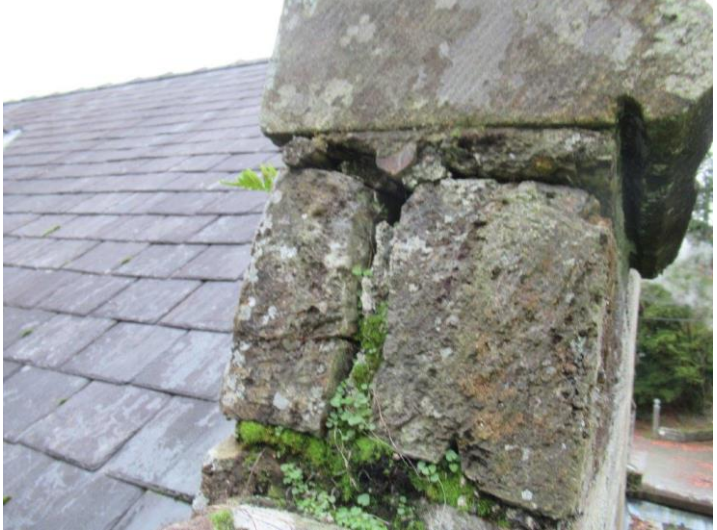
BARSCHEDULE OF PHOTOGRAPHS AND COMMENTS - Plas Tan y Blwch, Maentwrog, Blaenau Ffestiniog LL41 3YU - Snowdonia National Park Authority		
Comments	File	Photograph
Date:		
parapet and some additional lead flashing work. See report.		
Example of stepped coping arrangement related to the above image and issues requiring remedial works associated to gable to pitched roof related to R17, R18 and the parapet wall extending above this location.	IMG_590 6

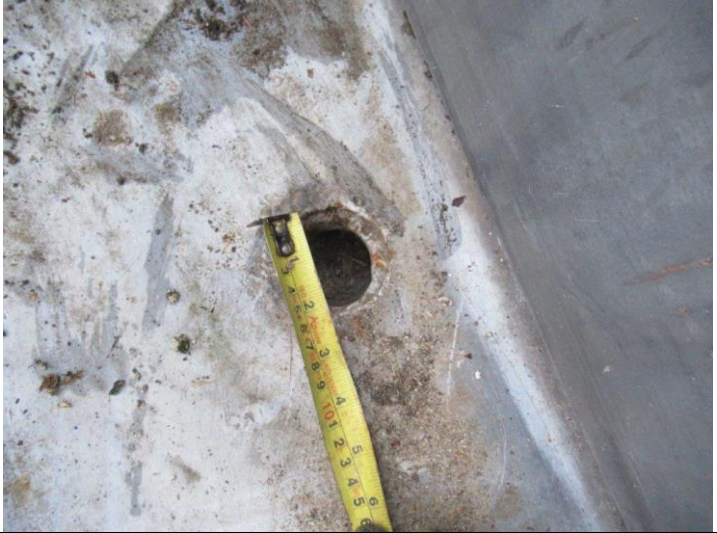
BARSCHEDULE OF PHOTOGRAPHS AND COMMENTS - Plas Tan y Blwch, Maentwrog, Blaenau Ffestiniog LL41 3YU - Snowdonia National Park Authority		
Comments	File	Photograph
Date:		
Roof slope R22. View to outlet. Note 50mm. Again no overflow at this location and susceptible to blockage and then water leading back up onto the steps and tracking into the building. Overflow detail required.	IMG_591 6

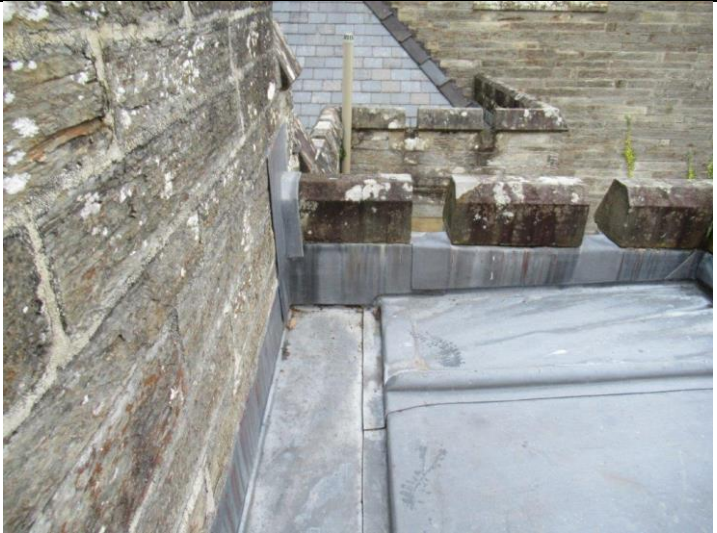
Continuation of the above.	IMG_591 7

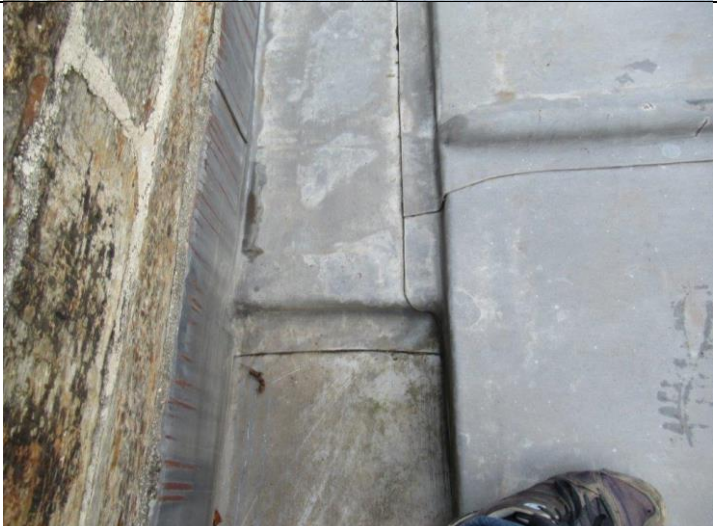
Continuation of the above. Note shallow steps.	IMG_591 8

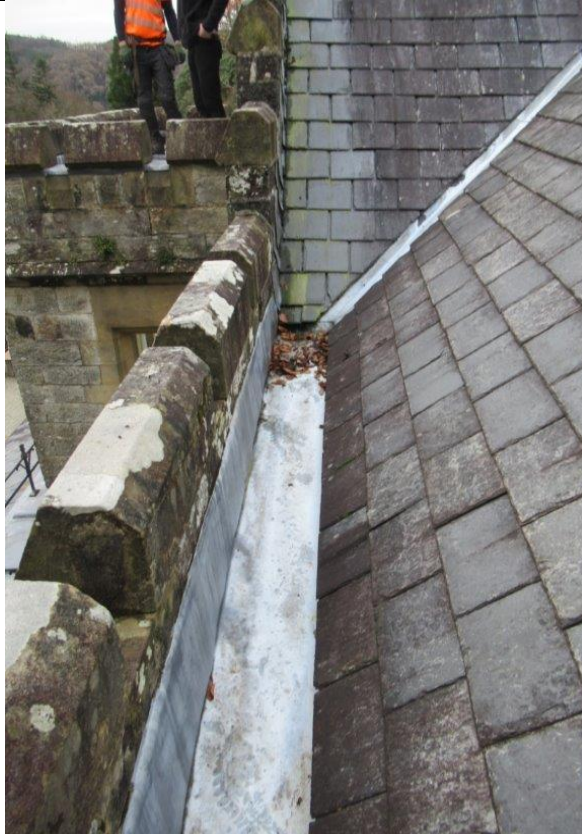
IMG\_591  
9

View of box gutter  
associated to roof  
slope R24.

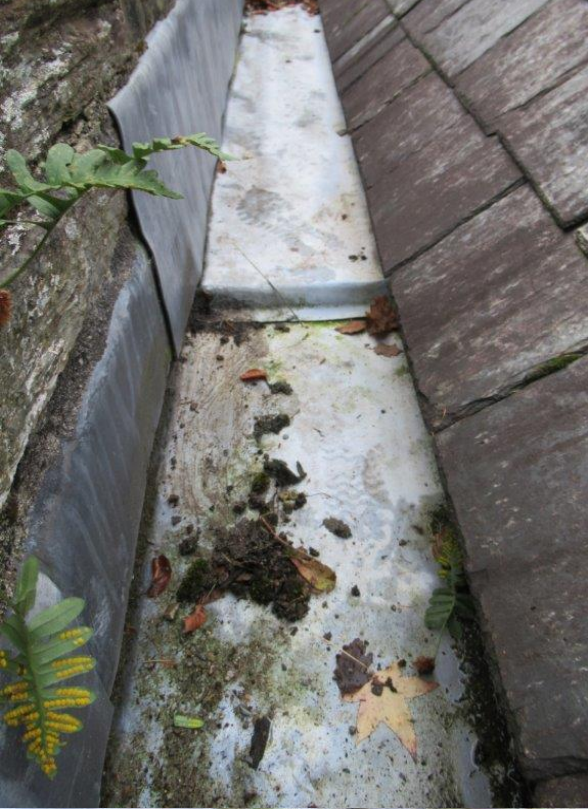
BARSCHEDULE OF PHOTOGRAPHS AND COMMENTS - Plas Tan y Blwch, Maentwrog, Blaenau Ffestiniog LL41 3YU - Snowdonia National Park Authority		
Comments	File	Photograph
Date:		
Continuation of the above. Note shallowness of steps circa 35mm or less.	IMG_592 2

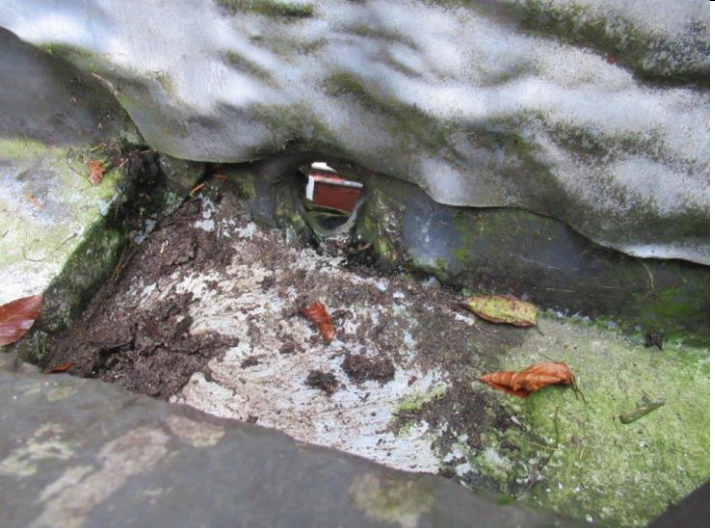
Outlet position to box gutter associated to the above less than 50mm. No overflow detail and right next to shallow step less than 30mm. This will block area of vegetation and allow build-up of water to then track back through and over the step position – redetailing required.	IMG_592 6

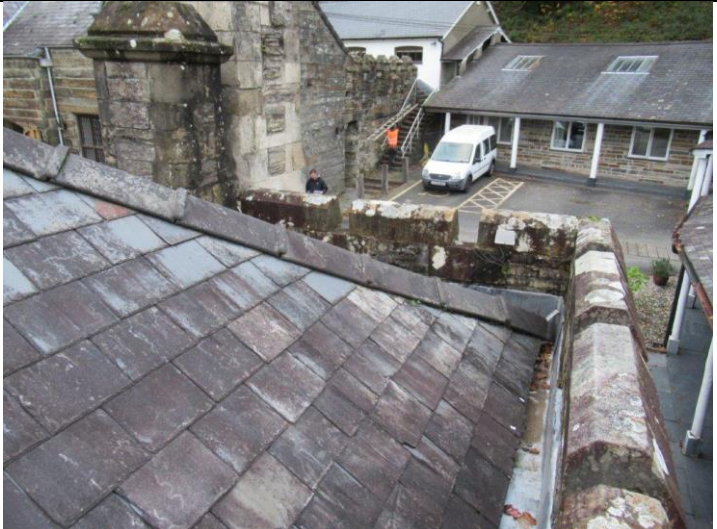
Roof slope R27 and view towards CH9 and CH10 and to the rear of the property. Note narrowness of box gutter at hip position as it extends to the corner less than 100mm. Susceptible to blockages.	IMG_593 8

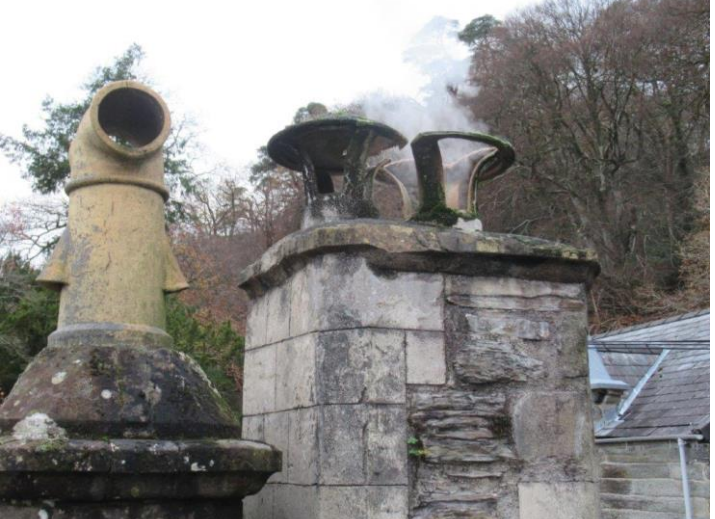
<p>Chimney CH10. Note flue is broken at top. These flues are likely to be asbestos type flues. Any repair should take this into account.</p>	IMG_594 4

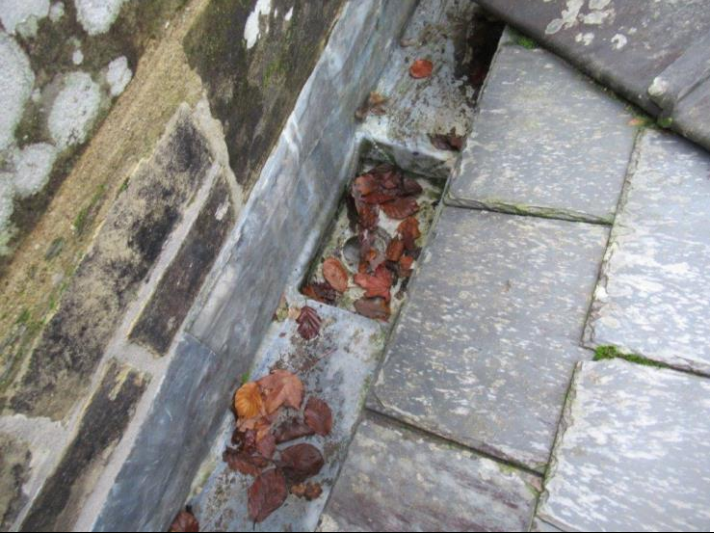
BARSCHEDULE OF PHOTOGRAPHS AND COMMENTS - Plas Tan y Blwch, Maentwrog, Blaenau Ffestiniog LL41 3YU - Snowdonia National Park Authority		
Comments	File	Photograph
Date:		
<p>Roof slope R27. Catchpit and outlet are minimal and will be susceptible to blockages and backfill and water tracking back into the structure at their laps. No overflow at this position. This will aid matters.</p>	<p>IMG_594 5</p>

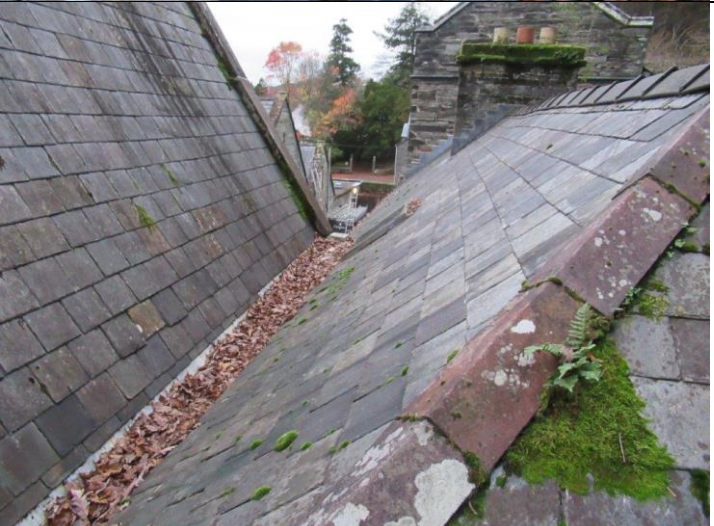
<p>Roof slope R30 and adjacent roof slope R30b. Note vegetation deposited to valley gutter. From discussion with the roofing contractor this was cleared within the last few weeks but has since refilled.</p>	<p>IMG_601 4</p>

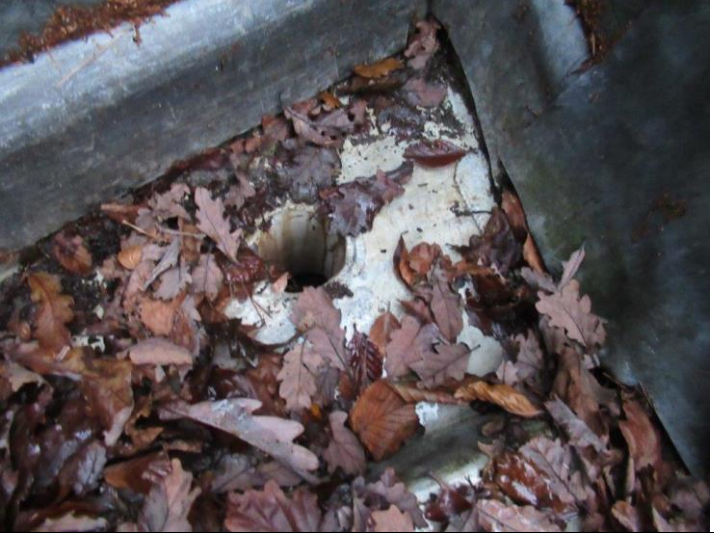
BARSCHEDULE OF PHOTOGRAPHS AND COMMENTS - Plas Tan y Blwch, Maentwrog, Blaenau Ffestiniog LL41 3YU - Snowdonia National Park Authority		
Comments	File	Photograph
Date:		
View to outlet at box gutter associated to R29. Narrow, 50mm diameter, no overflow. Susceptible to water backtracking at the minimal laps when blocked.	IMG_601 6

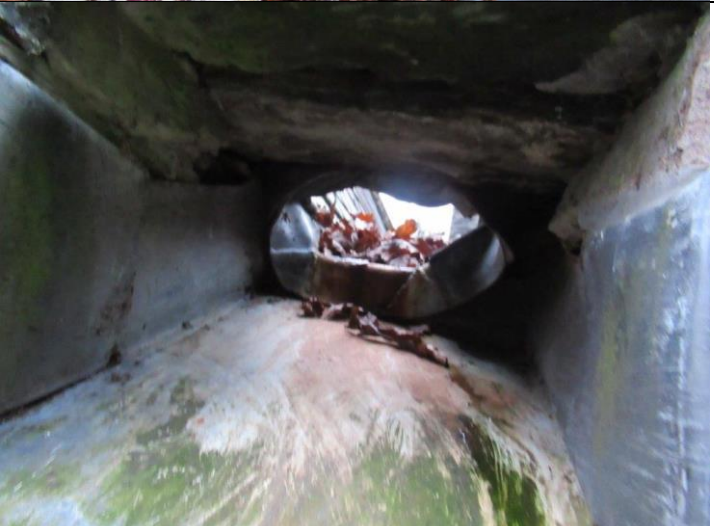
View of discharge associated to the above related to roof slope R30 and R30b adjacent. This detail is susceptible to blockage and needs to be enhanced to reduce likely hood of blockage and water penetration issues.	IMG_601 8

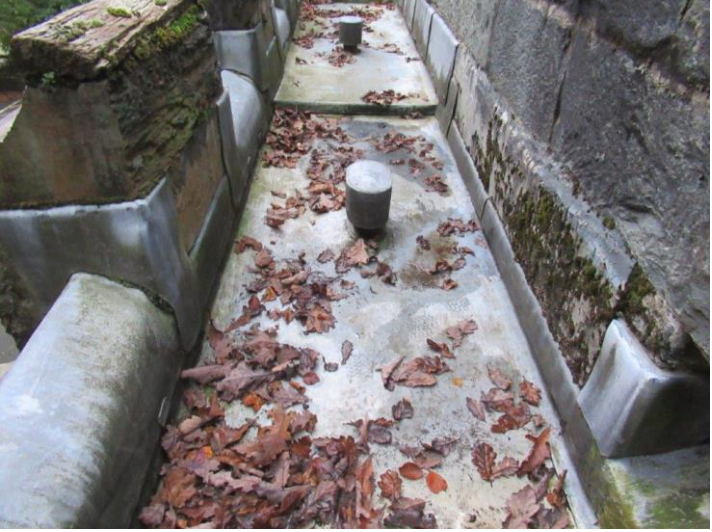
Comments	File	Photograph
Date:		
<p>Roof slope R29 box gutter. This bay is evidently having issues with decay below the leadwork as it is soft to walk on in areas and requires investigation and repair to this bay. The steps associated to the box gutter are minimal and 50mm or less. Ventilation assumed to be provided by these type of lead mushroom vents to the void below R29 in the roof space.</p>	<p>IMG_601 9</p>

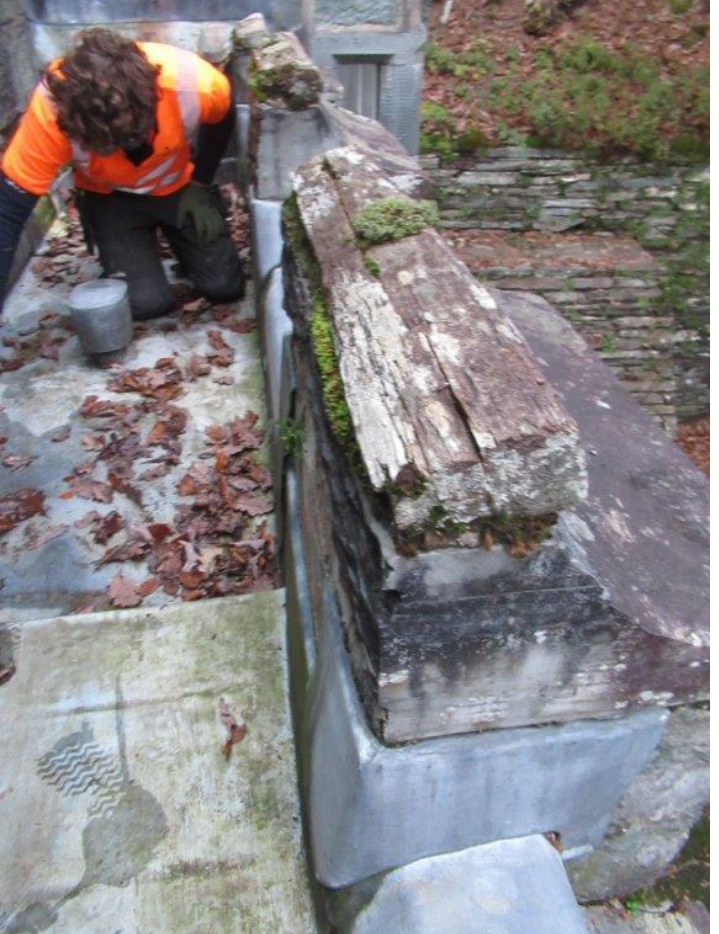
Comments	File	Photograph
Date:		
<p>View of some of the castlement detail to the parapet associated to R29 stonework in poor order. See notes in report on remedial works.</p>	<p>IMG_602 5</p>

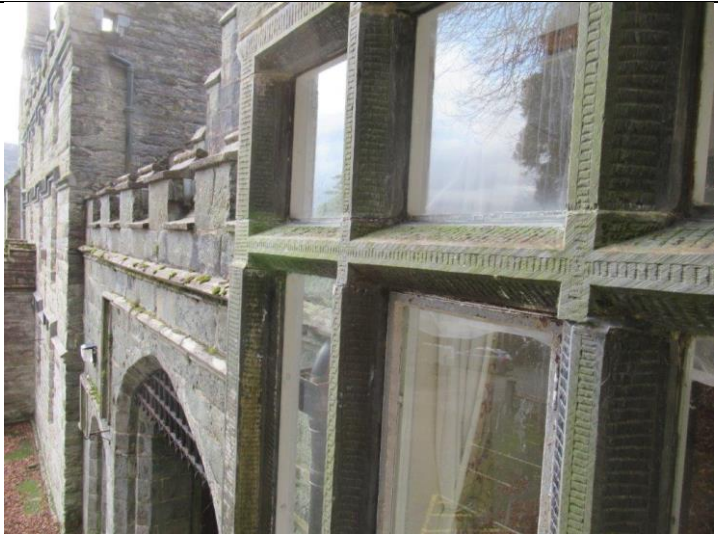
BARSCHEDULE OF PHOTOGRAPHS AND COMMENTS - Plas Tan y Blwch, Maentwrog, Blaenau Ffestiniog LL41 3YU - Snowdonia National Park Authority		
Comments	File	Photograph
Date:		
View of stone bay window detail serving room 15. Note some of the stonework mullions are out of alignment however, it appears that this has been constructed in this way originally.	IMG_606 2

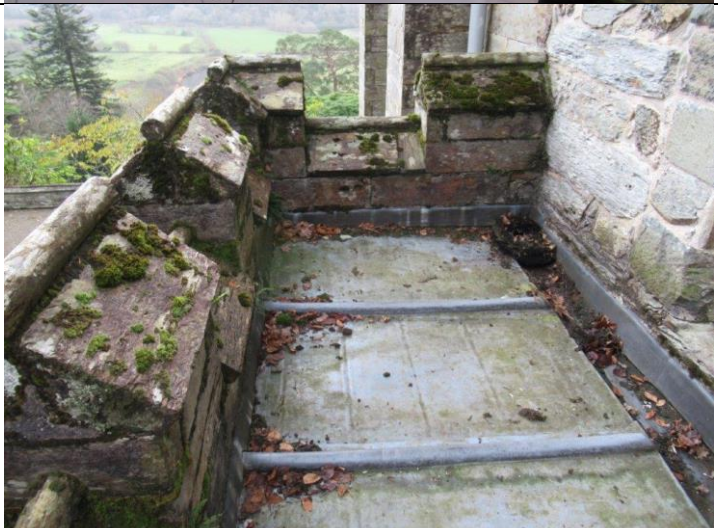
Related to the above. Note extent of vegetation build-up to box gutter and lead flat roof with roll top detailing. This will backfill and water will track back into the structure as the outlet is minimal and there is no overflow.	IMG_608 5

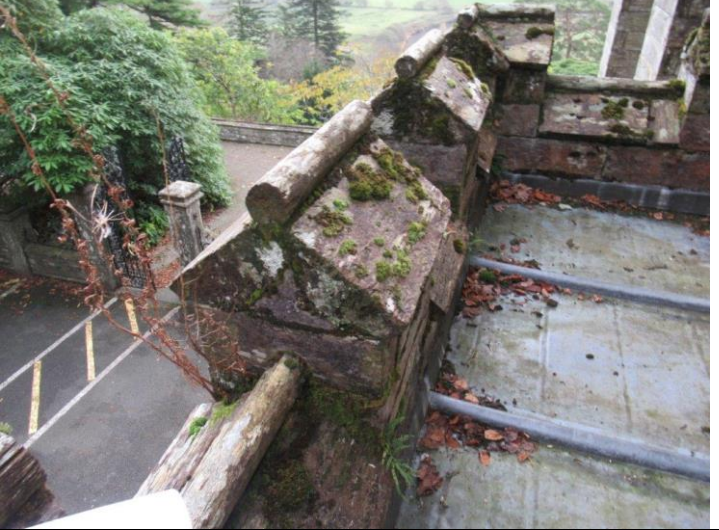
BARSCHEDULE OF PHOTOGRAPHS AND COMMENTS - Plas Tan y Blwch, Maentwrog, Blaenau Ffestiniog LL41 3YU - Snowdonia National Park Authority		
Comments	File	Photograph
Date:		
The stone copings to the castlements are in poor order. See report.	IMG_608 6

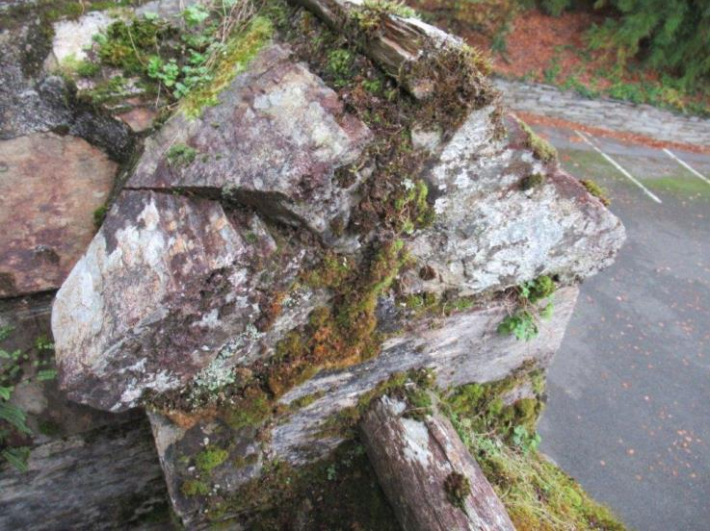
Further view related to the above and further evidence of poor order of copings. See report on remedial works.	IMG_608 7

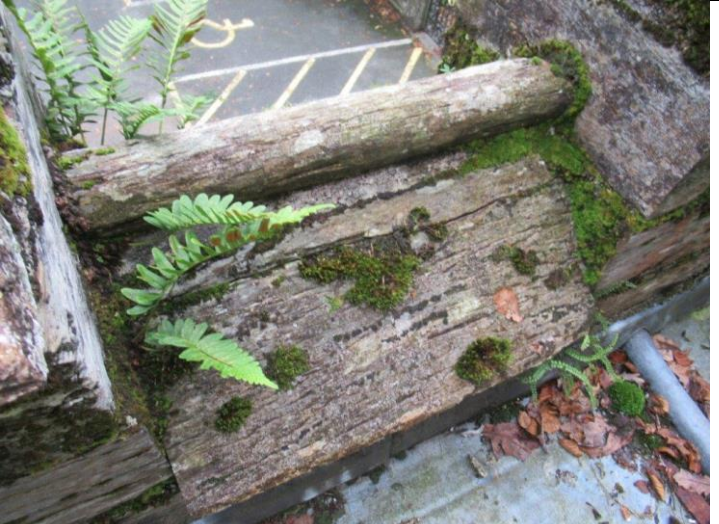
Further view related to the above. See report on remedial works. Note fissures and cracking to stone and this will be subject to delamination in coming years.	IMG_610 6

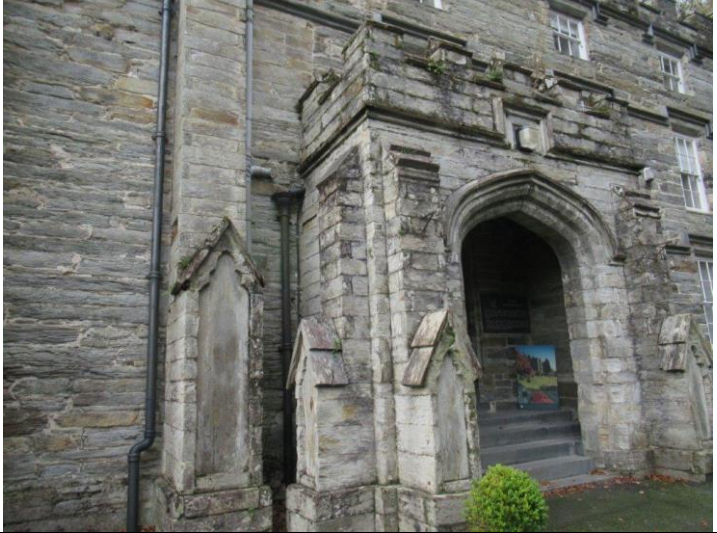
BARSCHEDULE OF PHOTOGRAPHS AND COMMENTS - Plas Tan y Blwch, Maentwrog, Blaenau Ffestiniog LL41 3YU - Snowdonia National Park Authority		
Comments	File	Photograph
Date:		
View of entrance porch to elevation B1 and stepped entrance at this location. View of saturation to upper masonry, vegetation and moss growth to pointing etc.	IMG_614 8

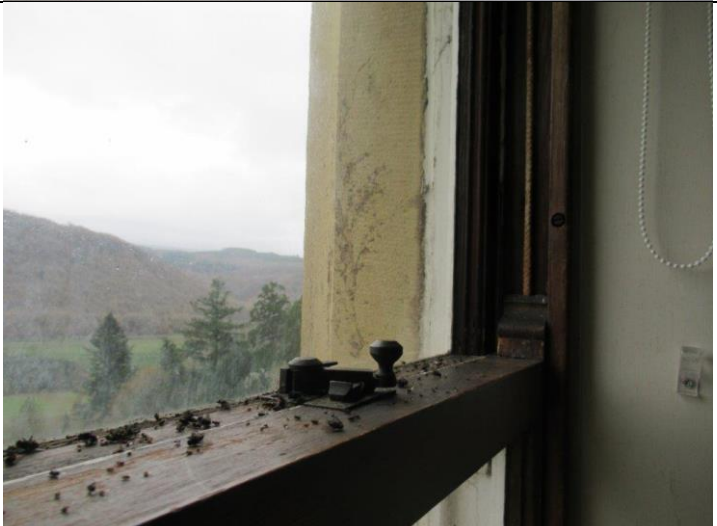
View within room. Issue with fly infestation. This requires to be addressed and resolved by specialists'	IMG_616 4

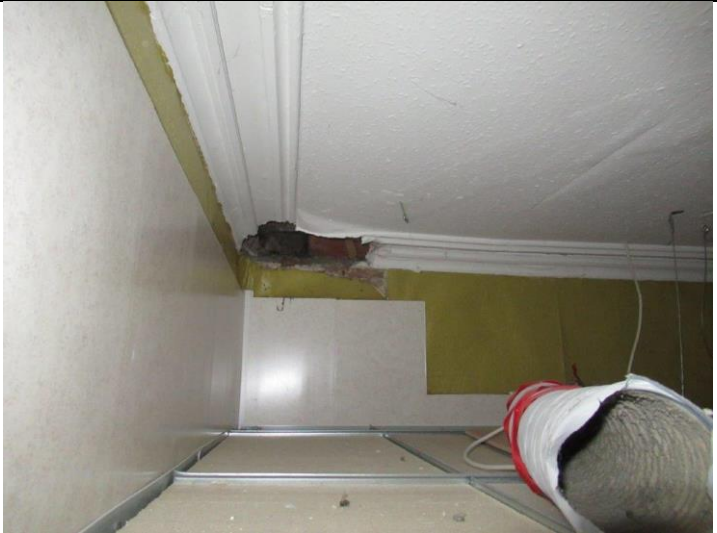
Note above suspended ceiling line to ensuite to this room (Room 3) penetration into void above firebreak disturbed associated to the lath and plaster ceiling. This needs to be made good. Also note extraction just discharges above the suspended ceiling and does not expel externally or connect to slate vent or any other detail.	IMG_617 9

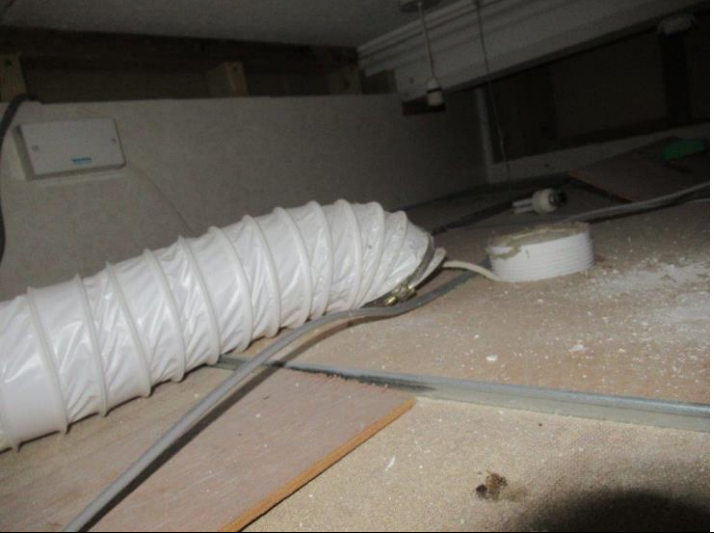
BARSCHEDULE OF PHOTOGRAPHS AND COMMENTS - Plas Tan y Blwch, Maentwrog, Blaenau Ffestiniog LL41 3YU - Snowdonia National Park Authority		
Comments	File	Photograph
Date:		
Note flexible pipework from extractor simply resting on suspended ceiling. Not connected.	IMG_618 1

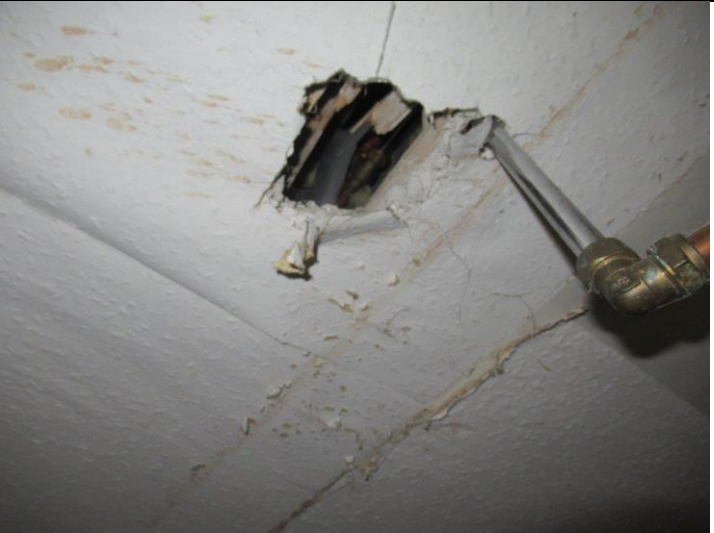
Further view of damage to lath and plaster ceiling as firebreak point. No firestopping.	IMG_618 2

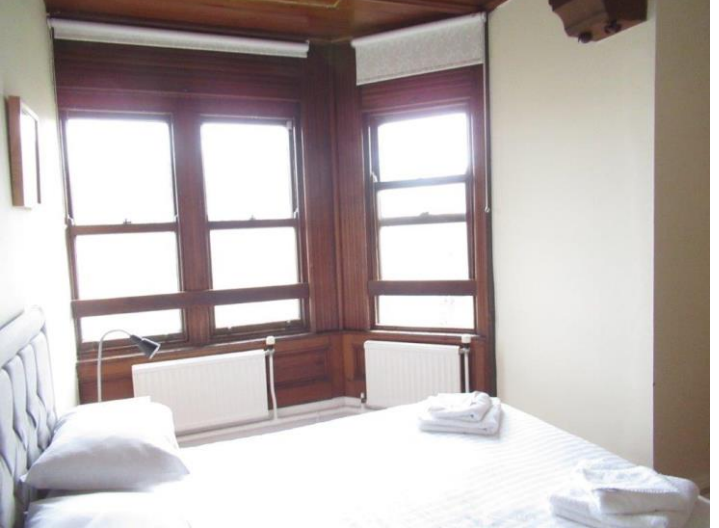
Comments	File	Photograph
Date:		
<p>Bedroom 2 bay window. Note timber section provided at lower end of window as guard due to window extending below 800mm in level and not considered to be safety glazing at this position. See report.</p>	<p>IMG_618 9</p>

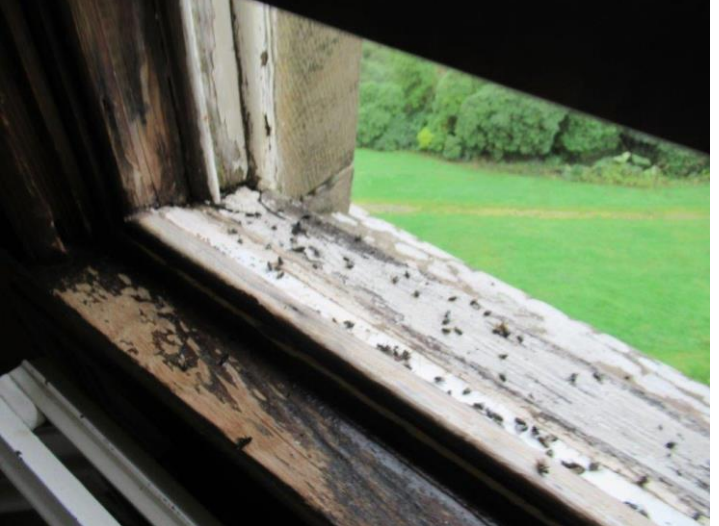
<p>Bedroom 2  Note fly infestation issue here, also to be addressed by specialist.</p>	<p>IMG_619 2</p>

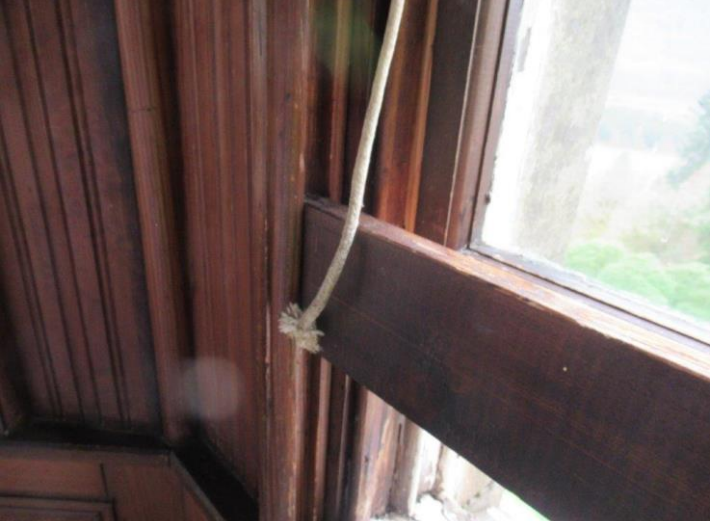
<p>Note cord associated to sash window has snapped and require repair.</p>	<p>IMG_619 6</p>

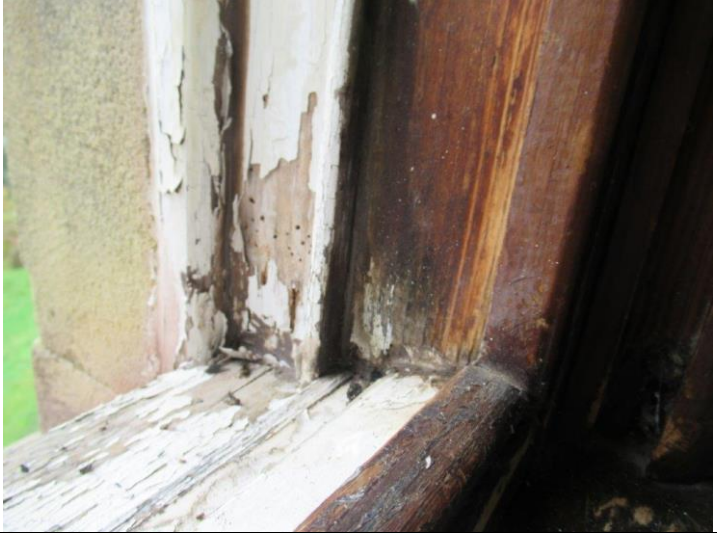
BARSCHEDULE OF PHOTOGRAPHS AND COMMENTS - Plas Tan y Blwch, Maentwrog, Blaenau Ffestiniog LL41 3YU - Snowdonia National Park Authority		
Comments	File	Photograph
Date:		
Note some sign of woodworm potentially to window frame and some decay at this position and lack of decoration. This requires resolving related to bedroom 2.	IMG_619 7

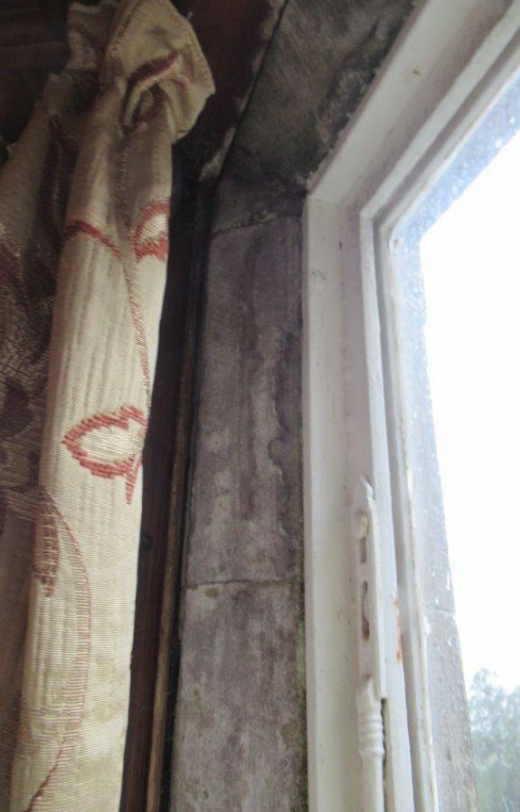
BARSCHEDULE OF PHOTOGRAPHS AND COMMENTS - Plas Tan y Blwch, Maentwrog, Blaenau Ffestiniog LL41 3YU - Snowdonia National Park Authority		
Comments	File	Photograph
Date:		
Bedroom 1 stone jambs associated to metal window single glazed cold bridging as to be expected.	IMG_622 5

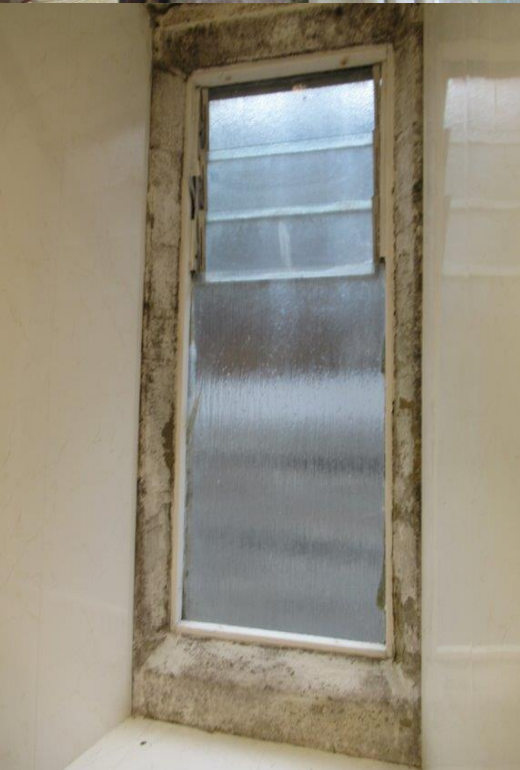
Window associated to ensuite. Note condensation issues to the stone jambs, cills and lintels as to be expected.	IMG_623 4

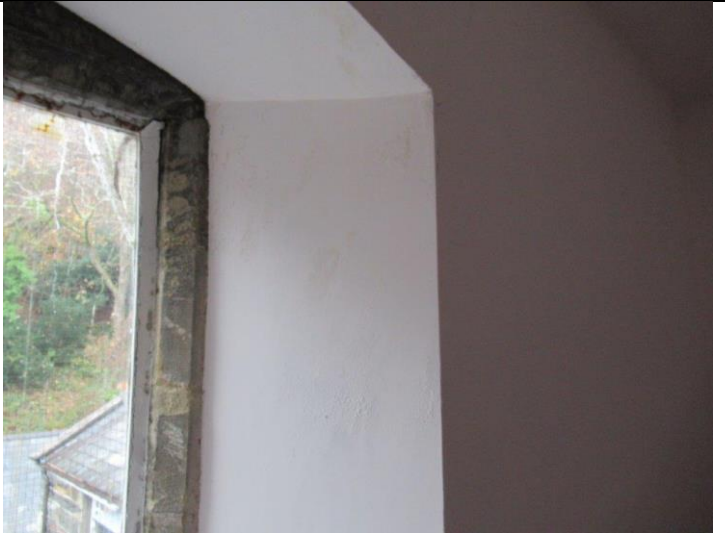
Related to the above. Damp penetration at head of window at jamb and opening head.	IMG_625 6

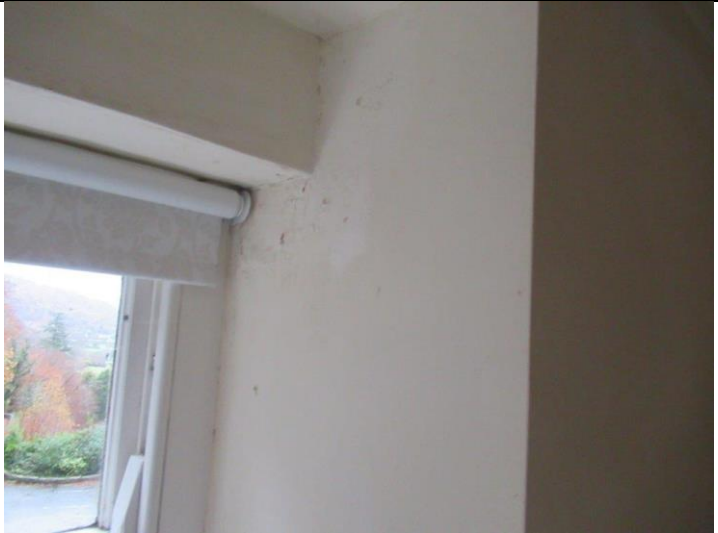
Note section of ply has been put underneath window position. There are also some signs of damp penetration to this window junction even though the wall is drylined and also some signs of damp to the sash window.	IMG_631 6

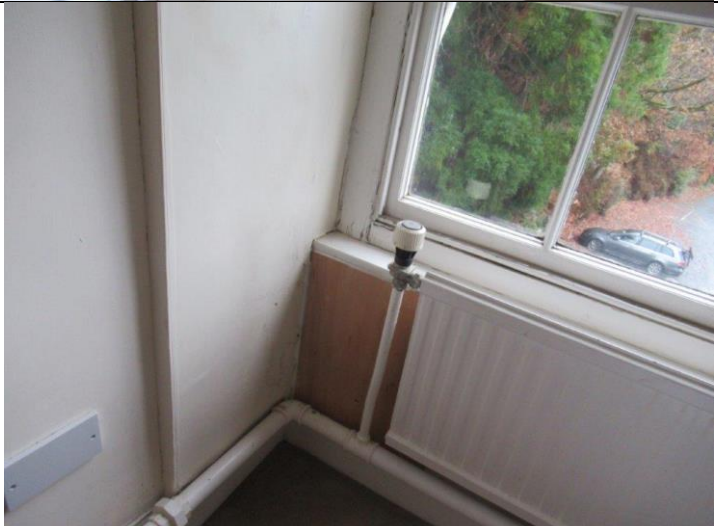
BARSCHEDULE OF PHOTOGRAPHS AND COMMENTS - Plas Tan y Blwch, Maentwrog, Blaenau Ffestiniog LL41 3YU - Snowdonia National Park Authority		
Comments	File	Photograph
Date:		
Note of dampness to window position and previous patch painting in this location to help conceal.	IMG_631 7

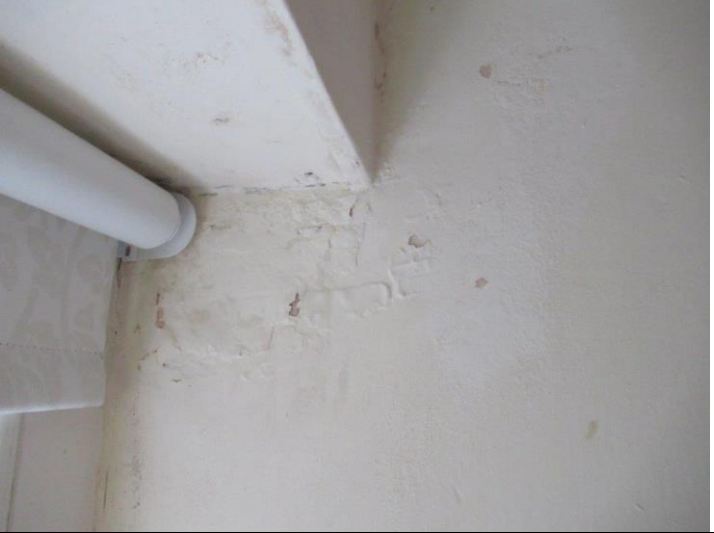
View to other side of window opening and at window head. Dampness again evident.	IMG_631 8

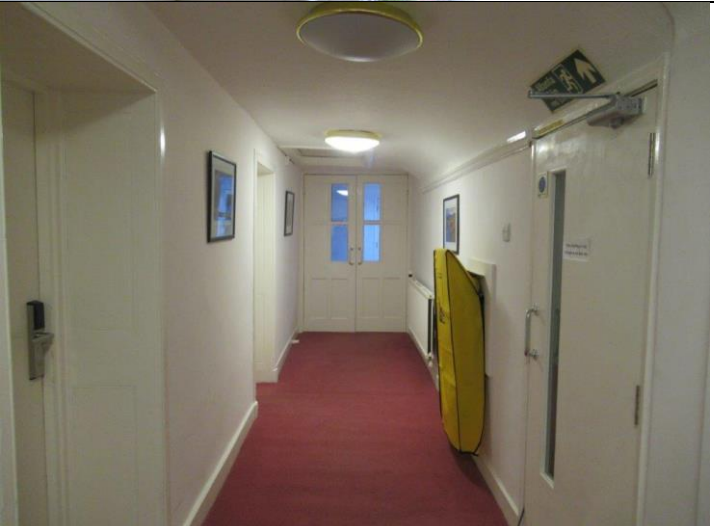
BARSCHEDULE OF PHOTOGRAPHS AND COMMENTS - Plas Tan y Blwch, Maentwrog, Blaenau Ffestiniog LL41 3YU - Snowdonia National Park Authority		
Comments	File	Photograph
Date:		
Corridor  Note loft access position? Fire resistance.	IMG_632 5
