**BUILDING SURVEY  
PLAS TAN Y BWLCH  
MAENTWROG  
BLAENAU FFESTINIOG  
LL41 3YU**

**Our Ref: LST/SM/212167**

**Date: November 2021**

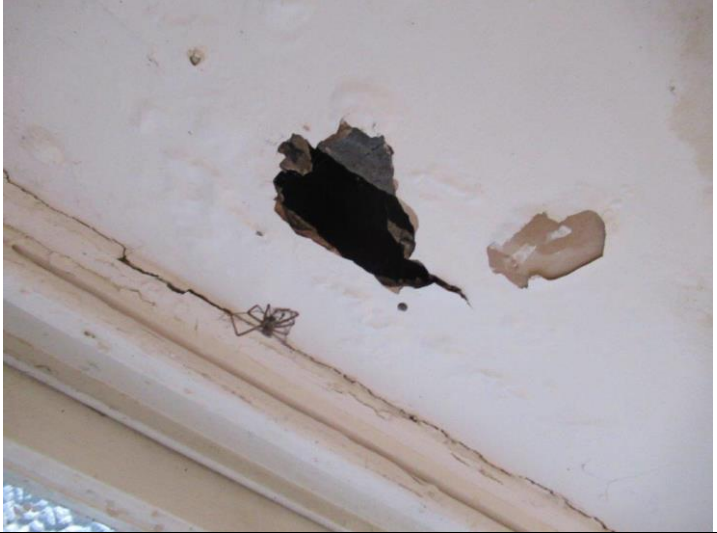
Corridor window at this level related to elevation D6. Note this has been previously lime plastered to the reveals but dampness continues at the head and some deterioration is occurring in this location.	IMG_632 7

Further view related to the above.	IMG_6329

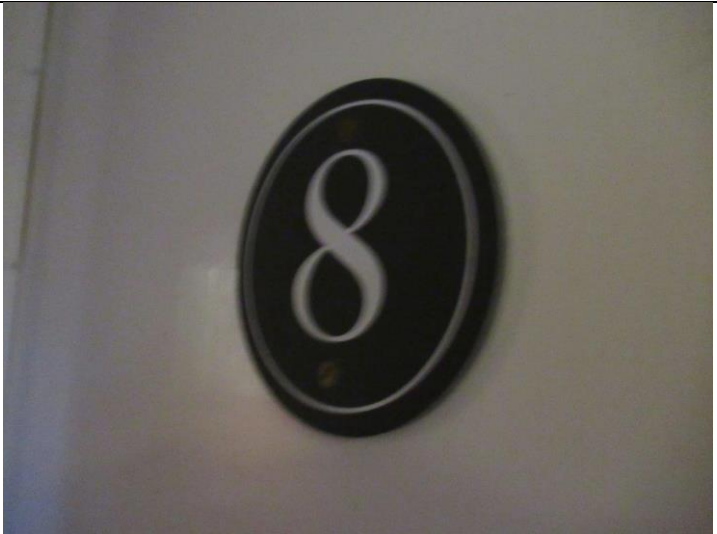
Room 8 door lock altered. Gap associated to door lock not filled or packed with intumescent packer to retain fire integrity. This requires resolving.	IMG_636 9

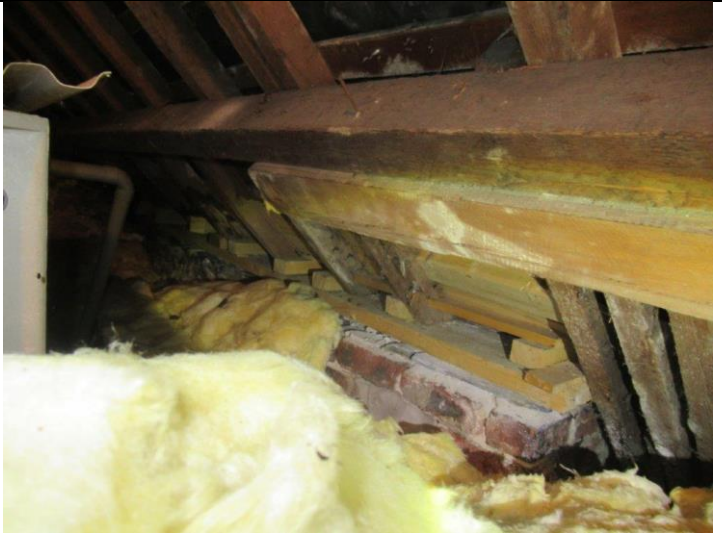
Room 10 and valley gutter position in roof void above. No obvious signs of water penetration here however, issues are occurring and require investigation at high level, as reported.	IMG_639 7

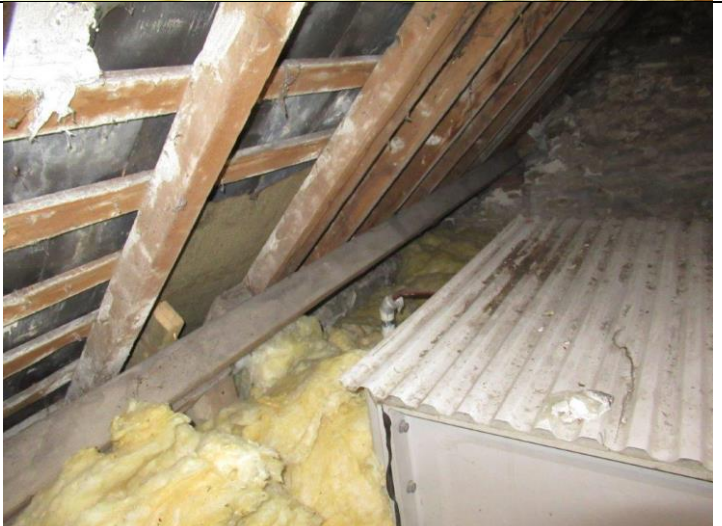
Further view related to the above.	IMG_640 0

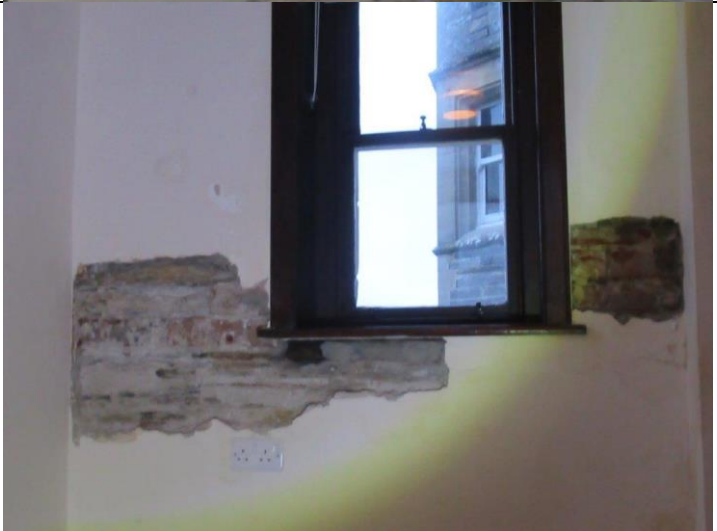
Dampness to external wall in room 10.	IMG_640 4

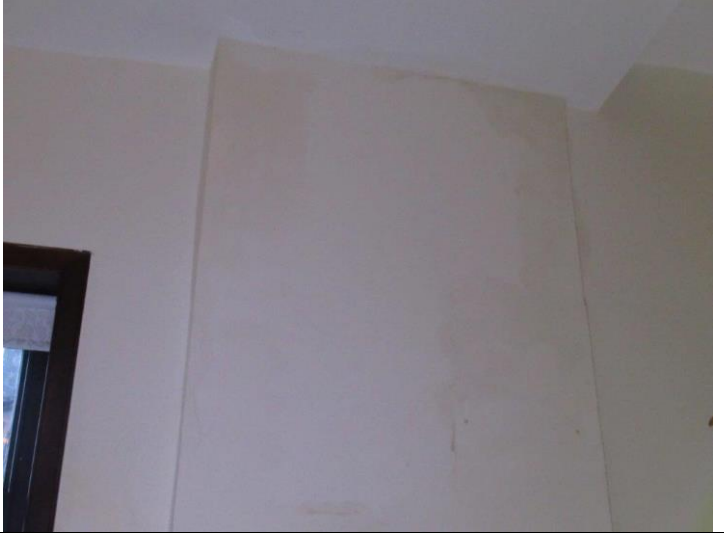
BARSCHEDULE OF PHOTOGRAPHS AND COMMENTS - Plas Tan y Blwch, Maentwrog, Blaenau Ffestiniog LL41 3YU - Snowdonia National Park Authority		
Comments	File	Photograph
Date:		
Dampness to chimney breast in room 10.	IMG_640 5

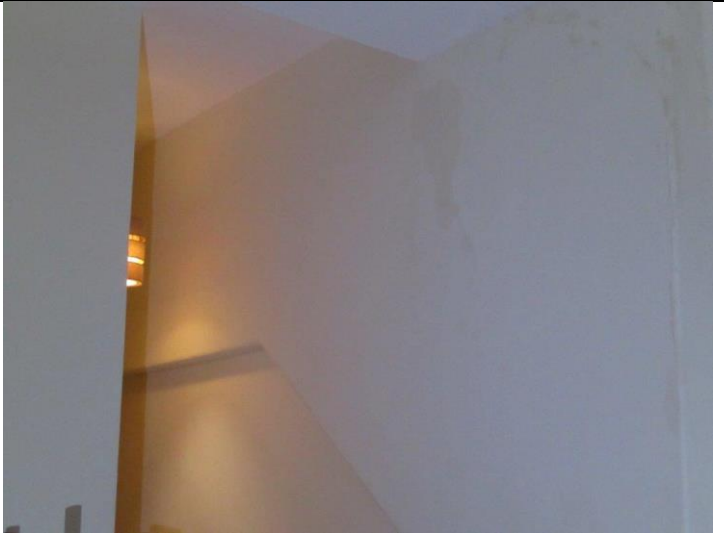
Room 10 dampness to external wall at ceiling level	IMG_640 8

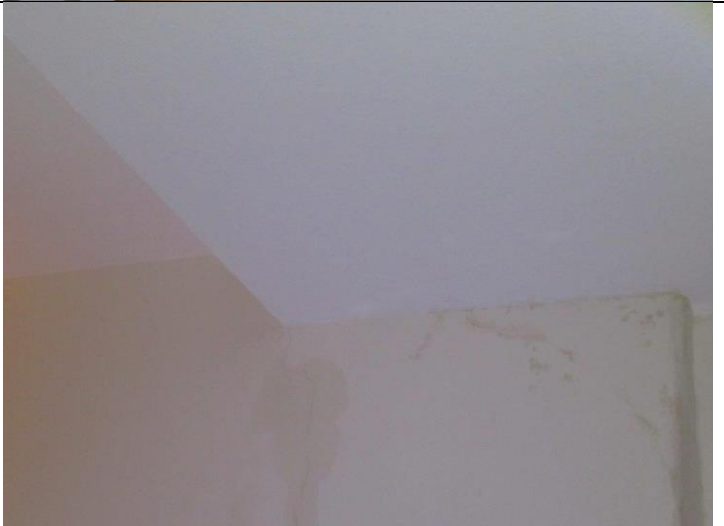
Further view of the above	IMG_640 9

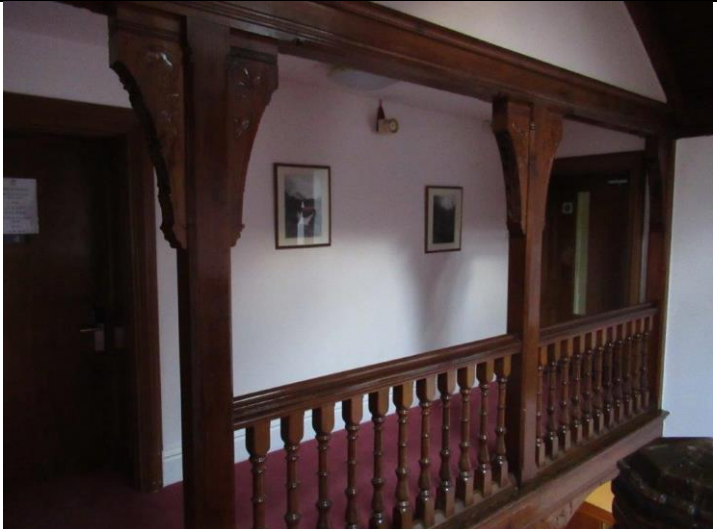
Balustrading typical to main timber stairs as architectural feature to the property is as reported an issue in regard to its guarding height – see report.	IMG_644 0

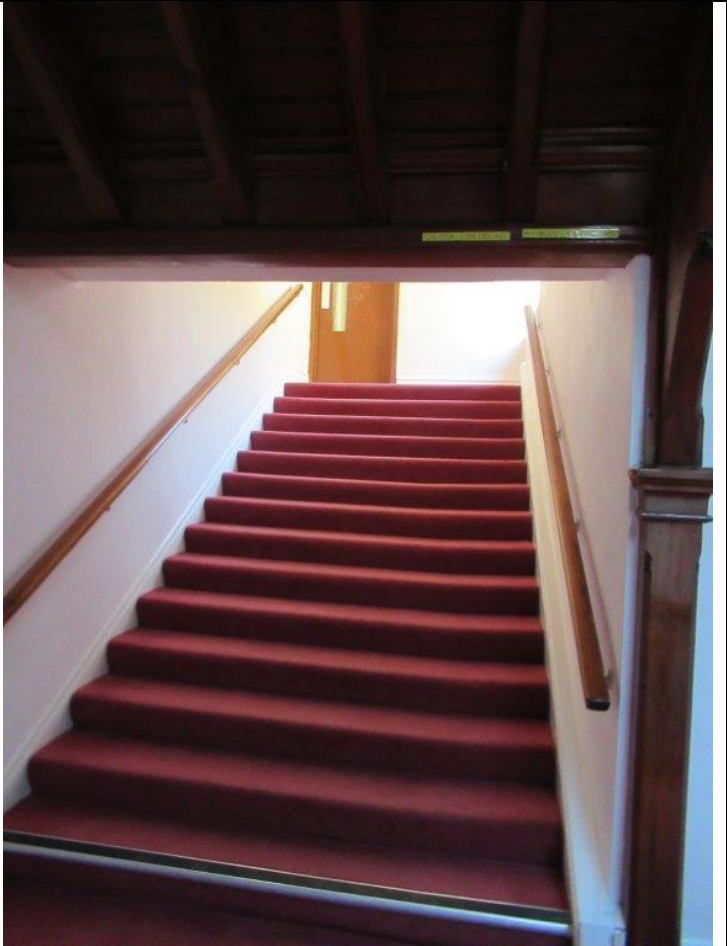
BARSCHEDULE OF PHOTOGRAPHS AND COMMENTS - Plas Tan y Blwch, Maentwrog, Blaenau Ffestiniog LL41 3YU - Snowdonia National Park Authority		
Comments	File	Photograph
Date:		
Note stairs at second floor position do not have any nosing detailing as do any of the stairwells to the main stairs. Nosing detail required for fire egress and DDA / EA purposes.	IMG_644 1

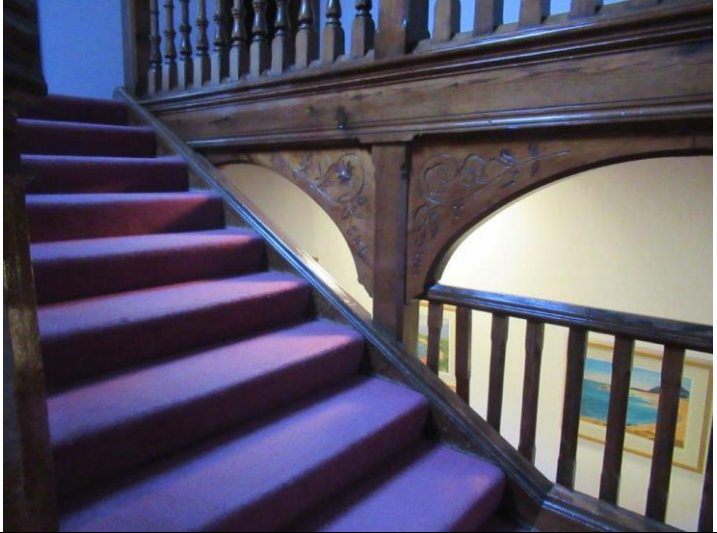
BARSCHEDULE OF PHOTOGRAPHS AND COMMENTS - Plas Tan y Blwch, Maentwrog, Blaenau Ffestiniog LL41 3YU - Snowdonia National Park Authority		
Comments	File	Photograph
Date:		
Large gaps to stairwell to be addressed for health & safety purposes.	IMG_645 3

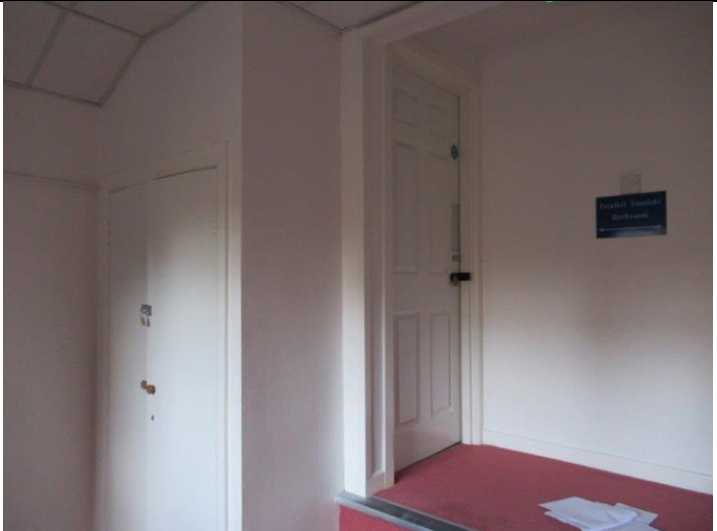
<p>Note corridor store doors not rated as fire doors.</p>	<p>IMG_646 6</p>

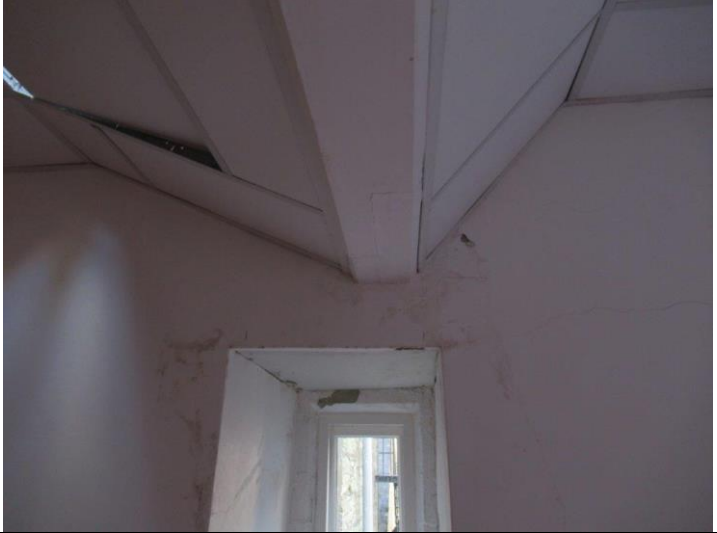
Comments	File	Photograph
Date:		
Related to the above.	IMG_646 8	 
View of first floor corridor back to room 14.	IMG_646 9	 
Corridor window below roof slope R32 and R31 valley gutter water penetration issues at the head due to the lack of adequate detailing as commented on in the report. This needs to be addressed.	IMG_647 6

BARSCHEDULE OF PHOTOGRAPHS AND COMMENTS - Plas Tan y Blwch, Maentwrog, Blaenau Ffestiniog LL41 3YU - Snowdonia National Park Authority		
Comments	File	Photograph
Date:		
Further view related to the above	IMG_6478

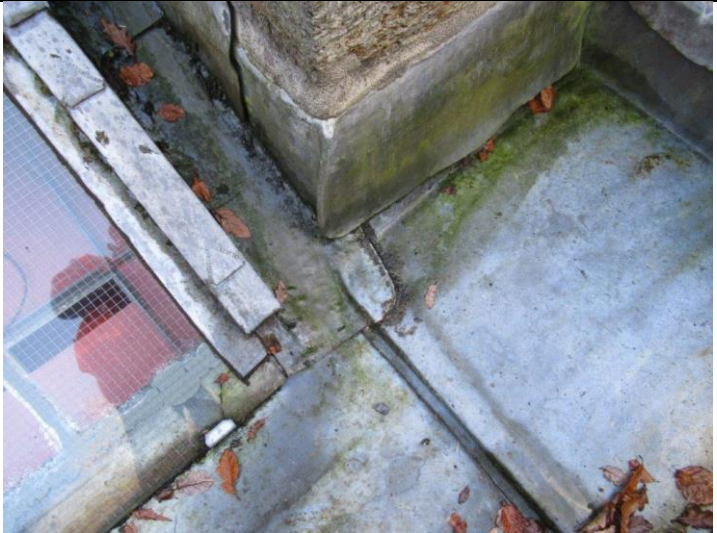
View of valley gutter tray head associated to roof slope R32 and R31 and the intricacies of the detailing here which are not working. Also note the narrowness of the step is below 20mm at this position to the valley gutter.	IMG_6480

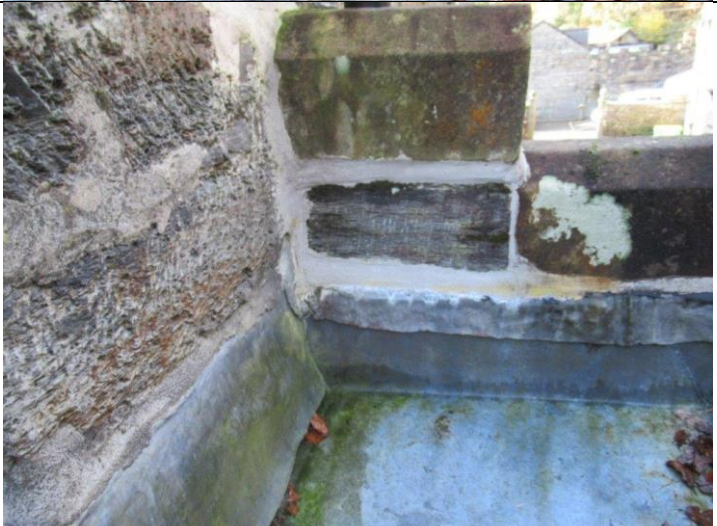
Flashing at this location.	IMG_6482

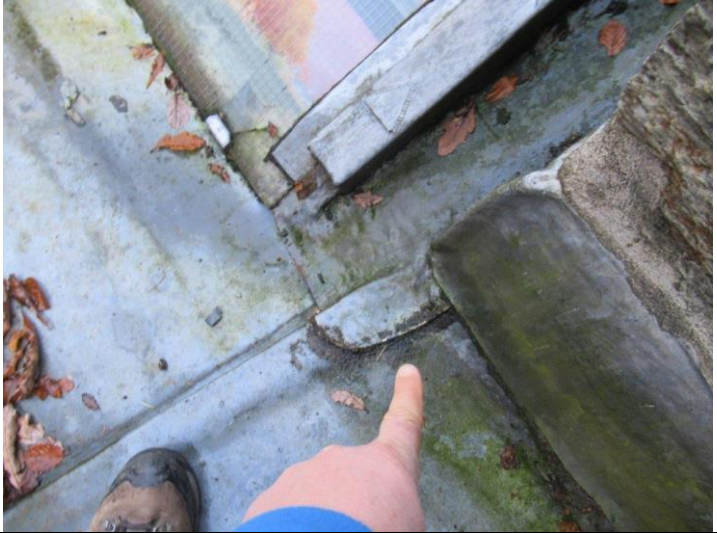
BARSCHEDULE OF PHOTOGRAPHS AND COMMENTS - Plas Tan y Blwch, Maentwrog, Blaenau Ffestiniog LL41 3YU - Snowdonia National Park Authority		
Comments	File	Photograph
Date:		
Possible entry point for water to travel under the lead at this position. This lead detail should extend under the step and step over. This requires stripping back and investigation at this position to resolve the lead detailing issue.	IMG_648 4

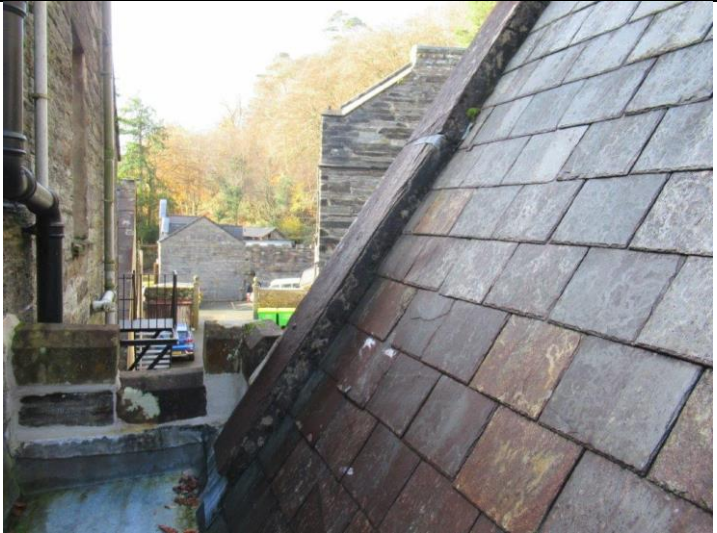
Roof slope R31 and view to copings which have been flush pointed to their sides? Soakers? Flashing detail at this position.	IMG_648 9

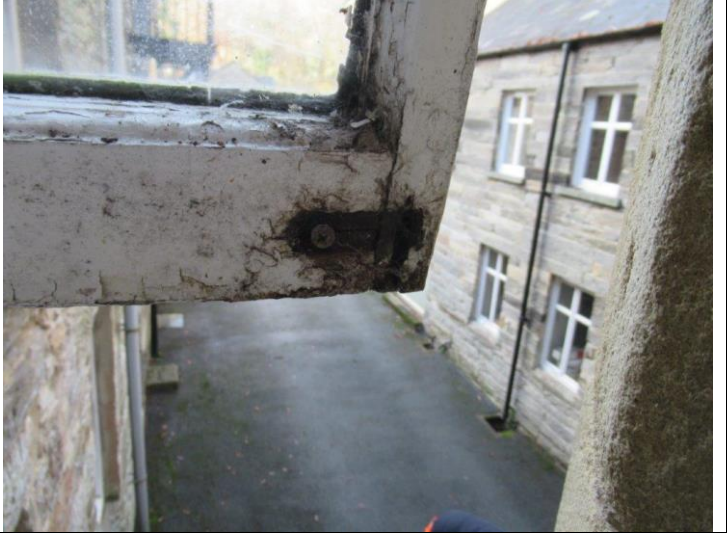
BARSCHEDULE OF PHOTOGRAPHS AND COMMENTS - Plas Tan y Blwch, Maentwrog, Blaenau Ffestiniog LL41 3YU - Snowdonia National Park Authority		
Comments	File	Photograph
Date:		
View of poor condition to window below roof slopes R32, and R31 where water penetration is occurring at the head of the valley gutter. It is likely that the casement window will require replacement.	IMG_6508

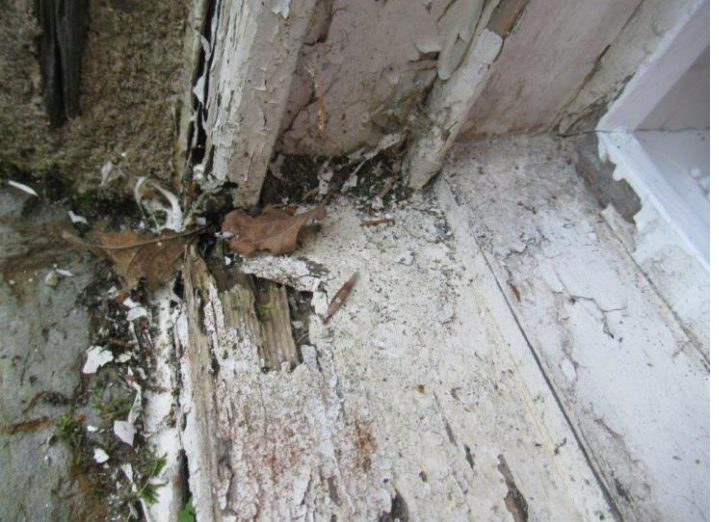
<p>Ensuite window to Blue Room. Note deterioration to the sash requires new cill and splicing in and repairs to sash frame and jambs.</p>	<p>IMG_658 9</p>

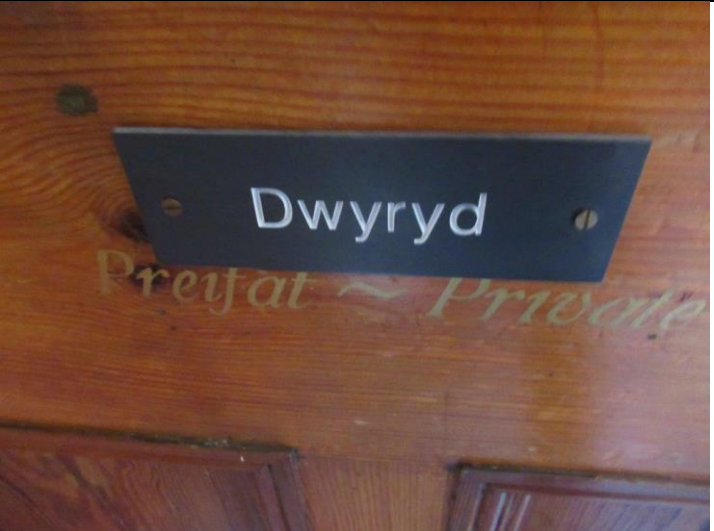
BARSCHEDULE OF PHOTOGRAPHS AND COMMENTS - Plas Tan y Bwlch, Maentwrog, Blaenau Ffestiniog LL41 3YU - Snowdonia National Park Authority		
Comments	File	Photograph
Date:		
Note deterioration and point of water penetration.	IMG_659 0	 
Dwryrd Room	IMG_659 1

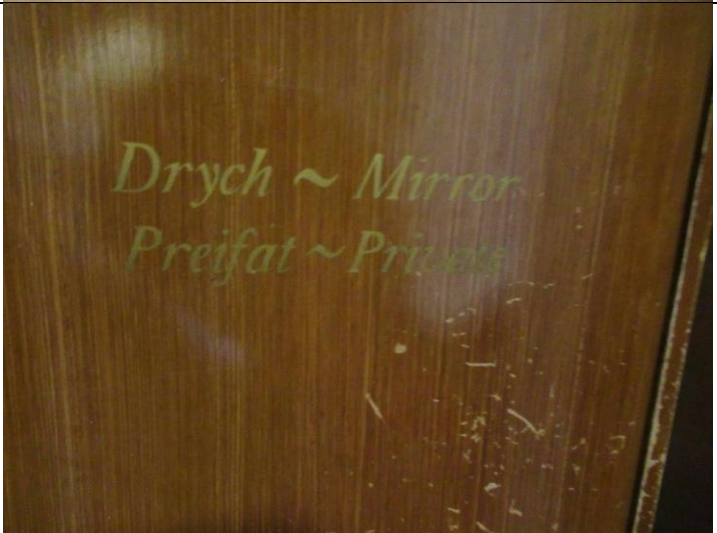
BARSCHEDULE OF PHOTOGRAPHS AND COMMENTS - Plas Tan y Blwch, Maentwrog, Blaenau Ffestiniog LL41 3YU - Snowdonia National Park Authority		
Comments	File	Photograph
Date:		
Mirror? Safety rated? Confirm, if not replace.	IMG_663 8	 
Broken pane of glass to sash window in Mirror Room. This requires repair.	IMG_664 8

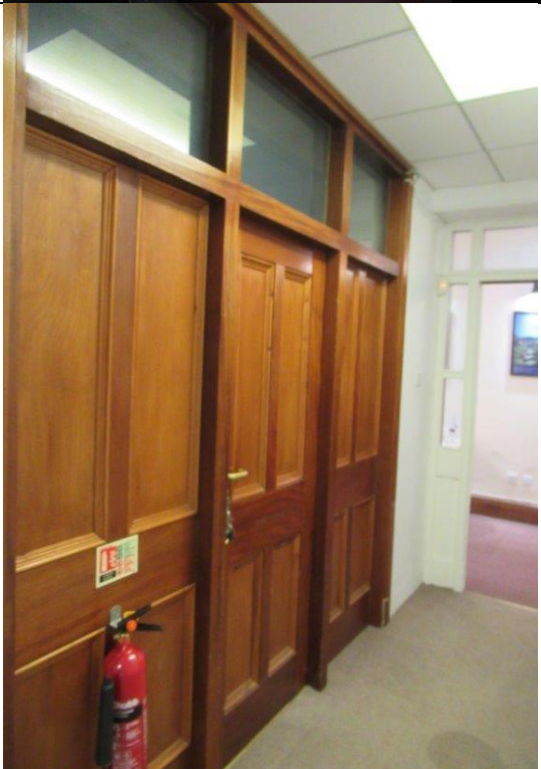
Corridor and timber detailing associated to IT Office / Store Area. Integrity of fire doors? Confirm sufficient rated allow for enhancement with Envirograph to achieve and glazing sufficiently rated.	IMG_675 0

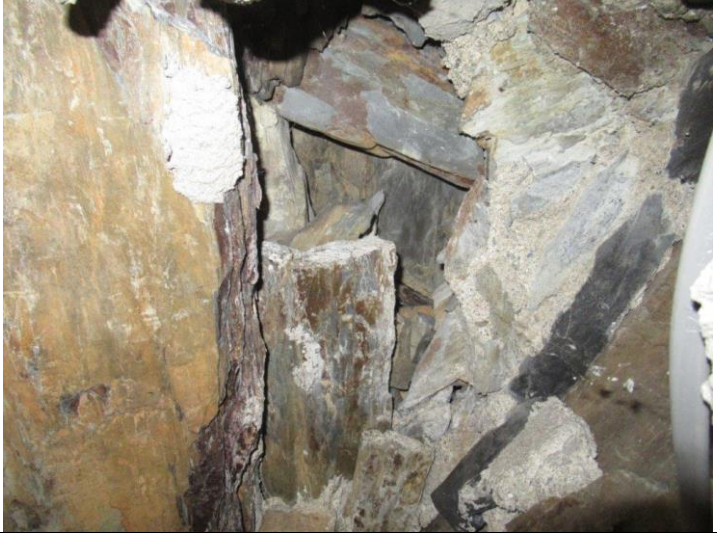
BARSCHEDULE OF PHOTOGRAPHS AND COMMENTS - Plas Tan y Blwch, Maentwrog, Blaenau Ffestiniog LL41 3YU - Snowdonia National Park Authority		
Comments	File	Photograph
Date:		
Timber rubble wall at opening to toilet window to men's toilet viewed above suspended ceiling and disturbed masonry above window.	IMG_677 3

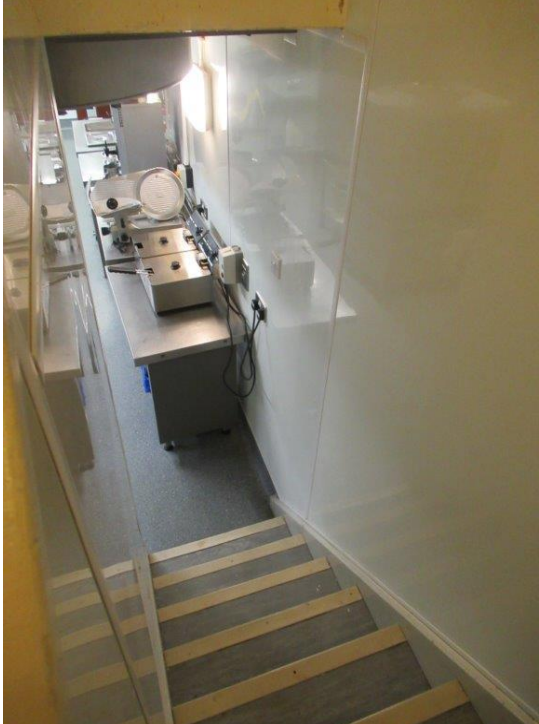
A photograph showing a close-up view of a stone building's exterior. A metal valley gutter runs along the roofline, leading down to a black downspout. The building is constructed of rough-hewn stone blocks. A blue car is partially visible in the bottom right corner.
<p>Stairs from kitchen leading to upper office and store areas. This area is open and therefore steam and warm moist air from the kitchen can rise up to these upper rooms. No formal extraction in these upper rooms.</p>	<p>IMG_685 3</p>

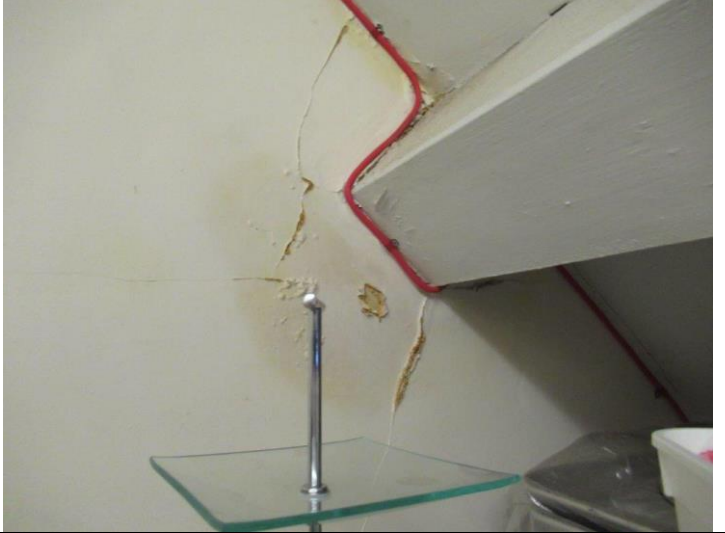
BARSCHEDULE OF PHOTOGRAPHS AND COMMENTS - Plas Tan y Blwch, Maentwrog, Blaenau Ffestiniog LL41 3YU - Snowdonia National Park Authority		
Comments	File	Photograph
Date:		
<p>Kitchen areas at first floor area above ground floor kitchen accessed off stairs. Note dampness to gable. Note salts emitting through wall at purlin position. Also note fire cable at position.</p>	<p>IMG_685 8</p>

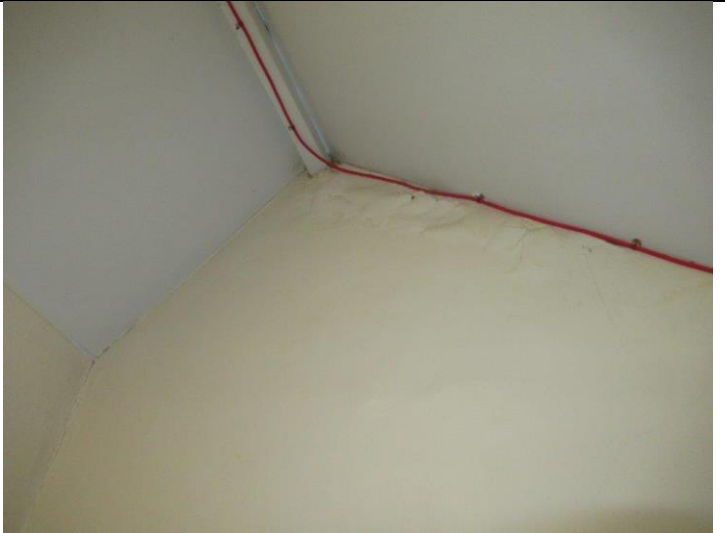
<p>Gable</p> <p>Note paintwork blowing at head of gable associated to copings possibly.</p>	<p>IMG_685 9</p>

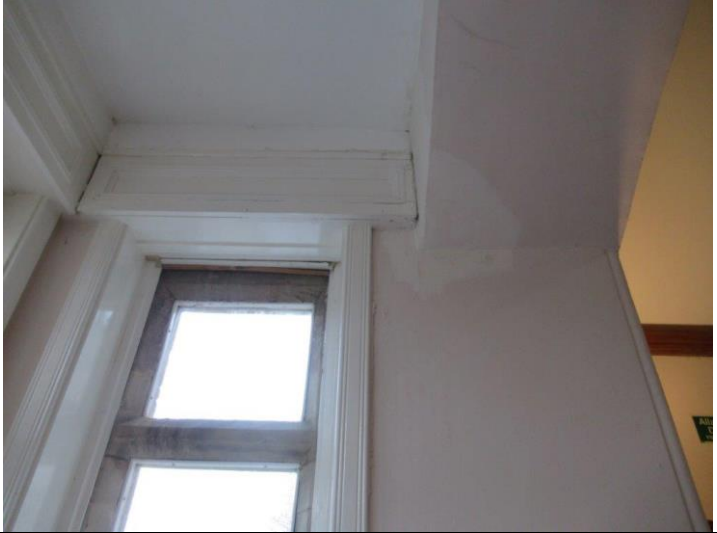
BARSCHEDULE OF PHOTOGRAPHS AND COMMENTS - Plas Tan y Blwch, Maentwrog, Blaenau Ffestiniog LL41 3YU - Snowdonia National Park Authority		
Comments	File	Photograph
Date:		
Note water penetration to one side of bay window which will relate to the outlet above typically when blocked for water penetration.	IMG_687 6

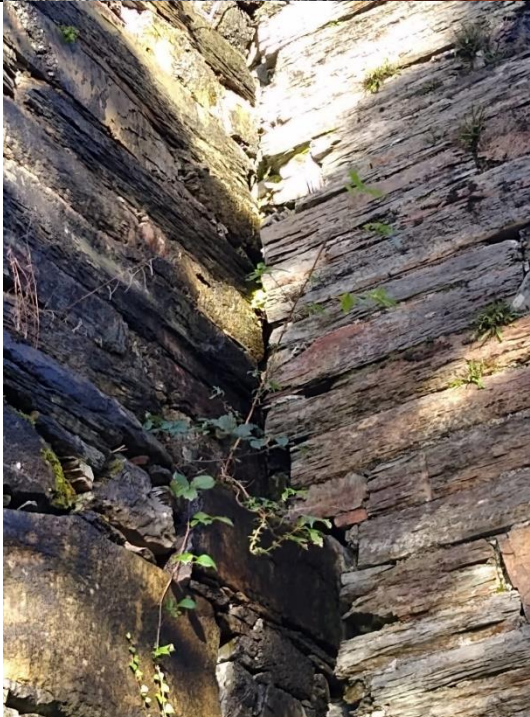
Image of cracking at buttress to retaining wall at second buttress from front right corner of retaining wall as facing front elevation. Elevation A1.	7b2b866b-933f-4b02-86bb-a32881afa791

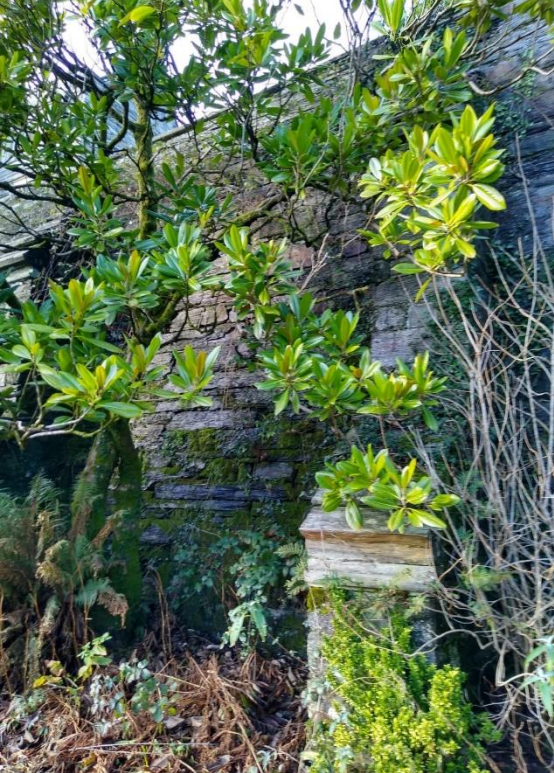
<p>Lower terrace retaining wall at one of the buttress positions. Some of the buttresses require repair due to weathering.</p>	<p>36b351f1-8b26-4bf7-928e-dac4df0c6967</p>

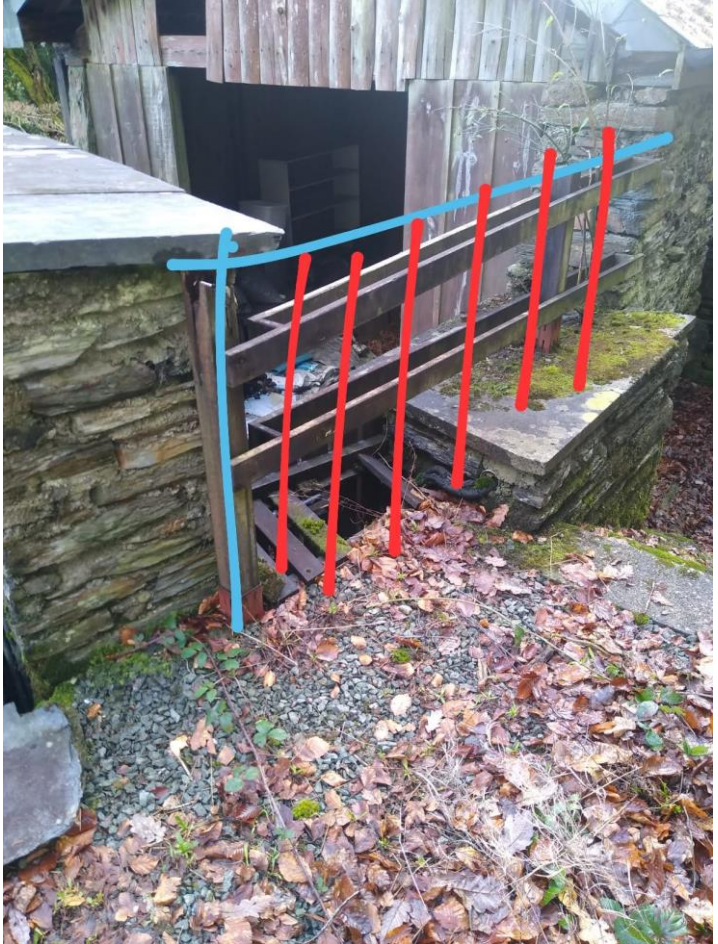
SCHEDULE OF PHOTOGRAPHS AND COMMENTS - Plas Tan Y Blwch		
Comments	File	Photograph
<p>Image with illustration of balustrading / guarding which should be provided at this location to secure the area from falls relating to junction of elevations J and K approximately.</p>	<p>21018998-69a1-431f-9d51-85ee53afb2e9</p>

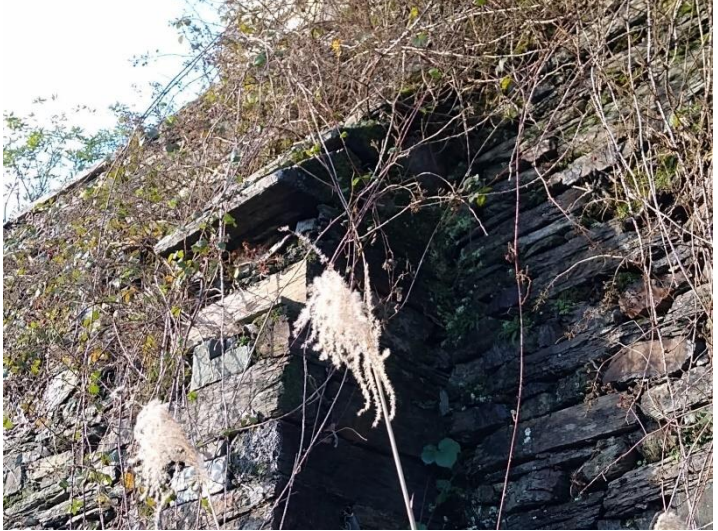
<p>Typical damage which has been noted to the buttressing associated to the retaining wall to the lower and upper terrace that requires repair to the buttresses. This is particularly relevant at the areas of the buttress where the pitched section of buttress meets vertical section.</p>	<p>33368672-1466-4dc2-b98e-ba07cf743c68</p>

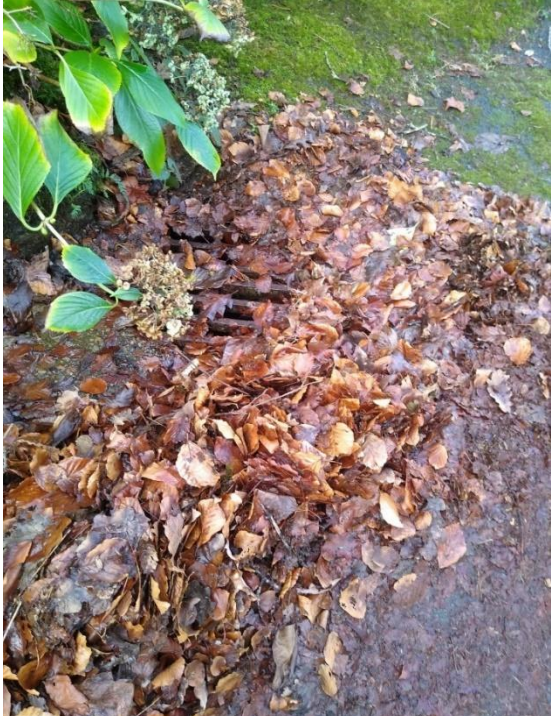
Foliage and leaf fall associated to road gully needs clearing or susceptible to blockage.	c141342f-8b81-46e0-bacd-6ccade94572a

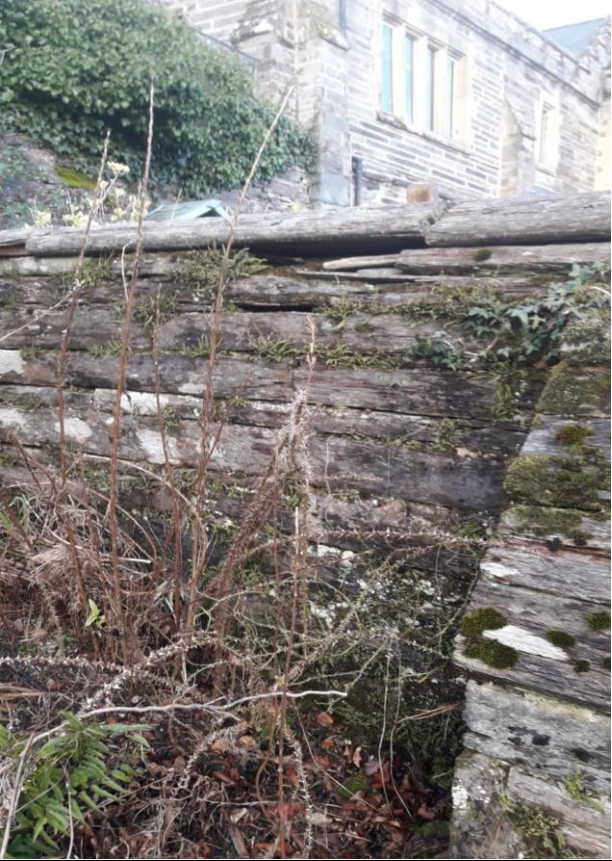
SCHEDULE OF PHOTOGRAPHS AND COMMENTS - Plas Tan Y Blwch		
Comments	File	Photograph
Note, stone repair required to balustrading. Stone balustrading associated to lower terrace.	fe1c298b-6c93-4475-a542-27f7c9dc8bf3

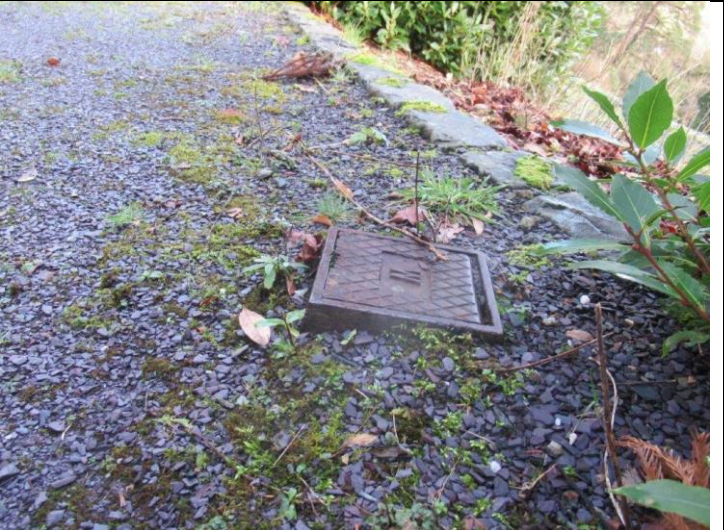
Water meter position to path uneven and raised poses trip hazard. Repair.	IMG_7535

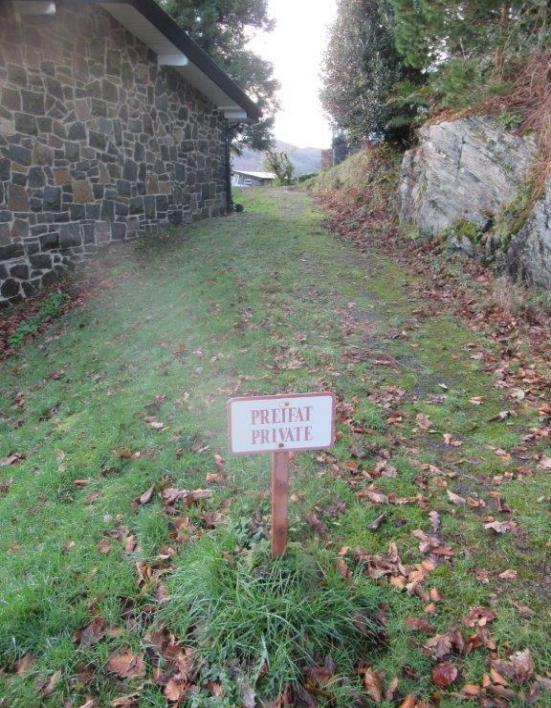
SCHEDULE OF PHOTOGRAPHS AND COMMENTS - Plas Tan Y Bwlch		
Comments	File	Photograph
<p>Not clear if this is accessible by garden users for accessibility purposes – wheelchairs etc and clarity on this and its adequacy considered if access permitted ?</p>	<p>IMG_753 9</p>

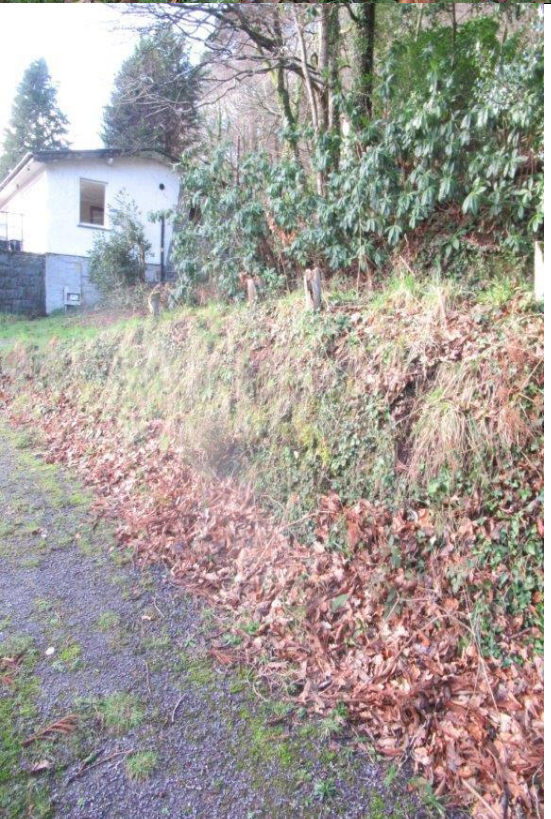
<p>View from house to Chalet. Not clear on accessibility at this location, also potential risk of drops to one side. Possibly consider some post and wire fencing at this location.</p>	<p>IMG_754 5</p>

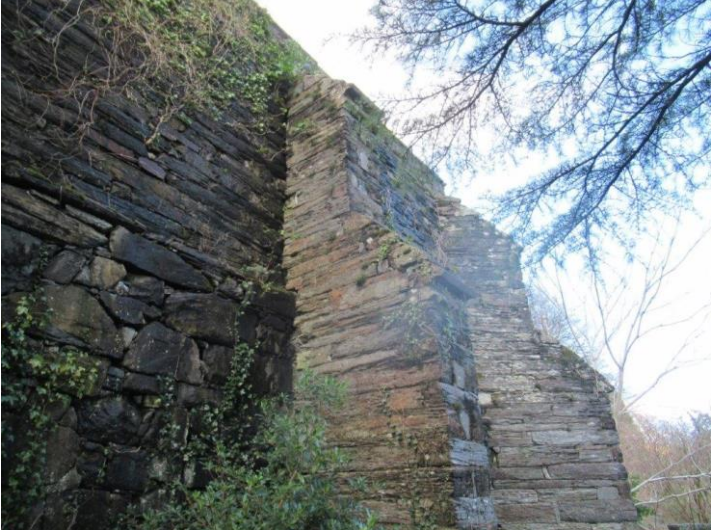
SCHEDULE OF PHOTOGRAPHS AND COMMENTS - Plas Tan Y Bwlch		
Comments	File	Photograph
Second buttress in from front right-hand corner to upper terrace elevation A1 and where cracking is occurring between buttress and retaining wall.	IMG_755 0
